INCIDENT

Aircraft Type and Registration:	Boeing 757-28A, G-TCBA	
No & Type of Engines:	2 Rolls-Royce RB211-535E4-37 turbofan engines	
Year of Manufacture:	1998	
Date & Time (UTC):	12 June 2010 at 0045 hrs	
Location:	Near London Gatwick Airport	
Type of Flight:	Commercial Air Transport (Passenger)	
Persons on Board:	Crew - 8	Passengers - 226
Injuries:	Crew - None	Passengers - None
Nature of Damage:	None	
Commander's Licence:	Airline Transport Pilot's Licence	
Commander's Age:	59 years	
Commander's Flying Experience:	16,875 hours (of which 8,134 were on type) Last 90 days - 139 hours Last 28 days - 76 hours	
Information Source:	Aircraft Accident Report Form submitted by the pilot

Synopsis

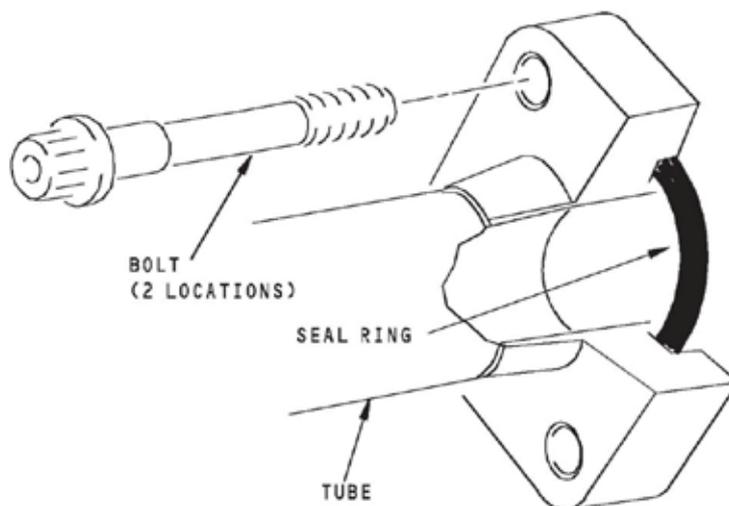
Figure 2

The operator's maintenance engineer traced the fuel leak to the seal ring between the HP fuel pump and the fuel flow governor (FFG) to HP fuel pump overspill return tube on the left-hand engine (shown in Figures 1 and 2). He therefore replaced this seal ring on both engines in accordance with the aircraft maintenance manual and a second maintenance engineer conducted a duplicate inspection, following which both engines were ground run at maximum static EPR to check for leaks. No fuel leaks were observed during this test and the aircraft was released to service.

FFG fuel overspill return tube coupling at the HP fuel pump (post SB RB.211-73-B047)

Investigation undertaken by the engine manufacturer determined that the width of the seal ring groove in the fuel tube end adapter was insufficient to allow the seal ring to seat properly in the groove when the joint was compressed during torque tightening of the assembly. If the seal ring did not seat correctly, it was possible for it to become pinched at the corners of the groove. The action of vibration and fuel pressure fluctuations caused portions of the pinched seal ring to erode, resulting in a loss of sealing capability.

As the seal ring removed from the aircraft was discarded following the incident, contrary to the operator's maintenance organisation's procedures, it has not been possible to identify positively the cause of the fuel leak. However, given the recorded history of fuel leaks due to trapping and subsequent erosion of the seal ring on engines without SB RB.211-73-G230 embodied, it is considered that this is the most likely mechanism that caused the fuel leak in this incident.

In response, the engine manufacturer introduced a further SB, RB.211-73-G230, in November 2009 that increased the width of the seal ring groove from 2.60 mm to 4.15 mm. No engines incorporating this SB have subsequently experienced fuel leaks at the HP fuel pump fuel tube couplings. The engine manufacturer comments that compliance guidance contained in this SB currently recommends embodiment of this modification when the engine is disassembled for refurbishment or overhaul. The modification is currently optional on-wing, when the parts require renewal or when the fuel tube connections are disturbed during maintenance.

Recent human factors analysis by the engine manufacturer indicates acceptable reliability when tubes are replaced during planned on-wing maintenance. Hence a revision to the Service Bulletin is planned, to recommend on-wing replacement during planned maintenance and during unplanned overhaul shop visits. Hence, it is expected that this modification will be fully implemented into the fleet by the end of 2013 and progress against this target will be monitored.
