## Boeing 727-230F, OO-DHY

| <b>AAIB Bulletin No: 12/2003</b> | <b>Ref: EW/C2002/11/04</b> | <b>Category: 1.1</b> |
| <b>Aircraft Type and Registration:</b> | Boeing 727-230F, OO-DHY | |

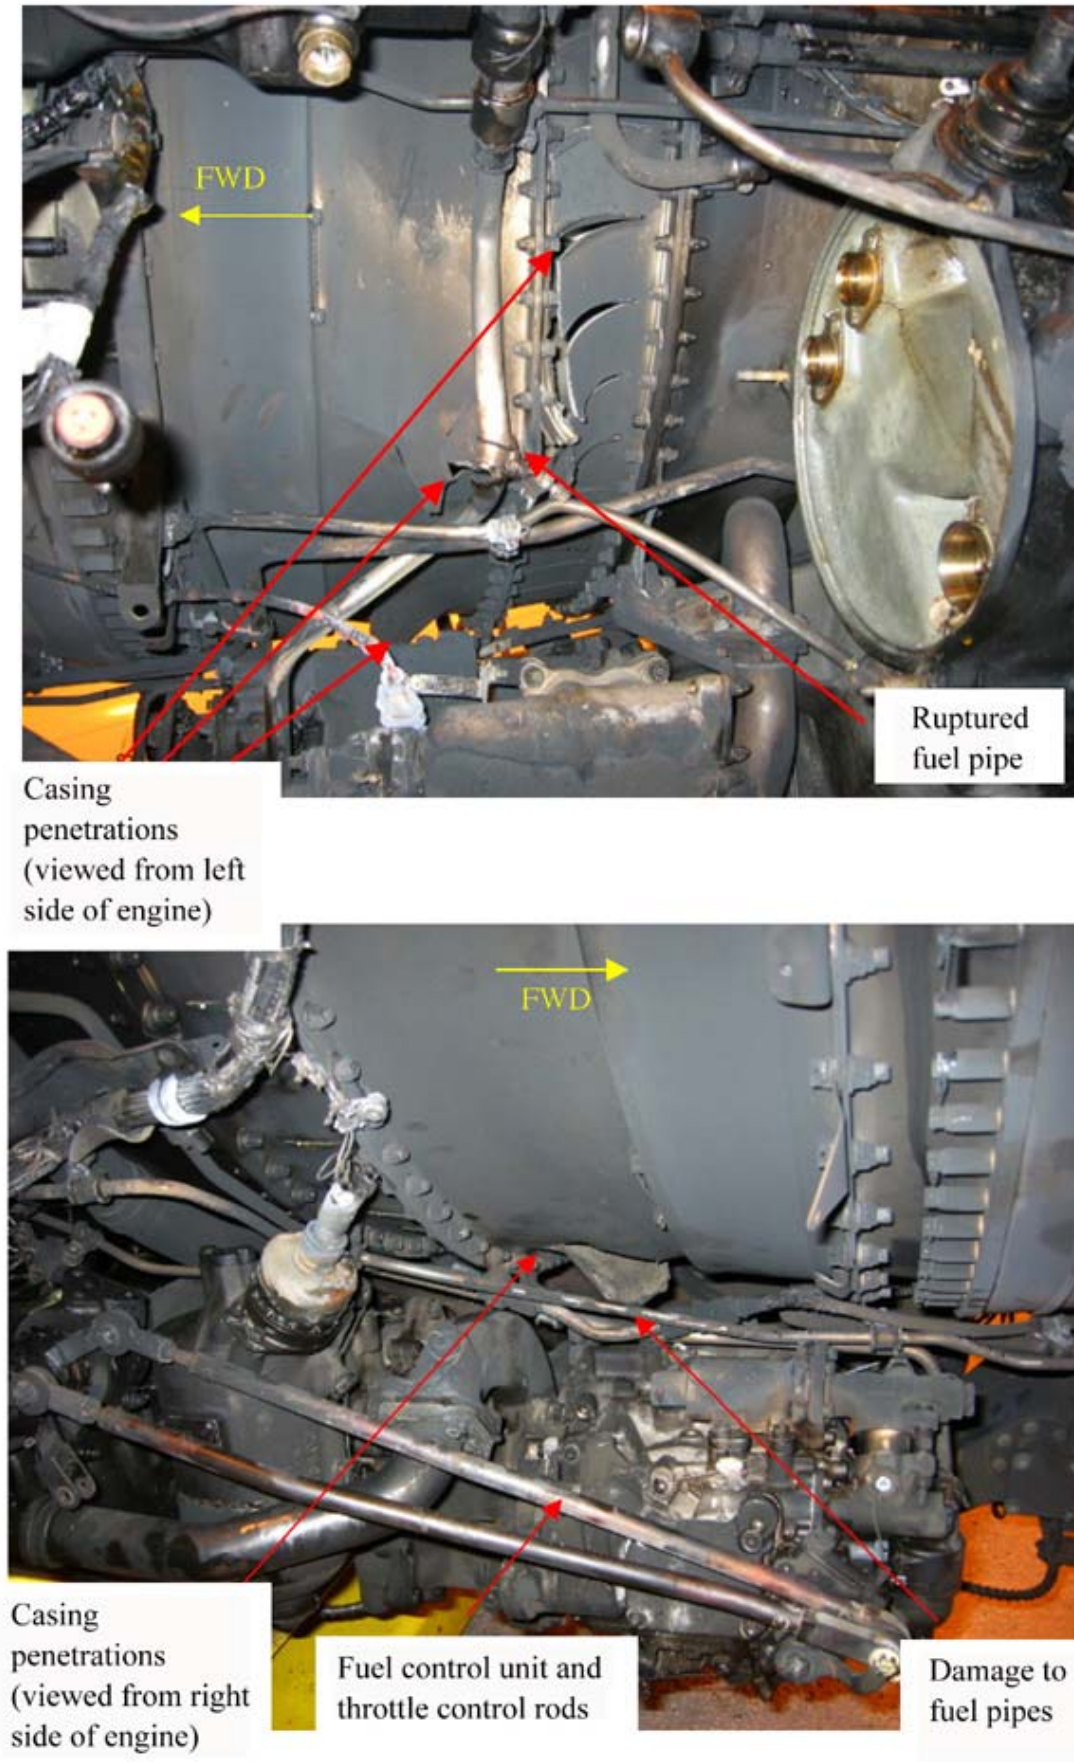
Figure 1 External Engine damage

No damage was evident externally, however, on opening the No 1 engine cowling there was evidence of significant fire damage centred around the underside of the engine. The fire has resulted in sooting and an oily residue around the outside of the engine casing and damage to wiring. The fuel control unit input rods showed signs of heat damage to the bearings. There was also evidence of penetration from inside the engine casing in the area of the discharge vanes in approximately the 5 o'clock position (viewed from the front). A small piece of debris was found within the cowling. Further examination revealed two penetrations of the engine casing around the 5 and 7 o'clock positions with damage to the oil tank and a ruptured fuel pipe (see Figure 1). Furthermore, some liberated material had penetrated and passed through the core of the engine, with some solidified metal spatter visible in the tail pipe. Visual examination of the LP compressor first stage showed moderate damage to both leading and trailing edges of the stator and rotors.

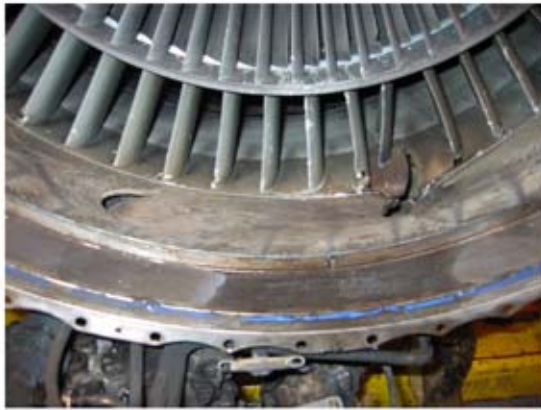
The penetration marks on the fan case were consistent with fan blade release kinematics. The initial blade tip impact was in the plane of rotation and the impact of the blade root was aft of the plane of rotation. Both impacts tore the containment case. It is probable that no significant material exited through these penetrations as only one piece of blade strap material was recovered from inside the cowling. There was no evidence of cowl penetration.

Second stage assembly removed - casing penetrations at 5-7 o'clock positions

The fan discharge vanes were severely damaged in the area of the case rupture and also in the 1 to 3 o'clock position. This appeared to have been caused by the liberated blade being dragged around just prior to final release or just after release. It is likely that the blade tip material exited via this route. There was also some damage to the core inlet guide vanes.

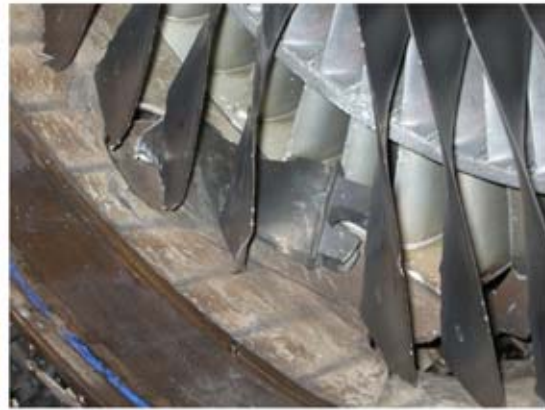
A boroscope examination and partial engine strip revealed that a second stage LP compressor fan blade had detached. A portion (approximately 2/3 span) of the blade had been retained within the casing. The blade had fractured at the root attachment that consisted of two clevis-type straps. The attachment pin was intact and still in place (see Figure 2).

Second stage fan assembly - 'as found' position of detached blade

Visual examination of the blade root fracture surfaces revealed extensive post failure rubbing damage. Where the surfaces had not been destroyed there was evidence indicating ductile overload failure. One of the fractures had a stepped appearance unlike the other three and is therefore considered to be a possible initiation site for the failure, however, post-failure damage had destroyed any corroborative evidence. There was also some twist in the root section indicating that the forces on the blade were sufficient to deform it during the failure. It was also probable that the forward part of the root had failed first, with the rear failing in overload during the twisting.

It is recommended that the FAA, in conjunction with Pratt & Whitney review the inspection and re-inspection period for the LP compressor second stage fan blades as detailed in ASB 5729 and mandated in AD 87-14-01.

It is recommended that the FAA, in conjunction with Pratt & Whitney, mandate SB 5866 that provides a more durable second stage fan blade root attachment and a higher life second stage disk.
