INCIDENT

Aircraft Type and Registration:	DHC-8-402 Dash 8, G-ECOK
No & Type of Engines:	2 Pratt & Whitney Canada PW150A turboprop engines
Year of Manufacture:	2008 (Serial No: 4230)
Date & Time (UTC):	16 Nov 2011 at 1300 hrs
Location:	8 nm north-east of Manchester Airport
Type of Flight:	Commercial Air Transport (Passenger)
Persons on Board:	Crew - 4 Passengers - 46
Injuries:	Crew - None Passengers - None
Nature of Damage:	None
Commander's Licence:	Airline Transport Pilot's Licence
Commander's Age:	46 years
Commander's Flying Experience:	7,000 hours (of which 1,600 were on type) Last 90 days - 130 hours Last 28 days - 50 hours
Information Source:	Aircraft Accident Report Form submitted by the pilot, operator's Safety Investigation Report and recorded flight data

Synopsis

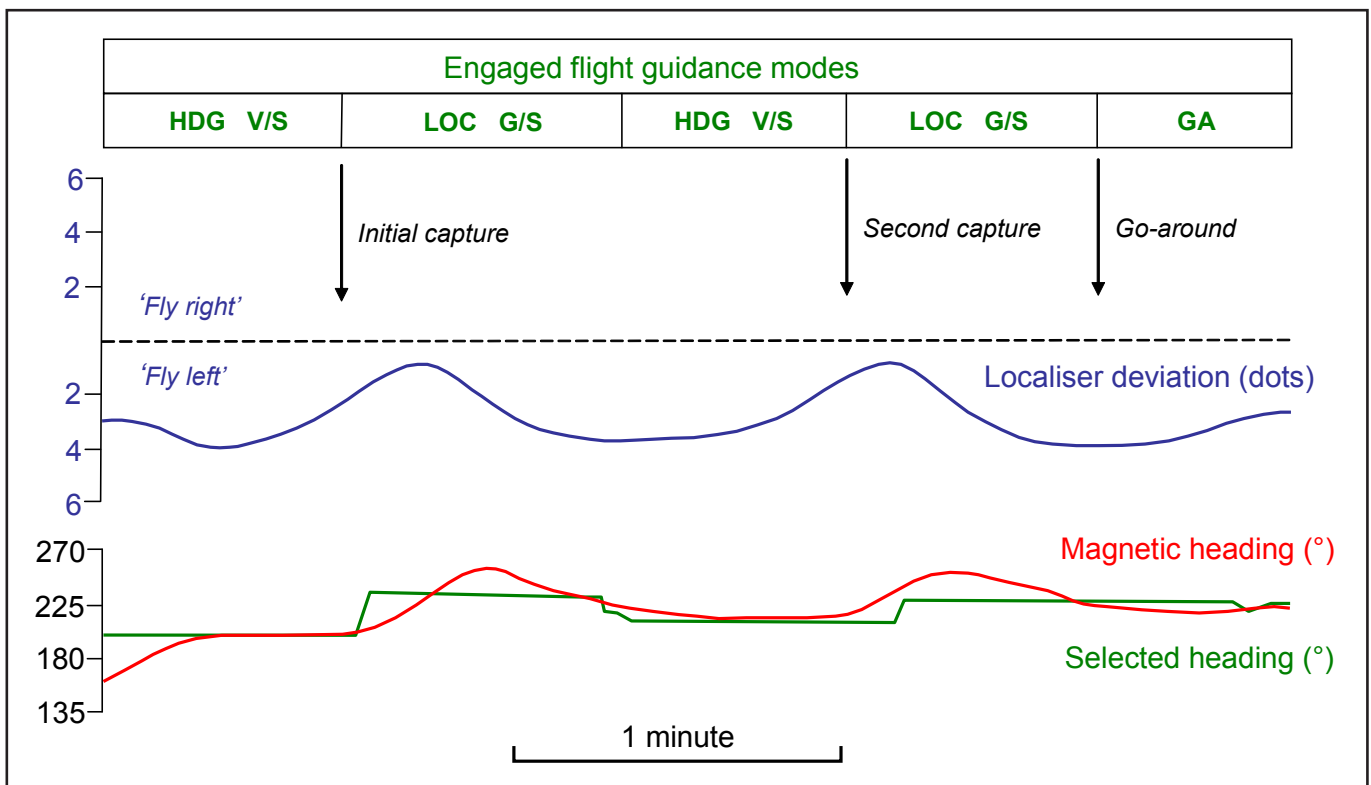
QAR derived information showing the relationship between localiser deviation and aircraft heading, with engaged flight guidance modes

As Figure 1 shows, the pattern of each localiser capture and subsequent deviation is remarkably similar. It is reasonable to assume that the handling pilot followed the flight guidance on each occasion (as he reported) in which case the flight guidance system responded in a very similar manner on each occasion too. With both

ILS receivers showing consistently accurate deviation and the position and altitude of each intercept being different, it is most likely that the guidance issue arose as a result of the discrepancy between the left and right inbound courses selected on the flight guidance control panel.
