Aircraft type and registration: Enstrom F28A G-BCFP (single engined light helicopter)

Date and time (GMT): 9 September 1984 at 1440 hrs

Location: Nr Theale, Reading

Nature of damage: Damage to main rotor blades and aircraft nose sufficient to make the helicopter uneconomic to repair

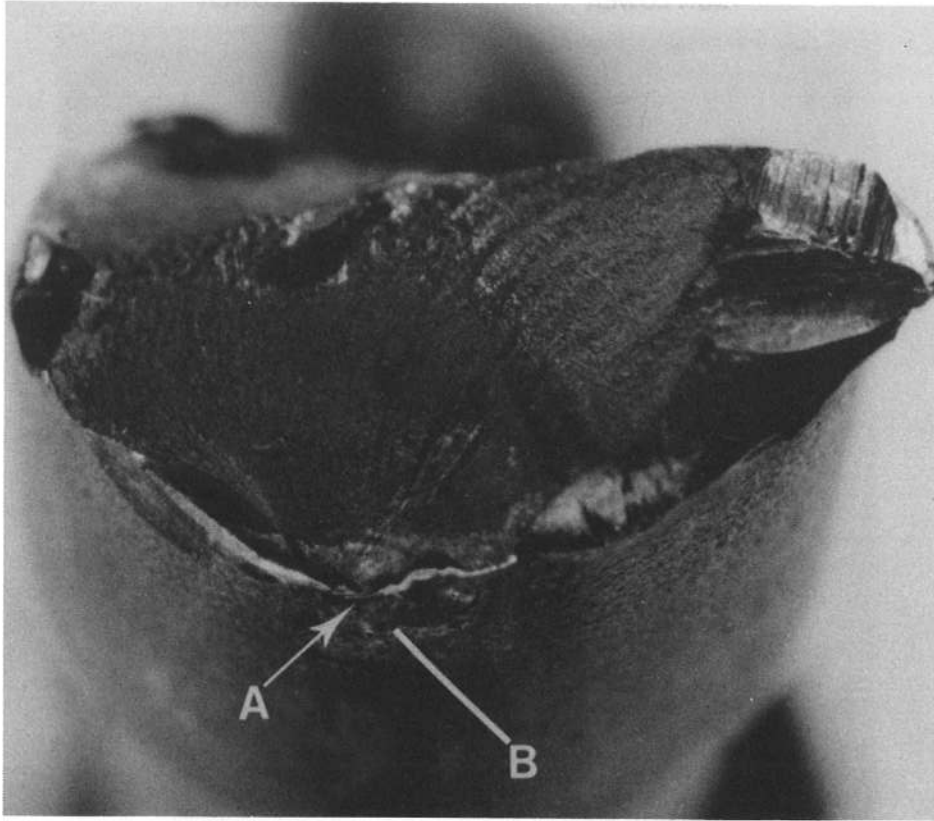
During the examination, portions of both No 2 big-end cap bolts (Lycoming Part No 75060) were recovered. Metallurgical examination of these bolts showed their material strength not to be in question but that their fracture faces revealed evidence of fatigue.

The upper one had fractured through the fitted land and the fracture, shown in Figure 1, exhibited clear evidence of fatigue crack growth to a depth of about 30% of the bolt cross section from an origin, arrowed A. This was associated with a small region of fretting on the surface of the land, arrowed B. The fracture surface of the lower bolt, shown in Figure 2, had failed in the waisted length. The fracture surface exhibited evidence of high strain fatigue, and although the region of initiation had been obscured by mechanical damage, it was evident that it had been caused as a direct result of the upper bolt failure.

FIG 1 FRACTURE OF NO.2 UPPER BOLT

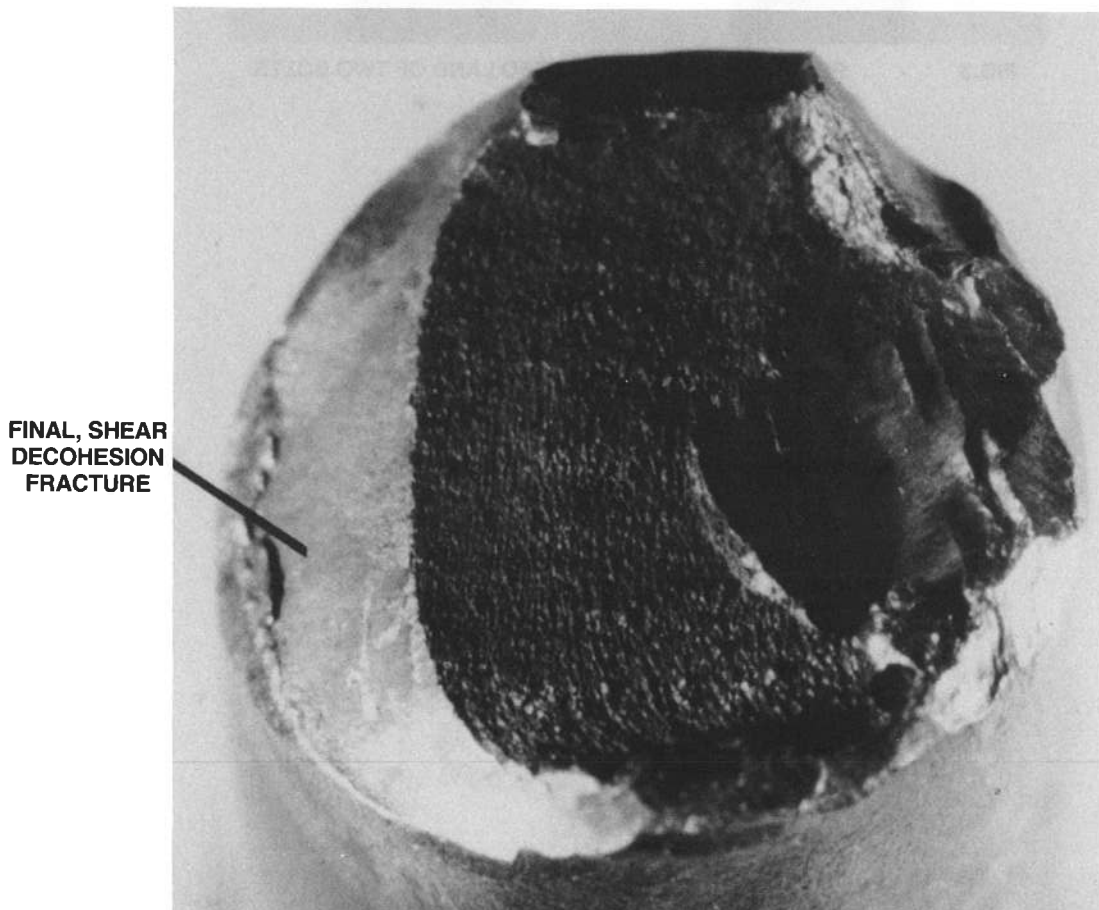
FIG.2 FRACTURE OF NO.2 LOWER BOLT

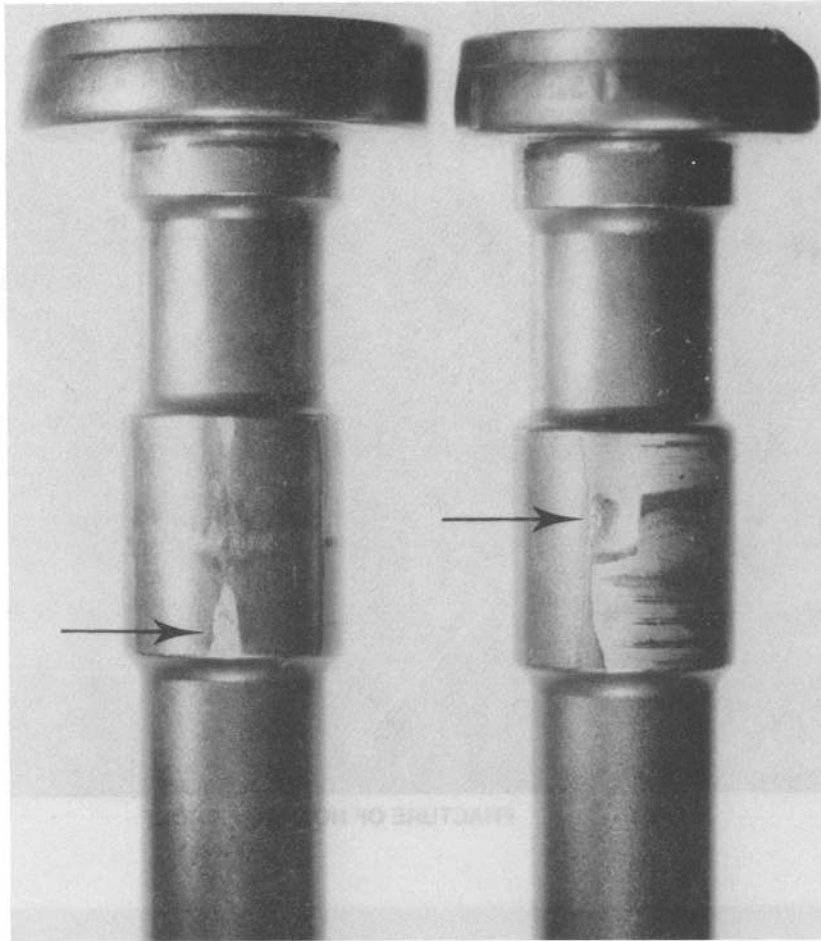
FIG.3

Examination of the other bolts from this engine revealed further evidence of fretting damage, although in most cases this was confined to the protective cadmium layer. The two worst examples are shown in Figure 3. Signs of wear similar to that shown in this Figure were visible on most of the cap bolts removed from this engine. It was evident that this wear had been induced by side contact of the bolts with the walls of their respective holes through the big-end journals, where comparable signs of wear were visible.

NO.1 LOWER

NO.3 LOWER

FRETTING DAMAGE ON FITTED LAND OF TWO BOLTS
