**No: 1/91**

**Ref: EW/A342**

**Aircraft Type and Registration:** Boeing 747-287B, G-VIRG

**Nature of Damage:** Damage to left inboard flap unit, left inboard aileron, Nos 3 & 4 canoe fairings and left inboard aft flap drive mechanism

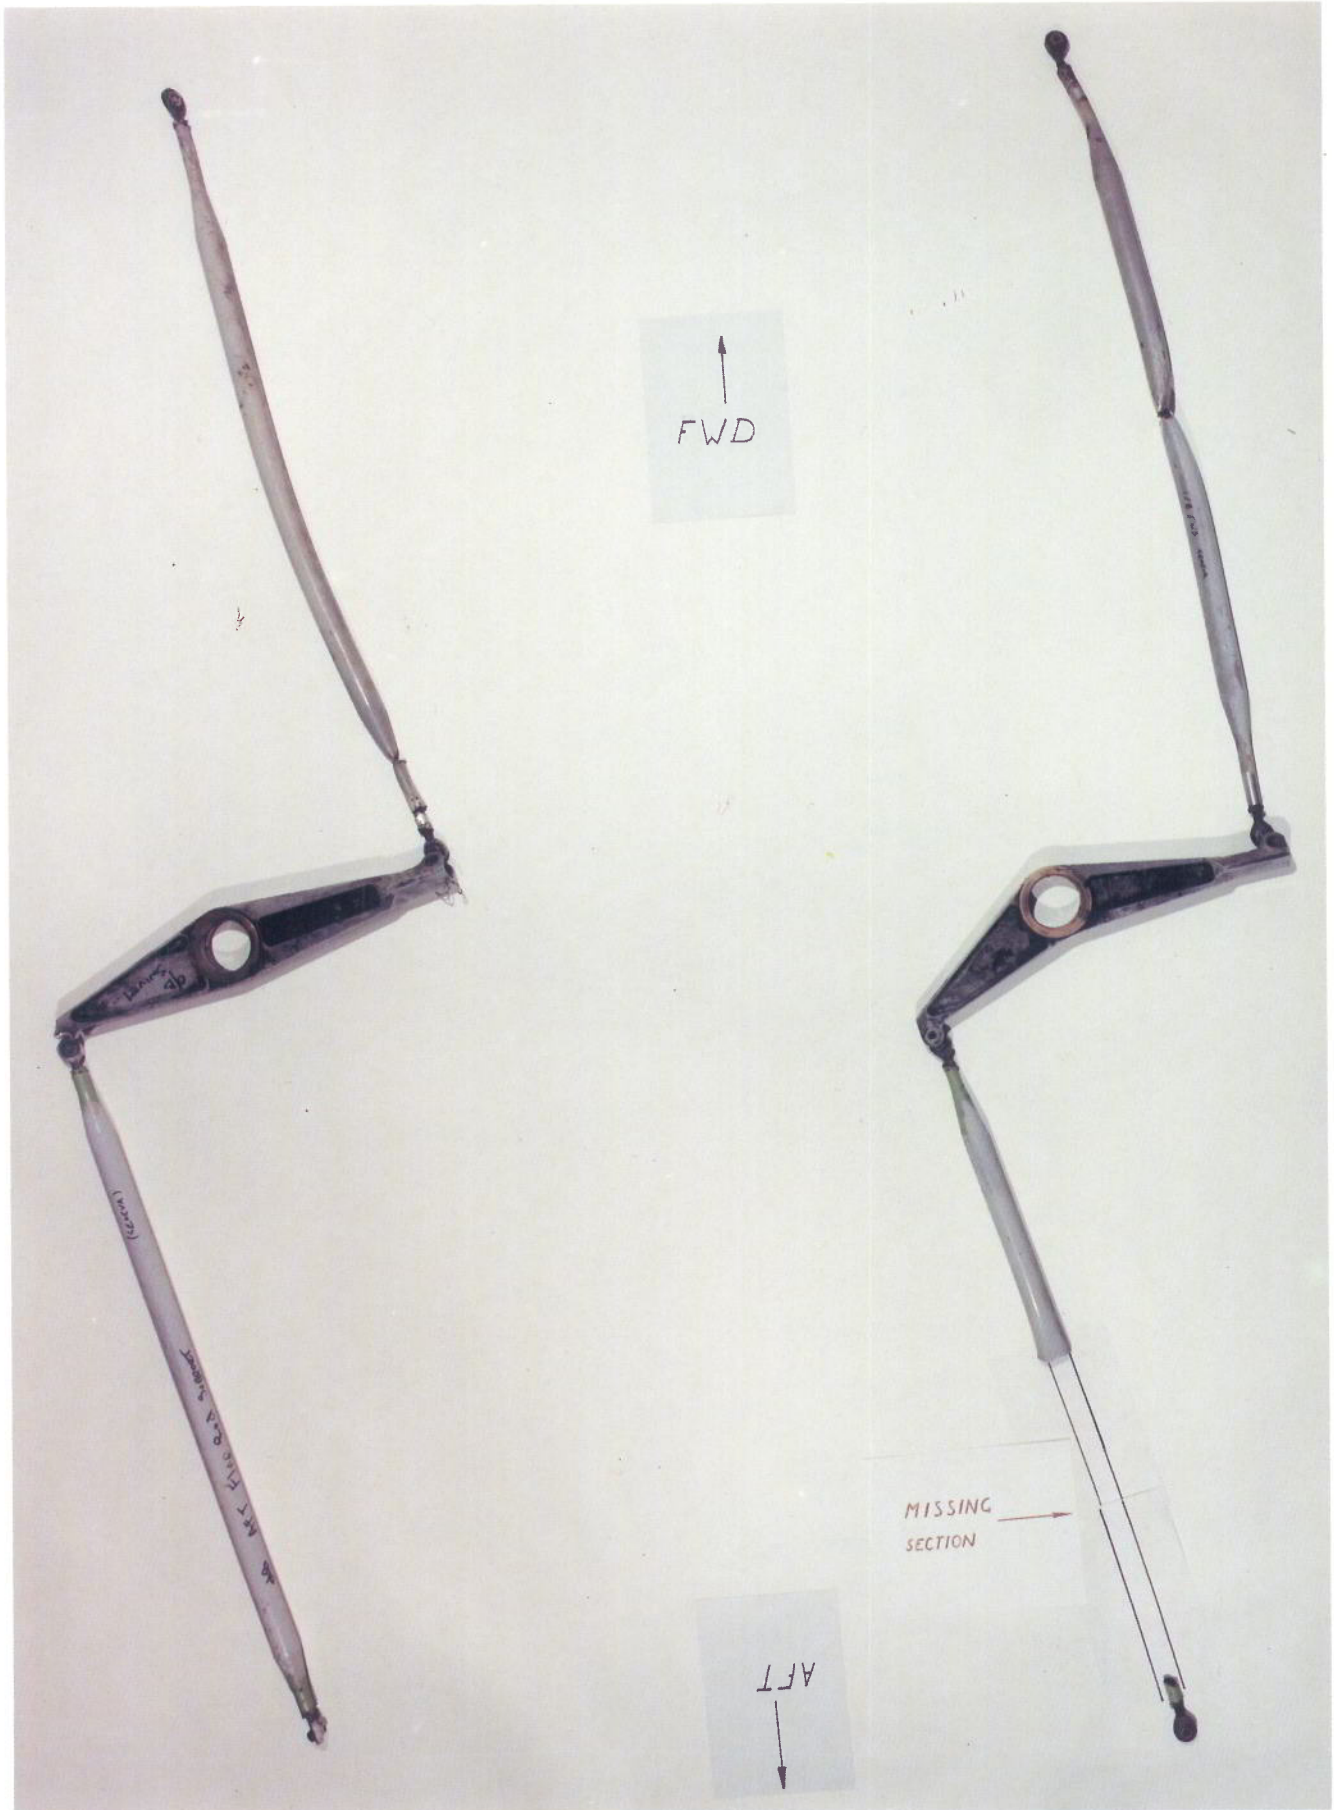
VIEW A

The failed operating rods were examined by AAIB. Since they bore no visible identification, it was necessary to re-assemble them, measure their original lengths, and compare these with the lengths of operating rods on a similar 747 aircraft. It was then established that a section of the inboard aft rod was missing. Although some photographs of the damaged area had been taken by the operator at Kennedy Airport before the repairs were made, they were sufficient only to establish the orientation of the inboard pair of rods. Later photographs of the operating rods and bellcranks taken at the AAIB are in the Appendix; View A shows the position of the mechanism with flaps extended to approximately 30° and View B shows the mechanism overextended, following failure of the forward rods.

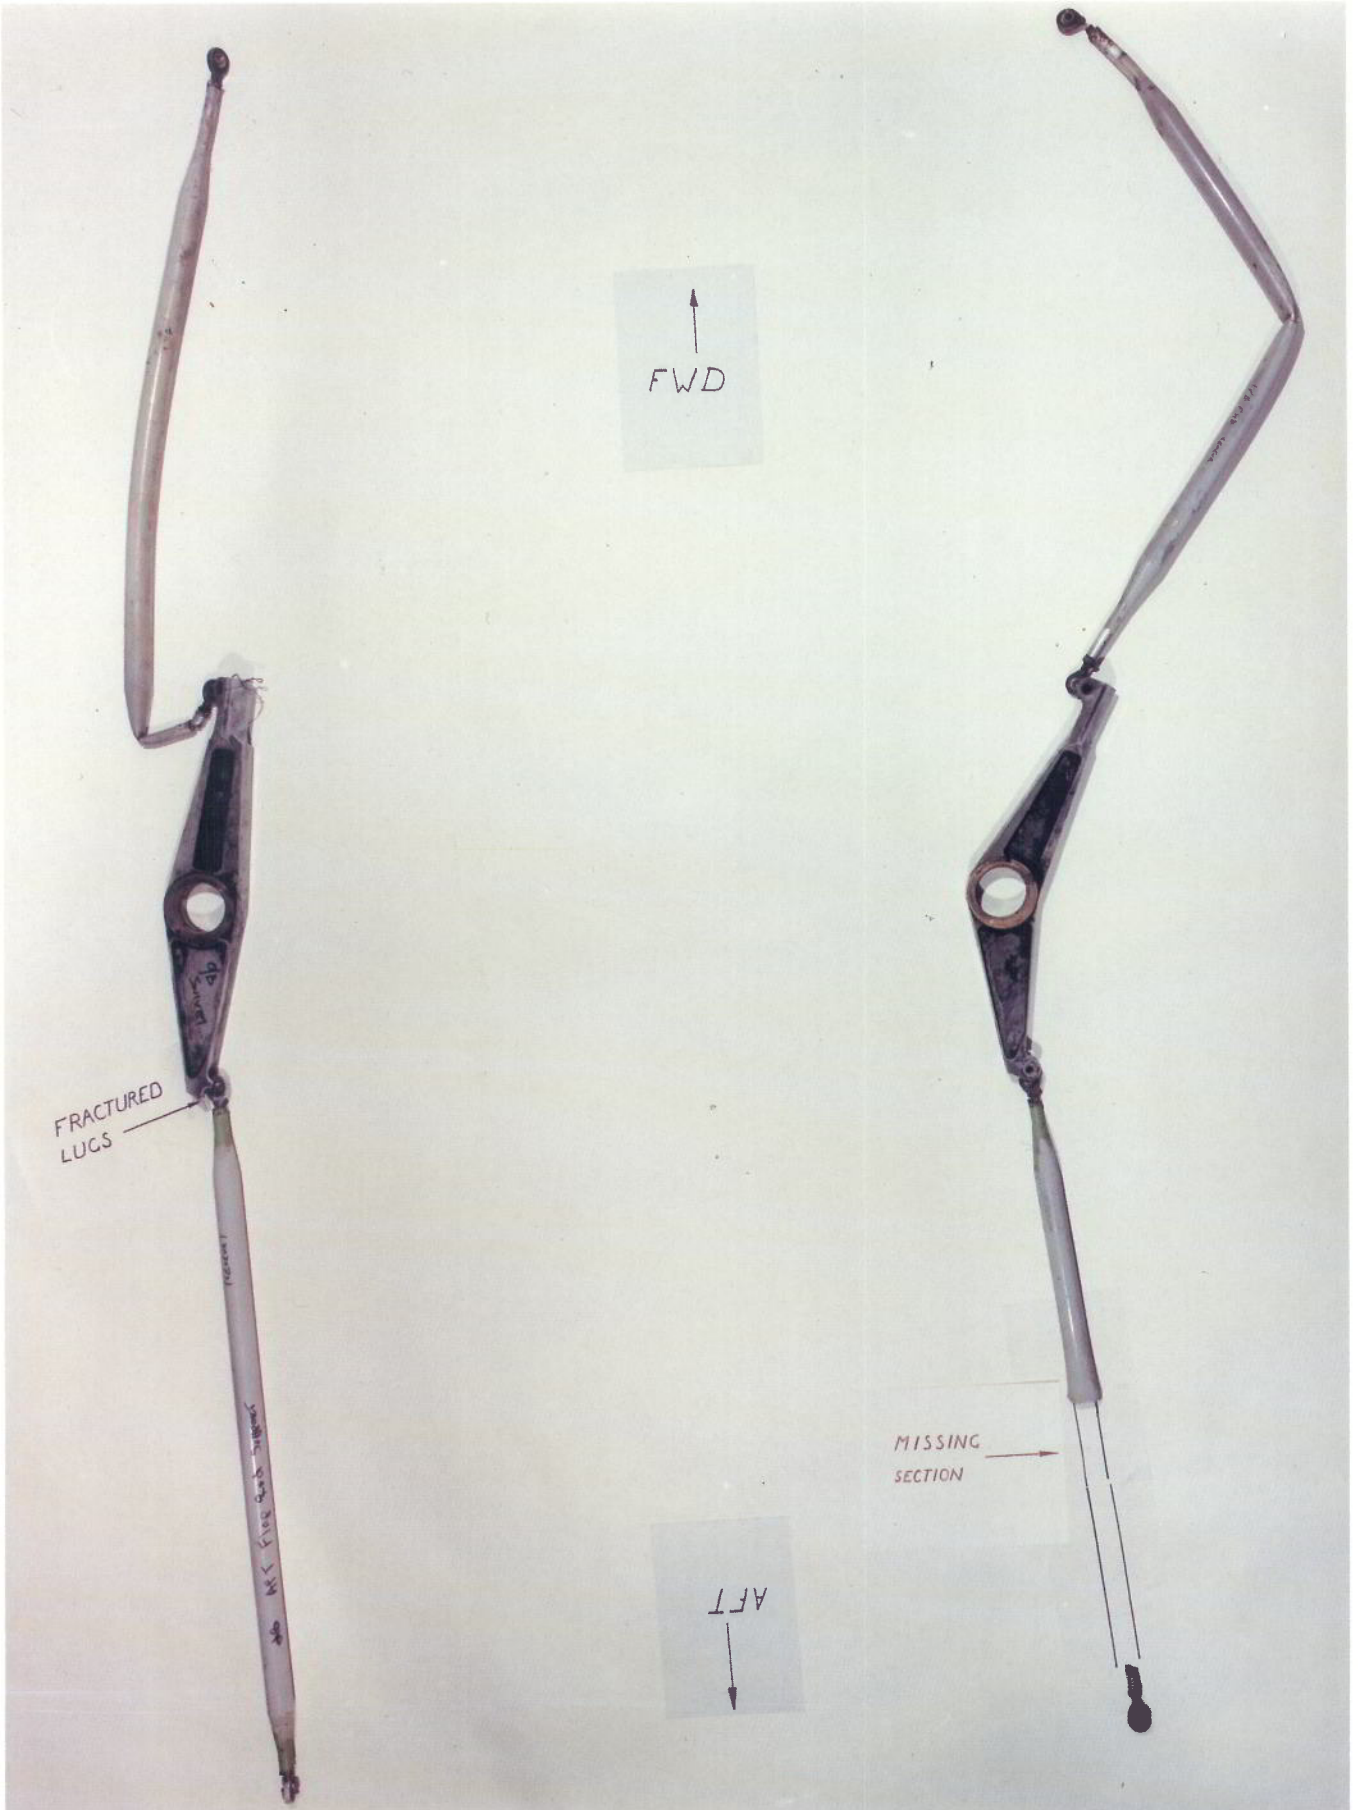
VIEW B

Examination of the rods and bellcranks revealed that both forward rods had failed in a complex fashion, initially in compressive buckling. The aft outboard rod had remained intact but its attachment lug on the bellcrank had failed. The inboard aft rod had broken into three segments, which were:

- a. compressive buckling and failure of the two forward rods arising from forceful overtravel of the aft flap beyond the selected position;
- b. continued movement of the aft flap beyond the maximum down (flaps 30) position, until the bellcranks were orientated fore and aft.
- c. sudden high tensile loads then occurring in the aft drive rods as the bellcranks reached the fore and aft position, reacted wholly by the bellcrank pivots, causing failure of the lugs on the outboard bellcrank attachment to the aft outboard rod and corresponding tensile failure of the aft inboard rod.
- d. compressive loading applied to the free end of the inboard aft rod during subsequent flap retraction or later during flap extension for examination. Such loading may have occurred as a result of the free end fouling part of the structure or mechanism within the canoe fairing
