Aircraft Type and Registration:	Yak-18T, RA-44506	
No & Type of Engines:	1 Ivchenko Vedeneyev M-14P piston engine	
Year of Manufacture:	1980	
Date & Time (UTC):	22 September 2002 at 1310 hrs	
Location:	Sleap Aerodrome, Shropshire	
Type of Flight:	Private	
Persons on Board:	Crew - 1	Passengers - 1
Injuries:	Crew - None	Passengers - None
Nature of Damage:	Damage to the left wing and landing gear	
Commander's Licence:	Private Pilot's Licence, with IMC and night ratings	
Commander's Age:	59 years	
Commander's Flying Experience:	12,000 hours (of which 232 were on type) Last 90 days - 22 hours Last 28 days - 22 hours	
Information Source:	Aircraft Accident Report Form submitted by the pilot

History of the flight

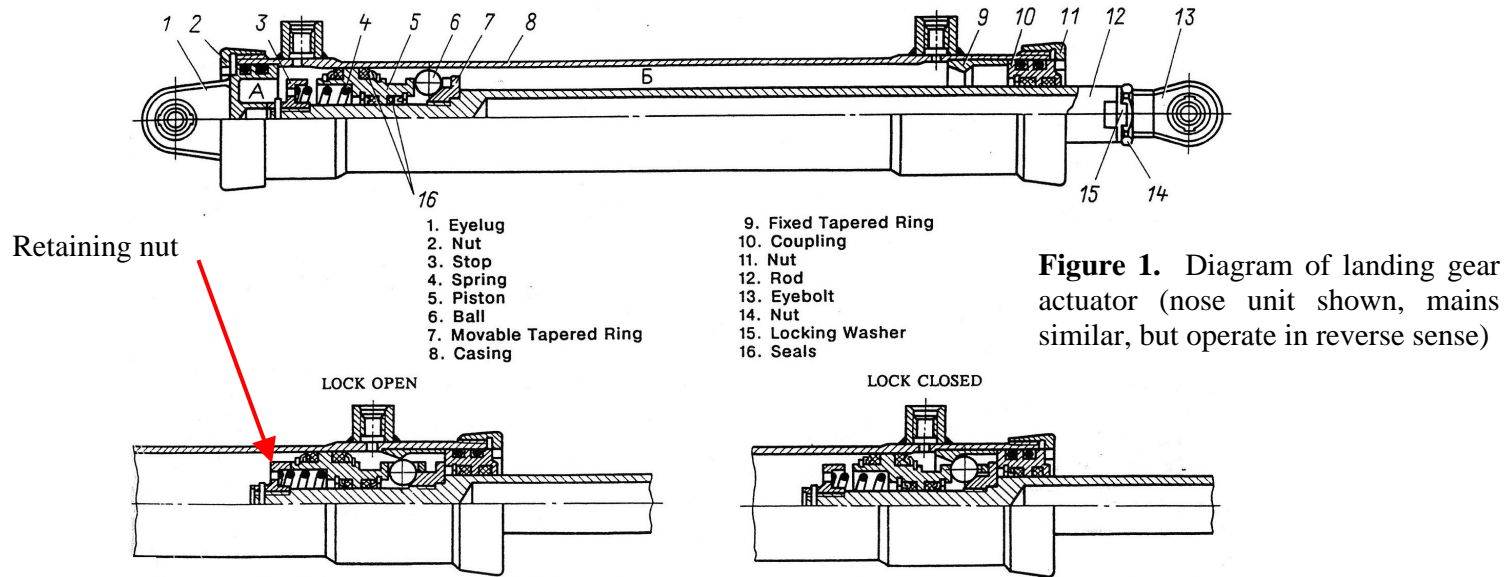
In the absence of a suitable drawing of a main landing gear actuator, Figure 1 shows a part sectional drawing of the nose gear actuator, in which the downlock mechanism is displayed. The piston, acting under pneumatic pressure, pushes a ring containing ball bearings against a tapered ring on the actuator ram. This pushes the balls outwards so that when the piston/ball bearing sleeve assembly reaches the end of its travel, the balls lock behind the lip of a fixed tapered ring in the actuator cylinder. When the landing gear is retracted, air is ported to the opposite side of the piston, the initial movement of which is against a spring. This movement pulls the sleeve away from the tapered ring on the ram, which allows the balls to drop back inside the lip of the fixed tapered ring, thus removing the downlock.

The piston assembly, together with the spring, are held in position by a retaining nut threaded onto the spindle at the end of the actuating ram. A locking pin (not shown in Figure 1) prevents rotation of the nut.

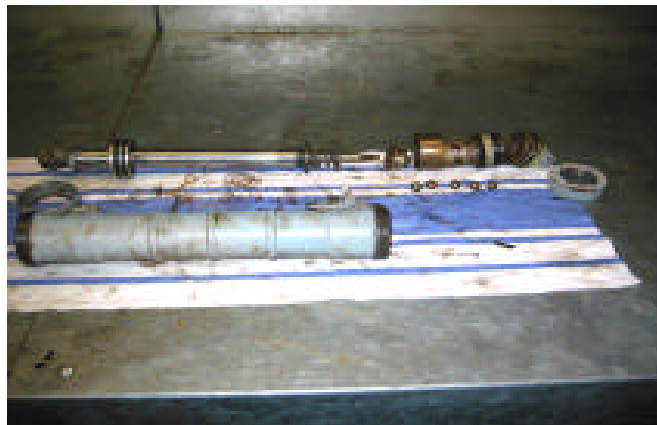
After disassembly of the failed landing gear actuator, it was immediately apparent that the retaining nut had come off the threaded spindle. The components of the actuator are shown in the photograph at Figure 2. Corrosion on the threads was seen (Figure 3) and, although the threads were visible, it was apparent that the thread crests had been stripped away. Following the failure of the threads, the loads would have been transferred to the locking pin, which then suffered a double shear failure. The three pieces of the pin produced as a result of this failure are also shown in Figure 3.

Figure 2. Actuator components

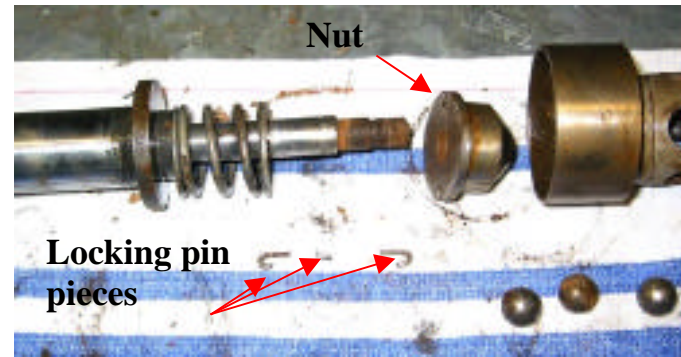
Following the release of the nut, the piston and sleeve assembly would have remained in the downlock position, but the actuator ram would have been unrestrained. Landing gear collapse would have occurred when the side brace was induced out of its over centre condition, perhaps by a runway surface irregularity.

Since arriving in the United Kingdom during the spring of 1999, RA-44506 had flown comparatively little. It is thus possible that, during recent years, considerable calendar time had elapsed between anti-corrosion treatments, leading to corrosion within the actuator. It should also be noted that pneumatic systems are prone to collect water, as a result of the compression process, with an associated risk of corrosion unless the system is drained after every flight.

Figure 3. Part of downlock mechanism; note corroded threads on actuator ram spindle

The Russian maintenance schedule required that anti-corrosion treatment to be applied to the landing gear actuators at intervals of 100 flying hours. This took the form of injecting a 50:50 mixture of glycerine and isopropyl alcohol into the actuator cylinders. The United Kingdom organisation that

imported the aircraft, and who subsequently maintained it, recommended that the treatment should be applied every 50 flying hours.
