**AAIB Bulletin No:** 12/93

**Aircraft Type and Registration:** Bell 206L-1 LongRanger, G-LONG

**Location:** Battersea Heliport

**Nature of Damage:** Tail boom creased in down flexure, engine turbine case ruptured with minor non-containment of debris

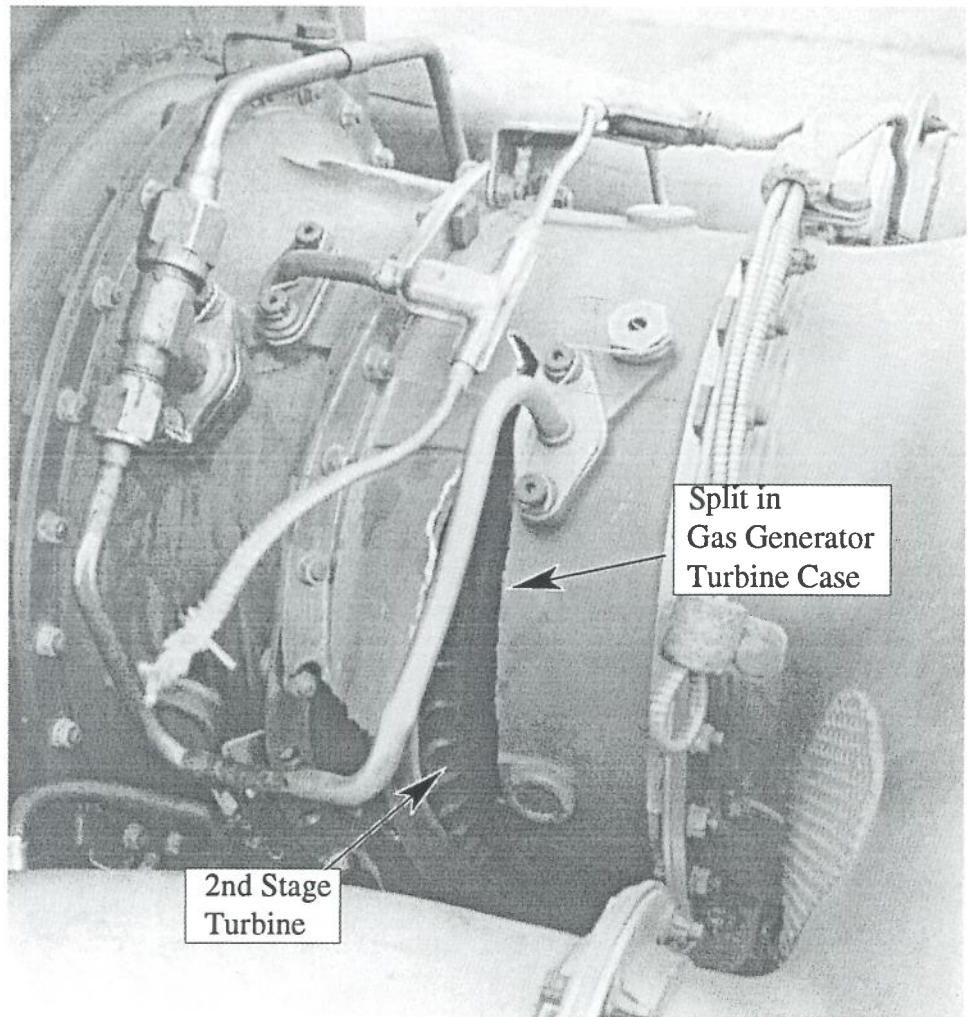
The aircraft was moved from Battersea to its maintenance base where examination revealed a hole in the turbine case (Fig 1) of the engine and evidence of small fragments having pierced the engine cowlings from the inside. It could be seen, through the hole, that the 1st stage turbine of the gas generator had fragmented and the loose segment (Fig 2), which could be extracted, constituted about  $\frac{1}{3}$  of the perimeter of the complete turbine wheel.

Fig 1 Turbine Section of engine of G-LONG

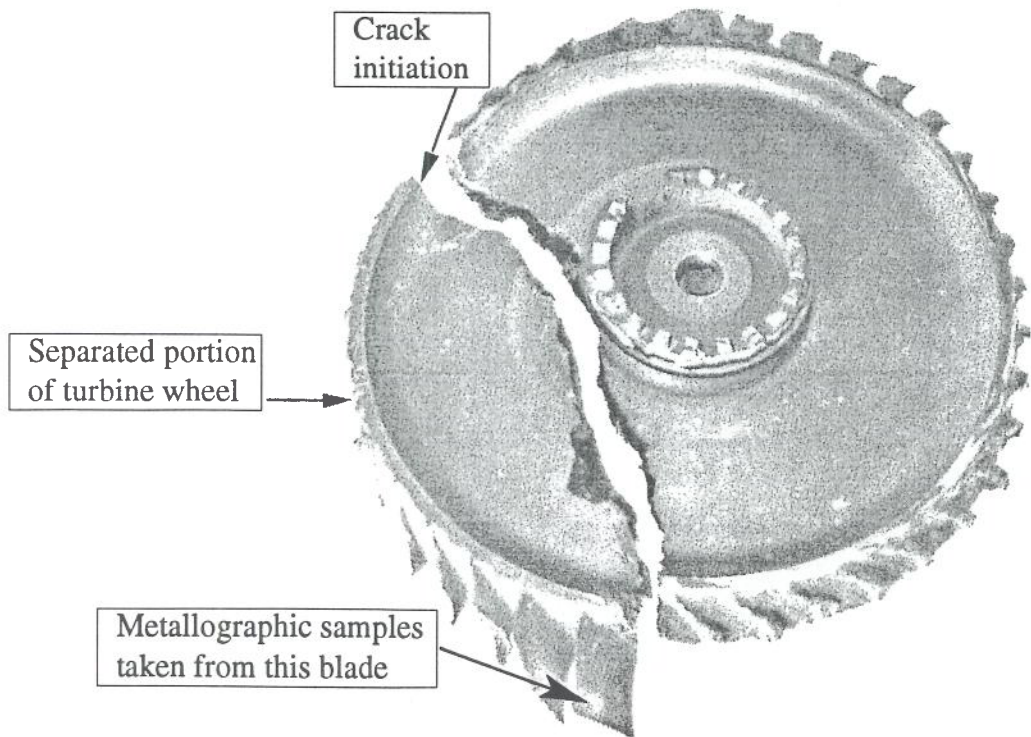
The 1st stage turbine fragments were subjected to metallurgical examination at DRA Farnborough which revealed that the major portion of the fracture had occurred as a fast brittle mode. This had, however, emanated from the base of a sector of the crack which ran almost directly radially towards the wheel centre and exhibited heavily oxidised fatigue like features. Examination also revealed a considerable number of small radial cracks in the rim of the turbine wheel disc. One of these was broken open and revealed some evidence of progression by a thermal fatigue mechanism. Metallographic examination of the only remaining full length turbine blade revealed evidence that the turbine had been subjected to an overtemperature within the recent past, probably of the order of 10 hours previously.

Fig 2 Fragmented 1st Stage Turbine Wheel

As a result of this accident, Bell Helicopter are about to issue an Alert Service Bulletin which will require that Bell 206L-1 aircraft are fitted with a turbine temperature gauge incorporating a 'tell tale' light, to assist operators to avoid inadvertent turbine overheat damage during start-up. There are currently only 3 aircraft, all of them Bell 206L-1 LongRangers, on the UK register which are fitted with this engine type.
