**ACCIDENT**

<b>Aircraft Type and Registration:</b>	Piper PA-34-220T Seneca III, G-LENY
<b>No &amp; Type of Engines:</b>	2 Teledyne Continental TSIO-360-KB piston engines
<b>Year of Manufacture:</b>	1982
<b>Date &amp; Time (UTC):</b>	19 December 2007 at 1709 hrs
<b>Location:</b>	4 nm south of Oxford (Kidlington) Airport
<b>Type of Flight:</b>	Commercial Air Transport
<b>Persons on Board:</b>	Crew - 1                      Passengers - None
<b>Injuries:</b>	Crew - 1 (Serious)      Passengers - N/A
<b>Nature of Damage:</b>	Aircraft destroyed
<b>Commander's Licence:</b>	Commercial Pilot's Licence
<b>Commander's Age:</b>	52 years
<b>Commander's Flying Experience:</b>	4,268 hours (of which 1010 were on type) Last 90 days - 164 hours Last 28 days - 46 hours
<b>Information Source:</b>	AAIB Field Investigation

**Synopsis**

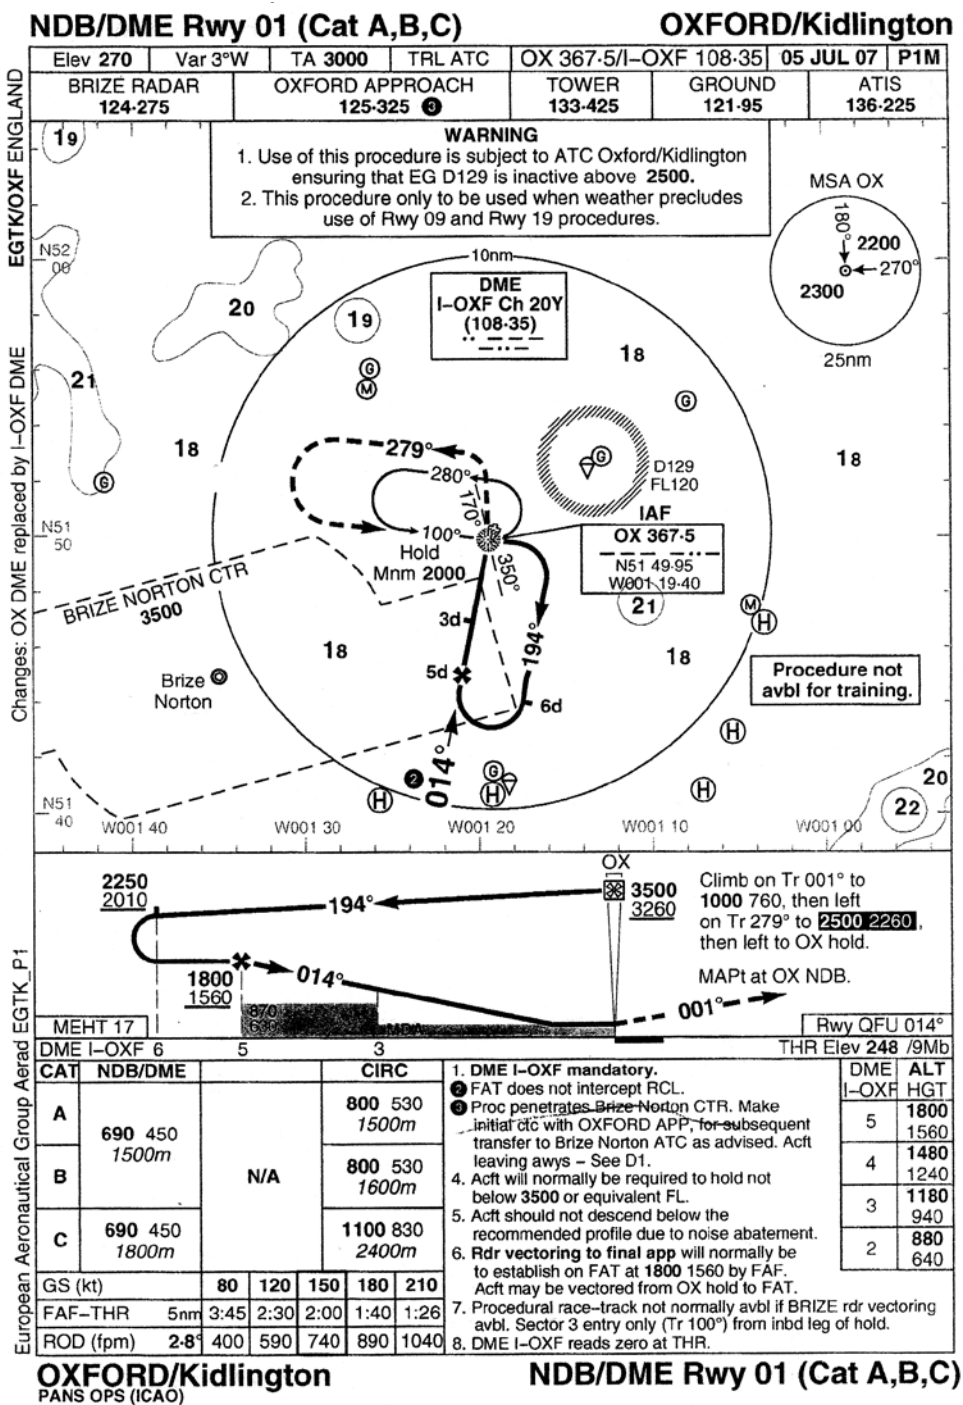
**Figure 1**  
Runway 01 Approach Chart

Runway 01 was served by an NDB/DME approach, shown at Figure 1 in the same format as that available to the pilot. The procedure involved a descent to the intermediate altitude of 1,800 ft as the aircraft

established on the inbound course of 014°(M). Final descent started at the Final Approach Fix (FAF), which was at 5 DME. A step-down fix existed at 3 DME with an associated MDA of 870 ft amsl. The procedure

MDA after the step-down fix was 690 ft amsl, equating to 450 ft above the runway threshold. The associated minimum required visibility was 1,500 m.

The Runway 01 approach chart contained information which assisted pilots to fly a CDA, and a note on the chart specifically stated that pilots should employ this technique for noise abatement reasons. Had the pilot observed this instruction and adhered to the published range/altitude profile, the aircraft would have remained above the step-down MDA of 870 ft until after the 3 DME point.

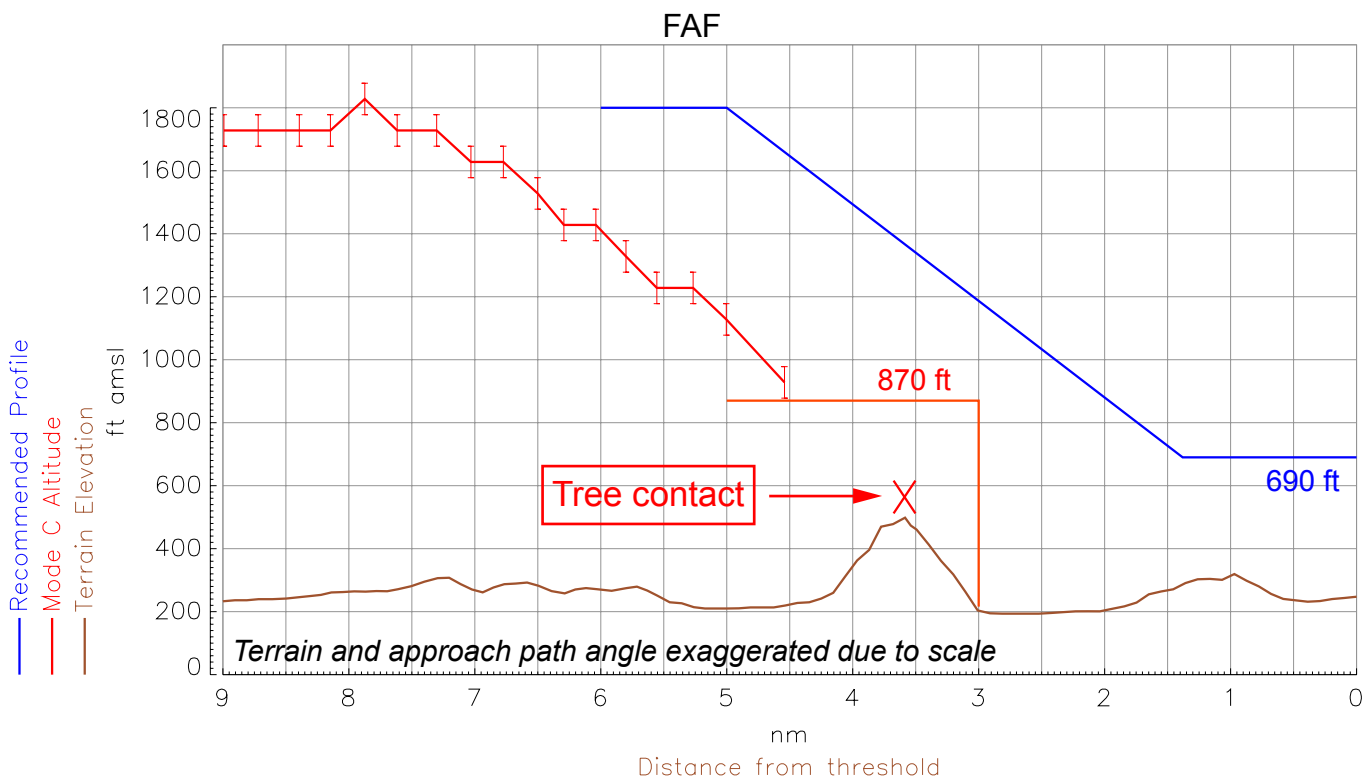
**Figure 2**  
Approach profile

Mode C values in this report have been converted to a corrected altitude. Figure 2 shows the aircraft's vertical profile from before the FAF; vertical error bars represent the Mode C resolution limitation.

The aircraft maintained level flight until starting to descend at about 7.3 nm from the runway threshold (equivalent to 7.3 DME), at which point it was established on the inbound radial. At 5.5 DME the aircraft track started to drift slightly right of track, and at the 5 DME FAF, when the final descent should have commenced, the aircraft was indicating 1,144 ft altitude, 656 ft below the recommended approach profile. It had also just started to drift to the right of the inbound track. To this point, the rate of descent was about 500 ft/min.

The aircraft continued to descend at a slightly increased rate until the last radar return, at 1708:36 hrs. The aircraft was at 4.5 nm range and 944 ft altitude, 696 ft below the recommended profile. This was just before the pilot made his last radio transmission. Based on the observed

rate of descent, the aircraft would have descended below the step-down MDA of 870 ft just after the last radar return, at about 4.4 nm. The last radar position placed the aircraft 1,700 m from the point of first impact with the trees, at an altitude of 944 ft and 130 m right of the inbound course.

Between the last radar return and the first contact with the trees, the rate of descent would have been between 700 and 900 ft/min. As Figure 2 shows, the radar data does suggest a slight increase in rate of descent in the latter stage. Based on the average groundspeed at that point, the aircraft would have hit the trees 30 seconds later. The average rate of descent from starting descent at 7.3 DME to the point of impact was about 600 ft/min, which would have been the rate required to follow the recommended profile from the FAF.

If the final descent rate was as predicted, the aircraft descended through the procedure MDA of 690 ft about 650 m and 11 seconds before the first point of contact. Had the aircraft levelled at the procedure MDA of 690 ft, the aircraft would have cleared the trees on its track by approximately 130 ft, and would have cleared the trees on the adjacent highest ground by about 90 ft (using an average tree height of 60 ft).
