**No:** 9/89

**Ref:** EW/C1111

**Aircraft Type and Registration:** McDonnell Douglas Corp DC 10-30, G-BHDJ

**Nature of Damage:** Ruptured HP bleed manifold, associated damage to an oil vent pipe and combustion chamber casing, minor damage to engine cowling.

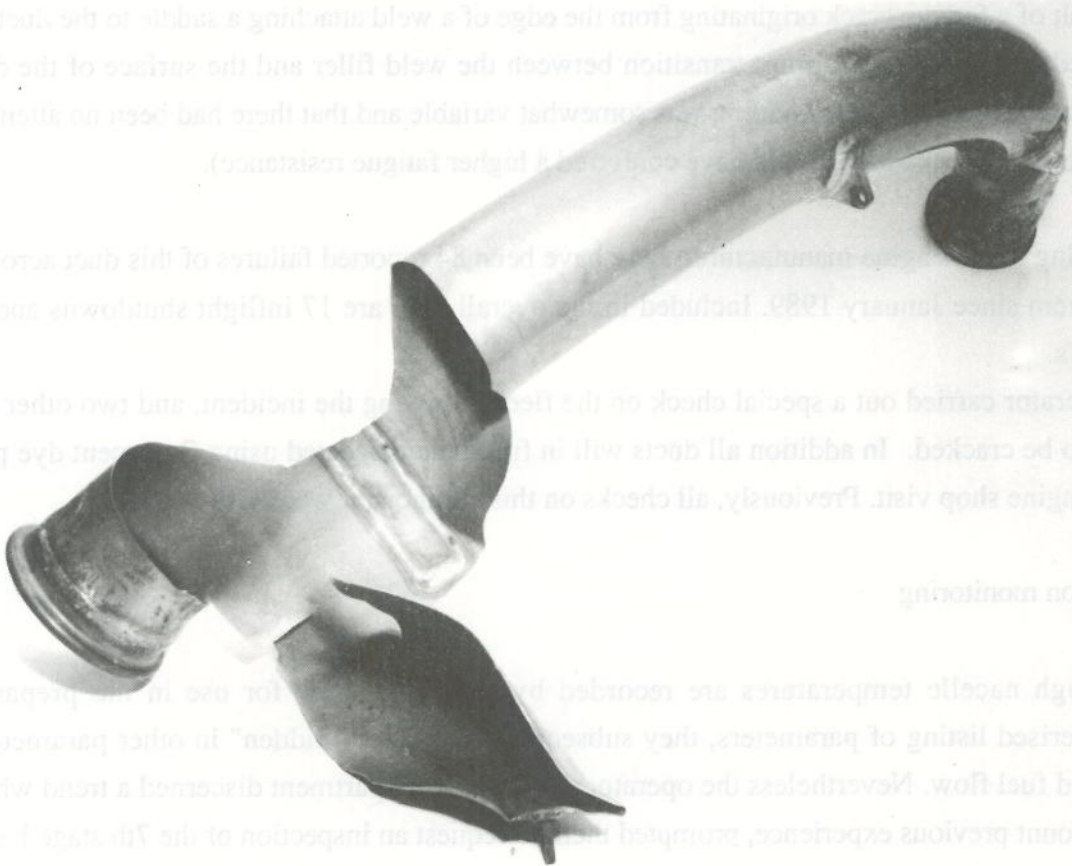
Following the incident it was found there was (non related) FOD damage to a 14th stage compressor blade: this was the reason for removing the engine. The bleed duct had failed in a spiral mode (see attached Figure), with the flailing portion striking the "B" sump vent pipe, causing the latter to be pushed rearwards into the combustion chamber casing.

The 14th stage (HP) bleed duct is supported on a number of struts attached to the engine casing. Each strut picks up on a lug which is welded to a saddle which is in turn welded to the duct. The failure was

the result of a fatigue crack originating from the edge of a weld attaching a saddle to the duct. The crack appeared to be due to an abrupt transition between the weld filler and the surface of the duct. It was noted that the quality of the welding was somewhat variable and that there had been no attempt to blend the toe of the weld (which would have conferred a higher fatigue resistance).

**G-BHDJ failed 14th stage bleed manifold**

The operator carried out a special check on the fleet following the incident, and two other ducts were found to be cracked. In addition all ducts will in future be inspected using florescent dye penetrant at every engine shop visit. Previously, all checks on this component were visual.
