**No:** 12/89

**Ref:** EW/C1115

**Aircraft Type and Registration:** York GA Isaacs Fury 11 Replica, G-BLMU

**Information Source:** AAIB Field Investigation

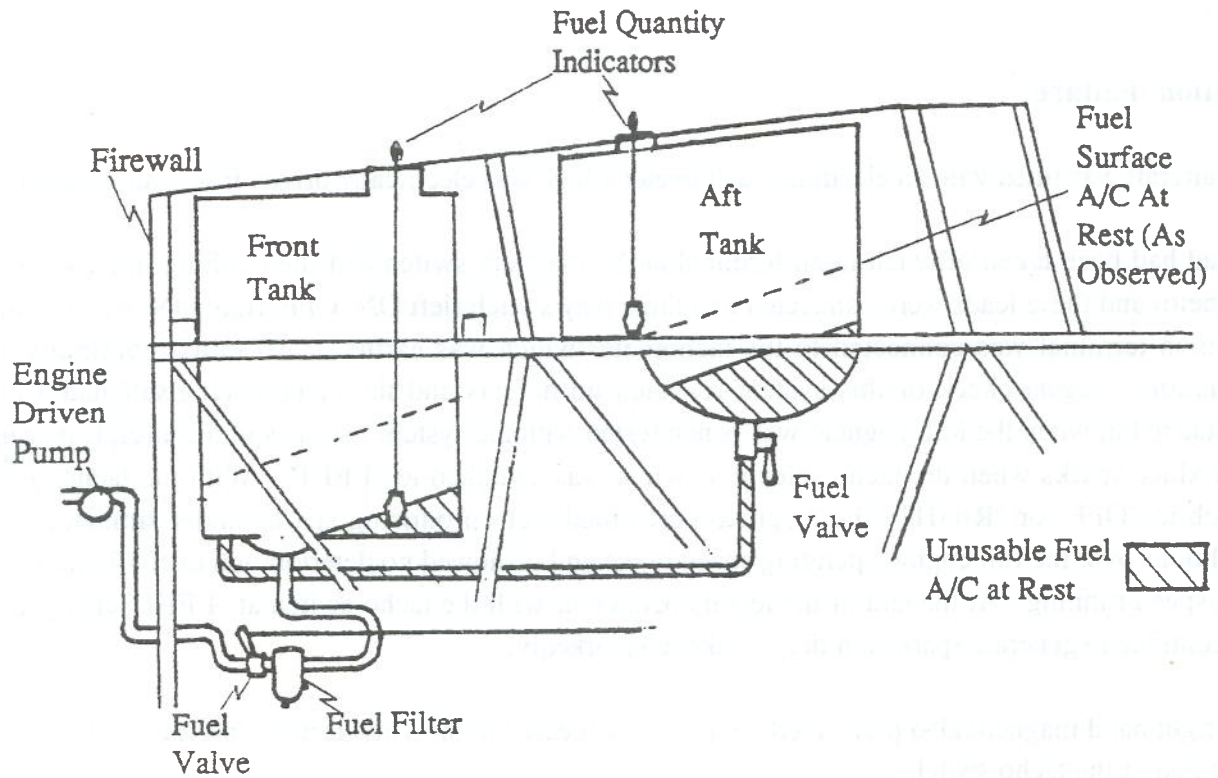
G-BLMU  
Fuel System (Schematic).

### **Fuel Starvation (See sketch of fuel system)**

The aircraft had two fuel tanks situated between the cockpit and firewall, the forward being an additional modification. The aft tank, with its own fuel cock, fed the front tank. A fuel line from a small sump in the front tank fed the engine driven pump through another fuel cock and a combined strainer and water-drain. No defect was found in the fuel lines. The strainer contained a small amount of debris but this was found to have a negligible effect on flow. The fuel primer was found closed and locked. The tanks lay upside-down after the crash. The filler caps had been dislodged by impact and the front tank had been punctured. Fuel had been seen draining away while the pilot was being rescued. Nevertheless fuel samples were recovered from the lines and both tanks; 2 litres from the aft tank and 0.3 litre from the front tank. However, the fuel level indicator rod attached to the float in the

front tank was found bent, where it passed through the filler cap, at a position which suggested a low level of fuel in that tank at impact. The indicator rod in the aft tank was undamaged.

On the ground, and possibly in the climb, there would be a tendency, with the aft fuel cock open, for the fuel which had been put into the front tank to drain to the aft to equalize levels with the aircraft in a nose-up attitude. Some approximate calculations were carried out on the distribution of fuel between the two tanks. The sump in the front tank, from which the engine was fed, was about 5 ins below the level of the lowest point in the aft tank with the fuselage level. In level flight the amount of unusable fuel would be very small. With the aircraft in its normal nose-up attitude on the ground, with the aft fuel cock open, the unusable fuel would be about 2.6 gallons (imp) (0.4 galls in front and 2.2 galls aft). The unusable fuel amount in the climb is not known. With fuel in the aft tank at the level reported by the owner before the refuelling total contents could well have been almost 7 or 8 gallons. The volume of the jerrycan used for the final refuelling was measured as 4.7 galls. 1 gallon remained in the can after the accident and so up to a maximum 3.7 gallons could have been added in the refuelling though it is not known how much was in the jerrycan before the refuelling.
