No: 10/88

Ref: EW/G88/06/08

Aircraft Type and Registration: Piper PA-28R-200 Arrow, G-BMNL

Location: Alderney Airport, Channel Islands

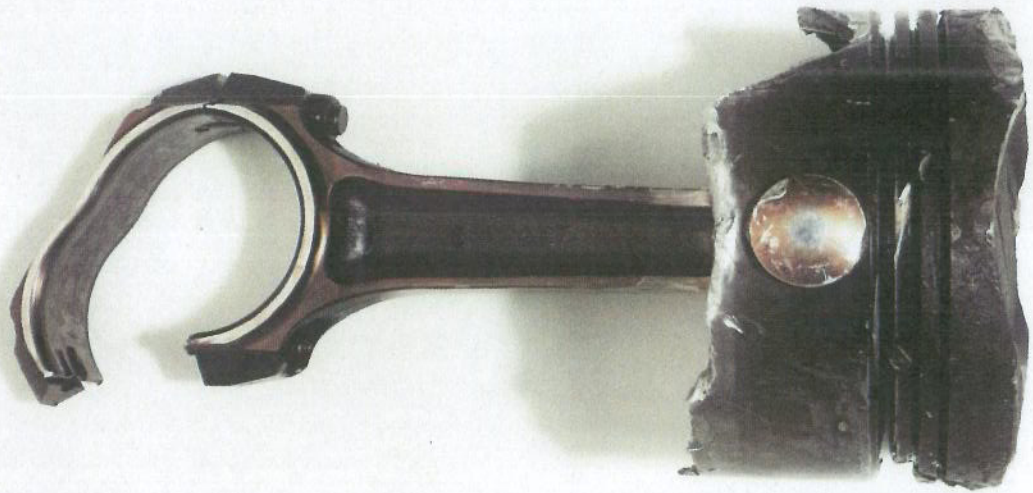
Subsequent inspection showed that the No 3 (right aft) cylinder had completely detached from the crankcase and the corresponding connecting-rod (figure 1) had been wrenched from the crankshaft, with considerable damage to the piston.

Figure 1: No 3 piston and connecting-rod, G-BMNL

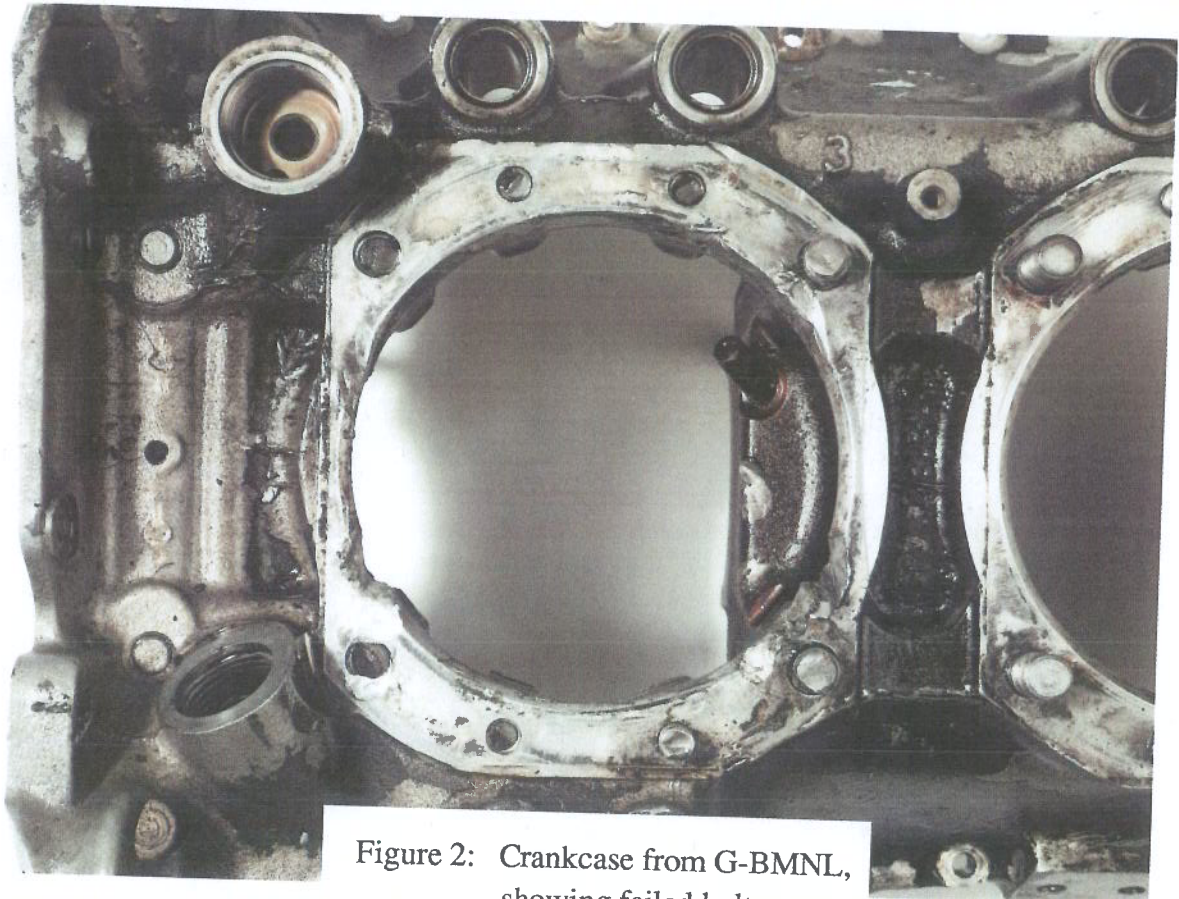
During AAIB investigation of the engine it became apparent that the connecting-rod failure had occurred after the cylinder had become detached. Of the 8 bolts (figure 2) which are used to secure the cylinder

to the crankcase, at least 5 showed positive evidence of fatigue failure. The apparent sequence of failure was that the bolts had become unevenly loaded, leading to progressive fatigue failure through a portion of their cross-section with final failure in overload as the cylinder detached.

The engine had accumulated 906 hours since major overhaul. All 4 cylinders had, however, been replaced 96 hours before the engine failure.

Figure 2: Crankcase from G-BMNL, showing failed bolts
