SERIOUS INCIDENT

Aircraft Type and Registration:	Airbus A321-231, G-EUXM
No & Type of Engines:	2 International Aero Engine V2533-A5 turbofan engines
Year of Manufacture:	2007 (Serial no: 3290)
Date & Time (UTC):	20 April 2012 at 1230 hrs
Location:	Lambourne Hold, near London Heathrow Airport
Type of Flight:	Commercial Air Transport (Passenger)
Persons on Board:	Crew - 7 Passengers - 182
Injuries:	Crew - None Passengers - None
Nature of Damage:	None
Commander's Licence:	Airline Transport Pilot's Licence
Commander's Age:	45 years
Commander's Flying Experience:	13,735 hours (of which 1,500 were on type) Last 90 days - 100 hours Last 28 days - 5 hours
Information Source:	AAIB Field Investigation

Synopsis

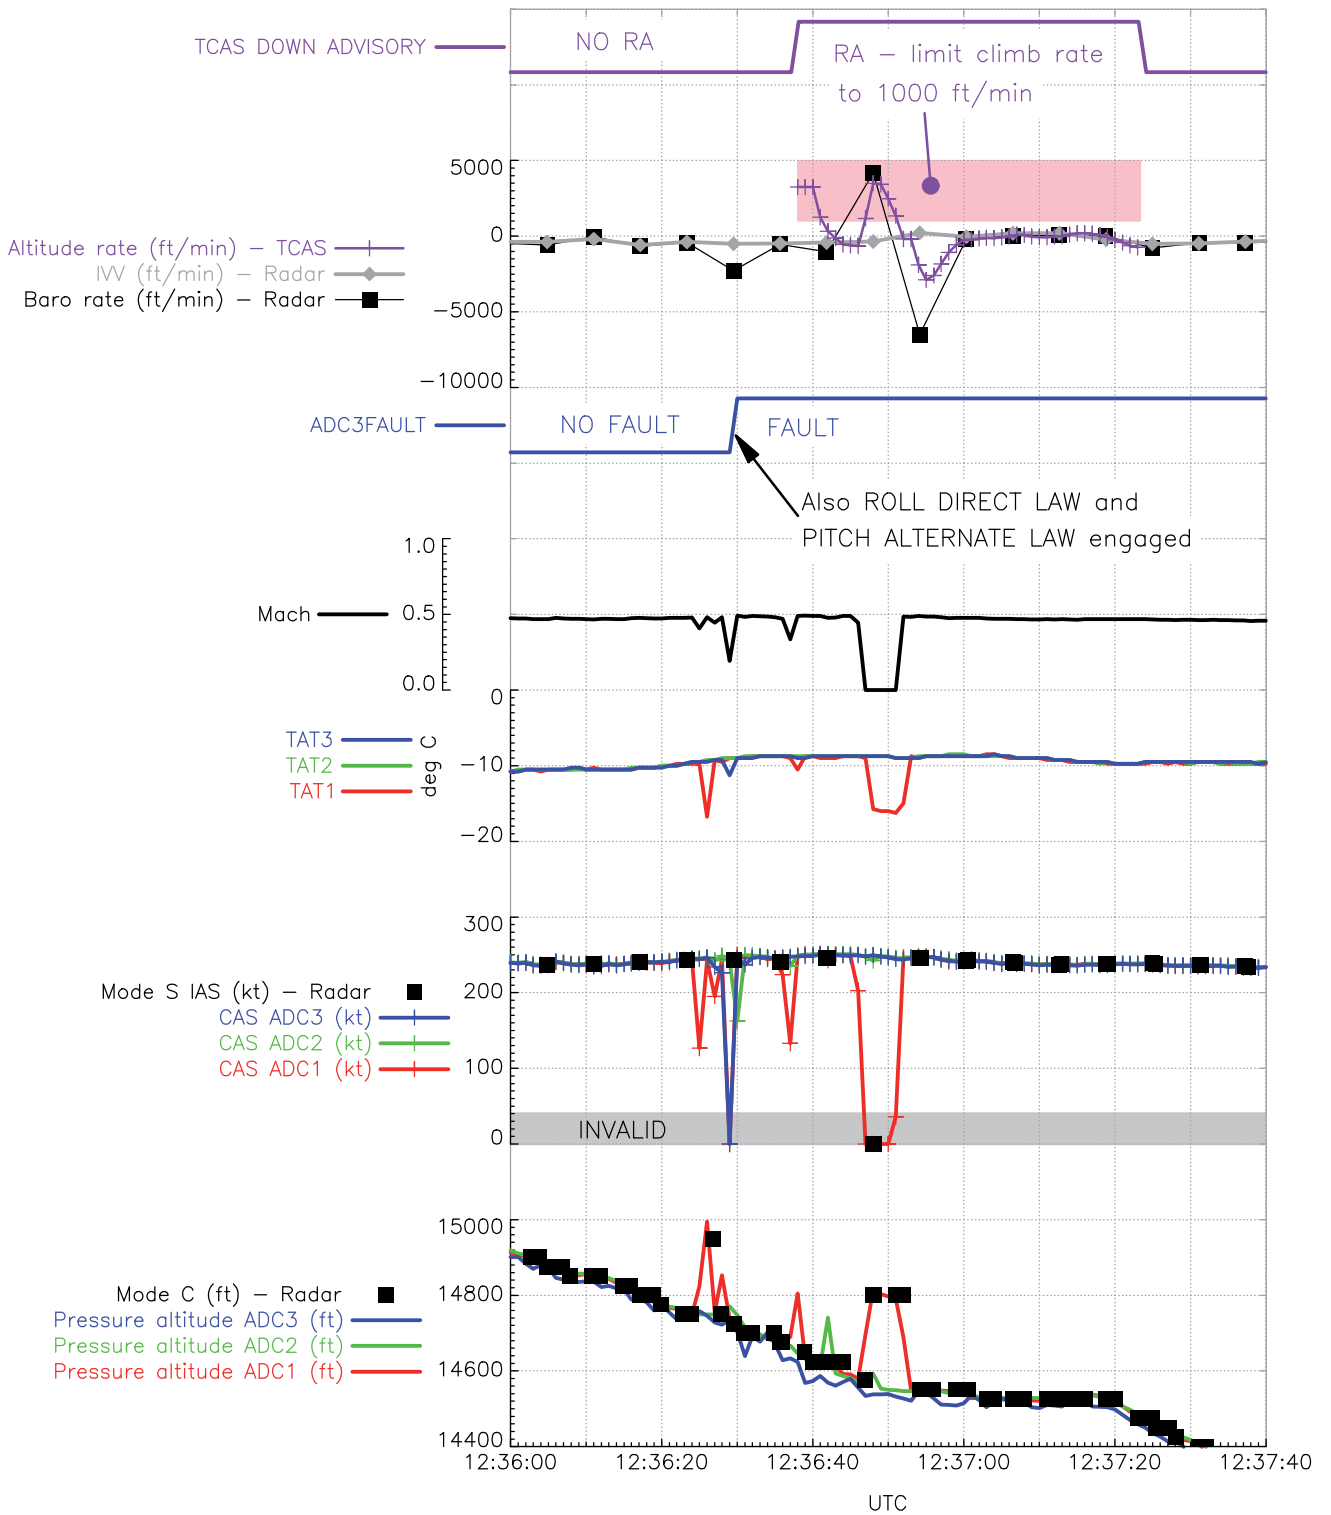
Figure 3

The recorded data showed problems associated with the air data of all three related systems on the aircraft, and a TCAS event. Pertinent parameters are shown in Figure 3.

The problems occurred whilst descending to a selected altitude of 14,000 ft within a hold north of London. Soon after passing 14,800 ft there was a period of approximately 27 seconds during which all three sources of altitude and airspeed data intermittently and independently jumped to either unreasonable but valid values or values indicating invalid data. This was associated with jumps in recorded air temperature and Mach number.

Pertinent parameters from the FDR, ACMS, TCAS and radar recordings

During this 27 second period, Air Data Computer (ADC) number 3 indicated a fault that was latched for the rest of the flight but the other two ADCs did not indicate any faults and no other system problems were apparent in the FDR data. Afterwards, and for the rest of the flight, all three sources of temperature, altitude and airspeed remained reasonable.

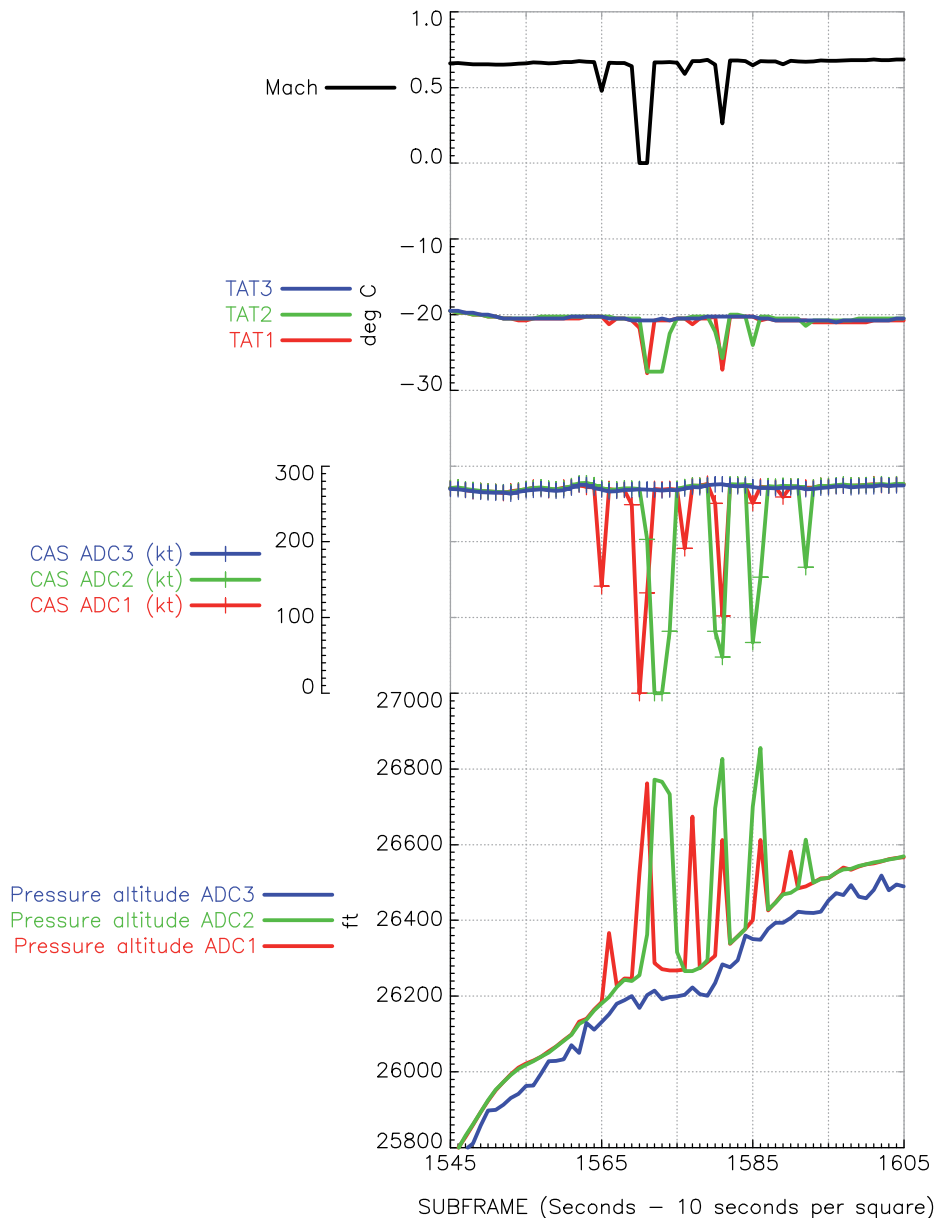
Figure 4

A second event occurred on the same aircraft on 16 June 2012, this time during the climb. The relevant data from the DAR and FDR are given in Figure 4. There was a similar period of disrupted air data during which no ADC faults were recorded; later in the flight faults with ADCs 2 and 3 were recorded as the result of crew actions.

Pertinent parameters from the FDR, ACMS, TCAS and radar recordings

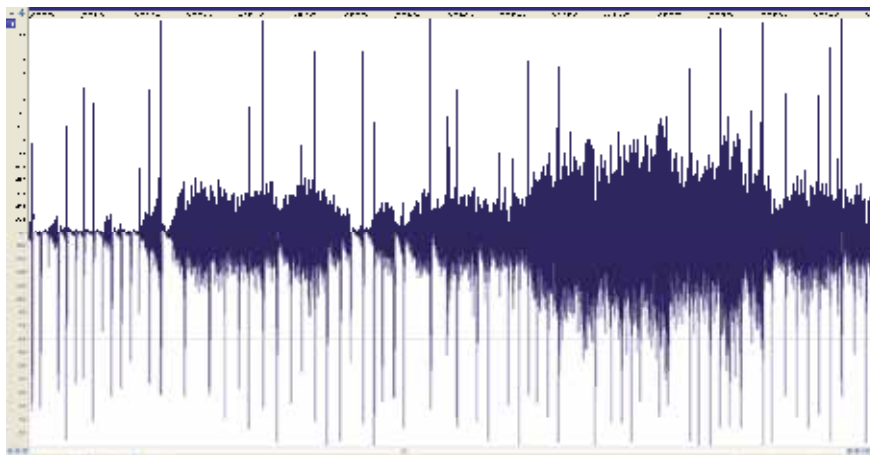
Figure 5

During both G-EUXM events the CVR Cockpit Area Microphone (CAM) channel recorded a number of periods during which large audio pulses were recorded, often resulting in a recorded waveform using the full amplitude capability of the recording. The time between pulses varied during the affected periods. The air data problems on both flights occurred during a part of one such period during each flight.

The pulses and their effect on the automatic gain control of the CAM channel amplifier resulted in the loss of the cockpit area ambient audio from the recording during intense periods of pulsing and significant degradation during the less intense periods.

Sample period of the CAM recording showing recorded pulses that were not heard by the crew

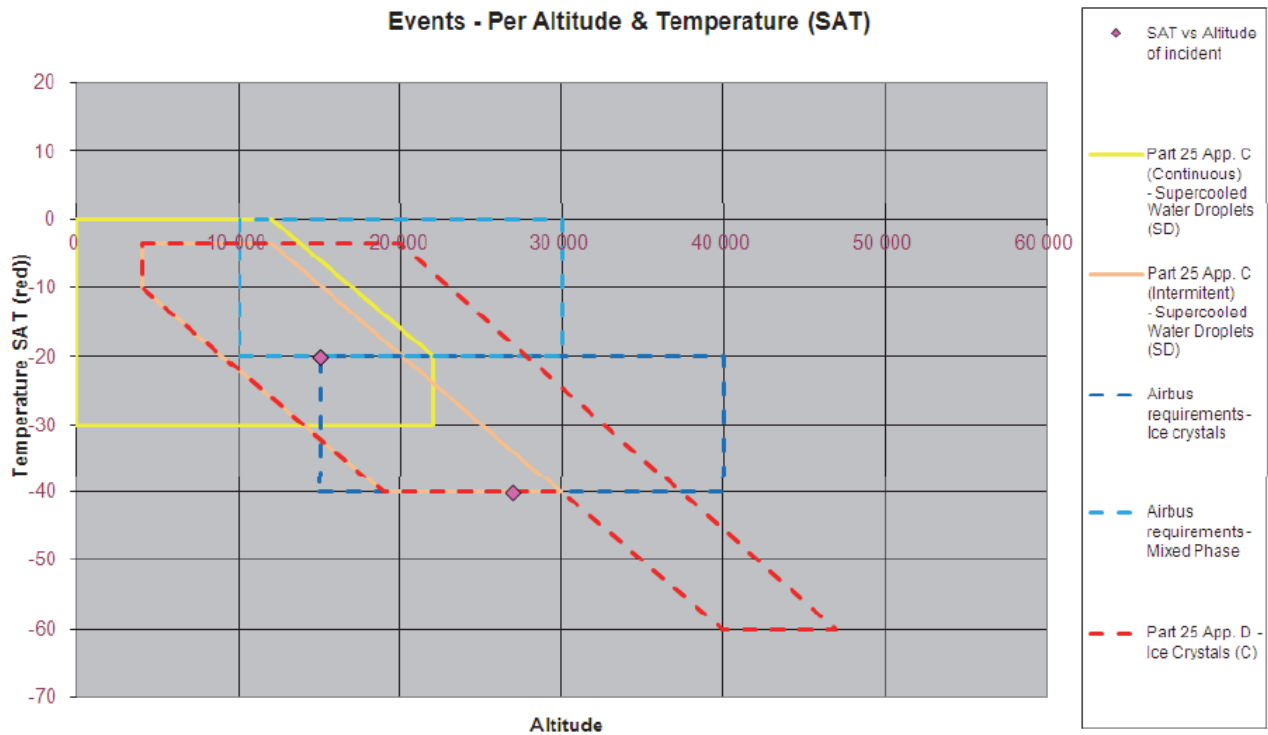
Airbus has conducted studies including investigating reported airspeed indication problems, icing wind tunnel testing and instrumented flights tests. The results have been shared with the aviation community and Airbus is working in partnership with other organisations on better understanding of icing problems. As a result of their studies, Airbus considers that the current EASA and Airbus requirements need to be improved to better address pitot probe icing. Airbus is in the process of developing expanded envelopes for inclusion in the EASA requirements, which address ice crystal issues. When the revised standards are approved, work can begin with the pitot probe manufacturers to develop designs that reflect the new understanding of pitot probe icing issues. The proposed standards are also given in Figure 6.

Altitude v SAT envelopes for the current and proposed requirements and the G-EUXM events.
The diamonds are the G-EUXM events
