## INCIDENT

| <b>Aircraft Type and Registration:</b> | Boeing 767-200, N653US | |
| <b>Location:</b> | Final approach to Runway 26L, London (Gatwick) Airport | |

## Synopsis

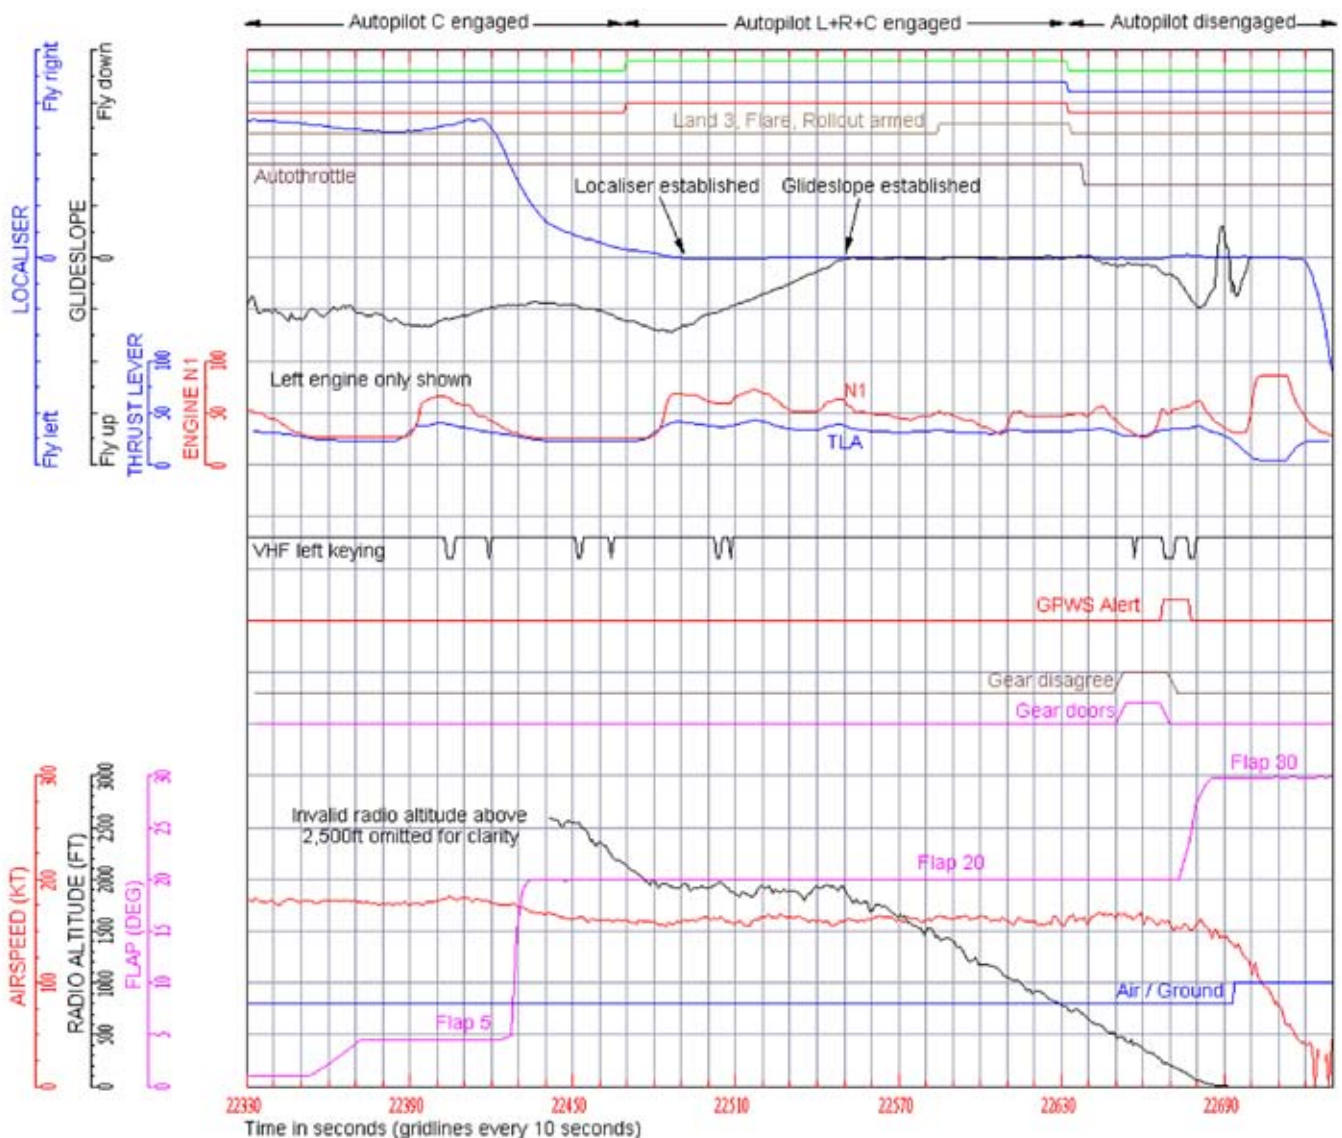
Figure 1

- Flap 20 selected at 2,900 ft amsl
- Localiser established at 2,000 ft amsl
- Glideslope established and followed from 2,000 ft amsl
- At 740 ft agl autopilot disconnected
- At 711 ft agl autothrust disconnected
- At approximately 500 ft agl, gear lever moved down (this occurred between 2 and 4 seconds before ATC queried the gear position)
- At 420 ft agl, whilst gear doors were open and gear position disagreed with gear lever position, N653US crew responded to ATC confirming three greens
- At 229 ft agl, GPWS alert began
- Between 225 ft agl and 175 ft agl crew confirmed three gear down and locked. During this transmission the gear doors closed and gear position agreed with lever position (gear down)
- At 170 ft agl, flaps began to extend past 20°

- 5 seconds later at 90 ft agl flaps moved through 25° and GPWS alert stopped
- 7 seconds later, at 16 ft agl, flaps reached 29.7 deg (stopped)
- 9 seconds later, aircraft touched down

Selected parameters

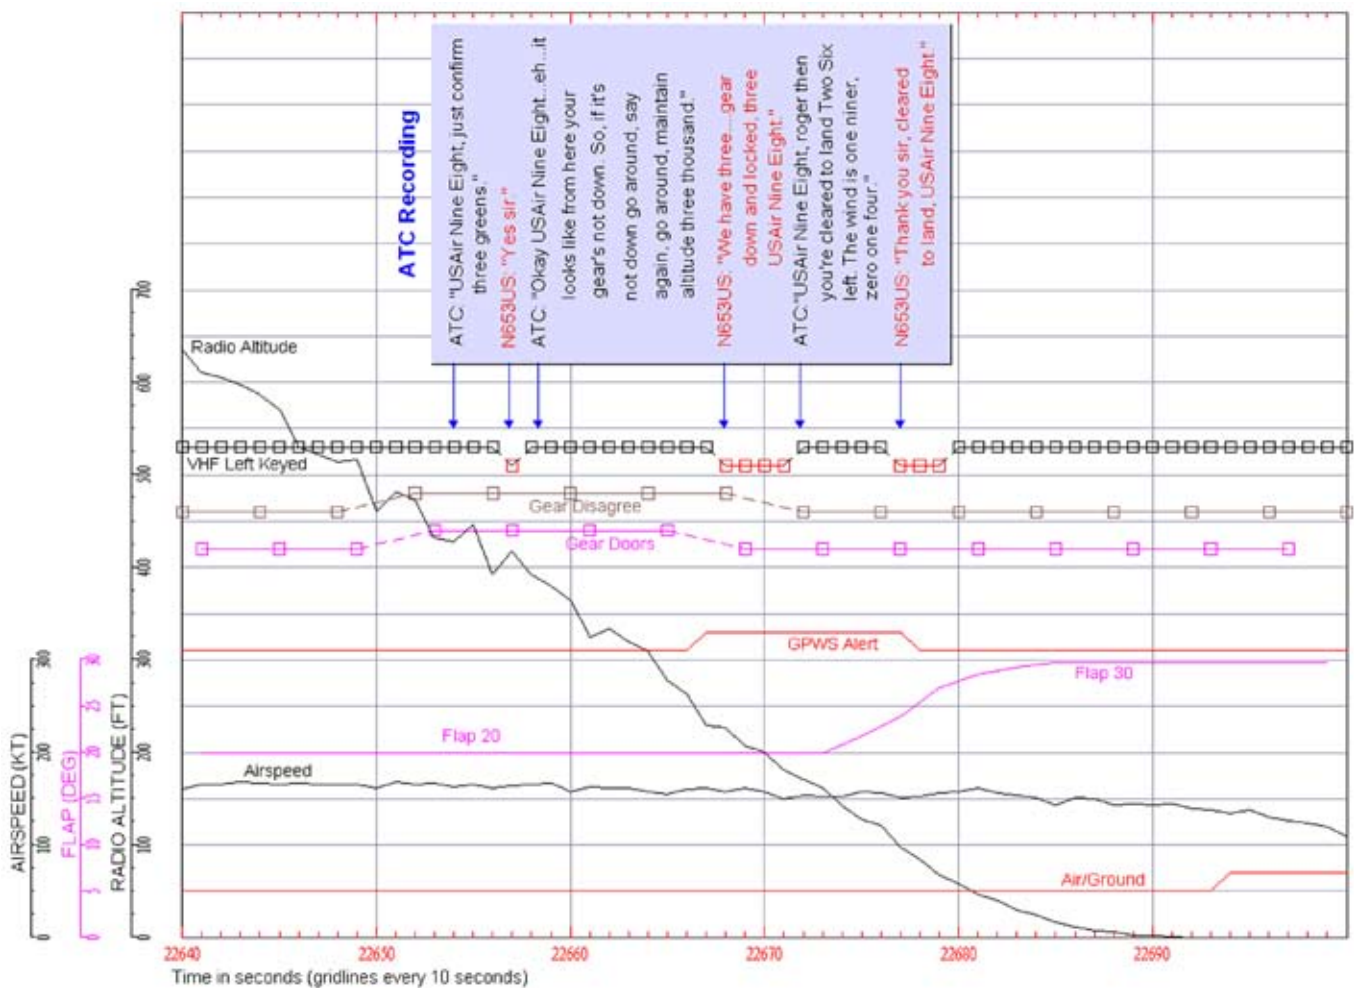
Figure 2

The recorded flight data indicated that there was a GPWS mode 4b alert active for a period of eleven seconds.

Expanded plot incorporating ATC recordings
