**INCIDENT**

**Aircraft Type and Registration:** Boeing 767-336, G-BNWG

**Date & Time (UTC):** 17 September 1993 at 1934 hrs

**Location:** London Heathrow Airport

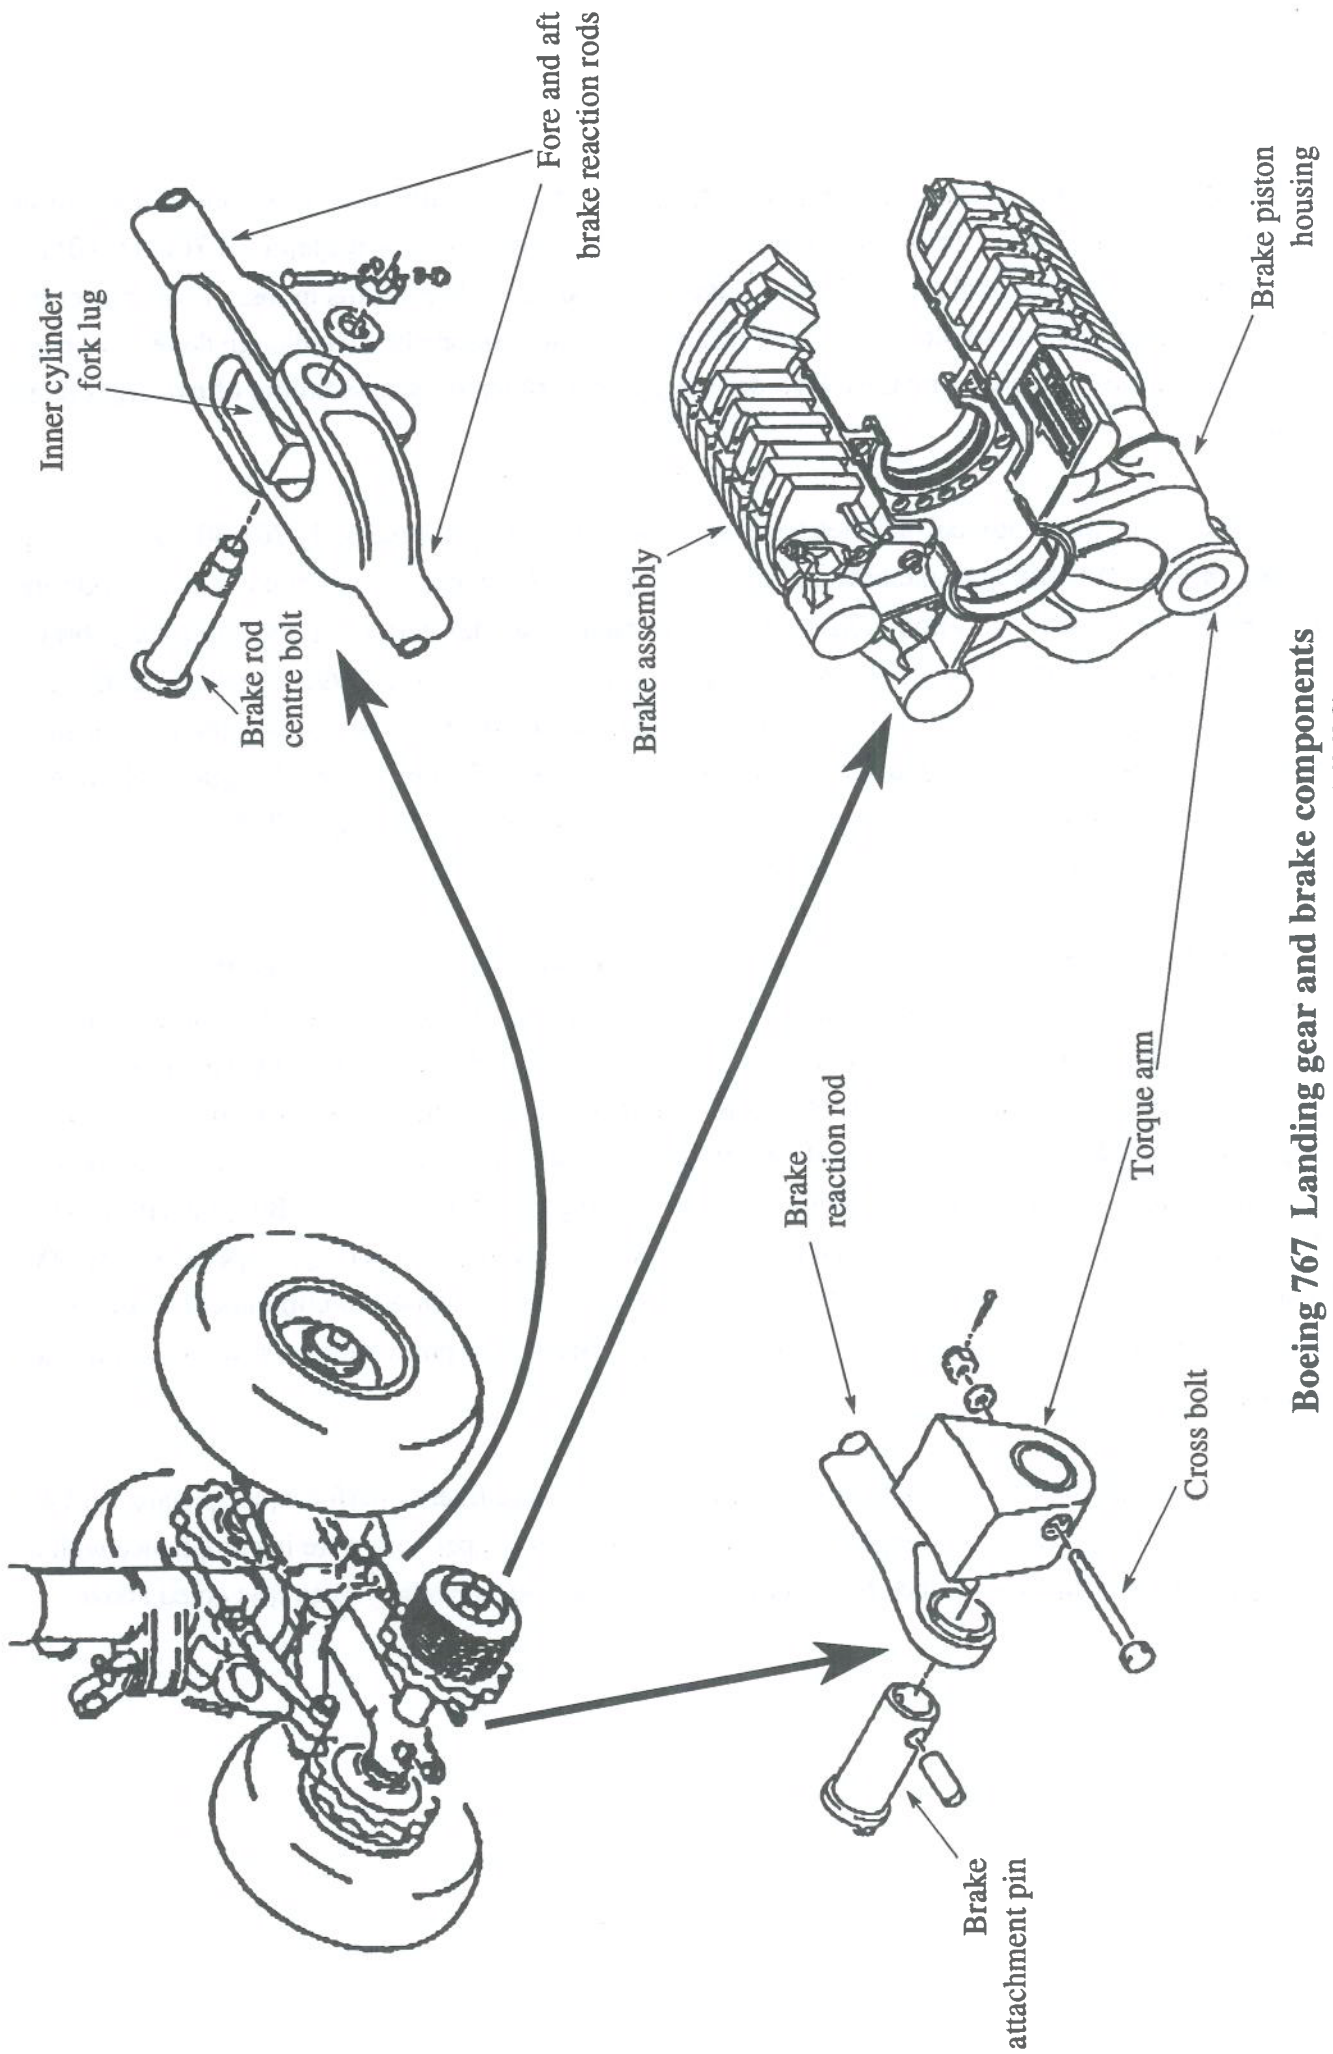
When the landing gear was examined, it was found that the brake reaction rod had become detached from the piston housing on the brake for the No 8 wheel (outboard aft wheel on the right-hand main landing gear). Witness marks on the brake reaction rod showed that the brake piston housing had then rotated rapidly on the axle, detaching the brake hydraulic lines.

The accompanying figure shows the brake components of the 767 main landing gear. The torque loads from each brake assembly are reacted by the brake reaction rod, which is attached to the torque arm of the piston housing by the brake attachment pin. This pin is retained within the brake piston housing by a single cross bolt. The brake rod centre bolt acts as a pivot pin, securing the forked ends of the fore-and-aft brake reaction rods to a fork lug at the lower end of the inner cylinder of the landing gear leg.

In this occurrence to G-BNWX, the brake attachment pin had migrated out of the brake piston housing as a result of the failure of the retaining cross bolt, the head of which remained with the piston housing. The migration of the brake attachment pin under load was demonstrated by damage to the torque arm on the piston housing; the torque arm had been 'ovalised' on the side adjacent to the brake reaction rod and its bronze bushing had been badly damaged.

Evidence available on the broken cross bolt itself demonstrated conclusively that its failure was caused by overload in shear and that the bolt had not suffered any significant damage before it failed. The manner in which this failure occurred was consistent with a shearing action between the brake attachment pin and the torque arm of the brake piston housing, both of which exhibited damage demonstrating this action. The relative positions of the damage sites suggested that the shearing action had taken place at one end of the cross bolt only and that it had resulted from a slewing, or 'prying', action induced by a very large load applied through the brake reaction rod.

**Boeing 767 Landing gear and brake components  
(G-BNWS, 17/9/93 and G-BNWS, 9/9/93)**

The records show that failures of the brake rod centre bolt are related to the number of landing cycles and that increased frequency of inspection and replacement of these bolts is likely to be effective in containing the problem. The low number of cycles on some failed cross bolts, however, and the lack of pre-existing damage on the cross bolt from G-BNWS, indicate that failure of the cross bolt is largely independent of the number of landings. Separate Service Bulletins have been issued concerning the brake rod centre bolt and the piston housing cross bolt. Service Bulletin SB 767-32-A0116 details inspection and replacement of brake rod centre bolts and bushings, repeated every 800 flight cycles. Service Bulletin SB 767-32-A0126 includes a modification to eliminate the cross bolt and, in its stead, installs a 'keeper' pin to retain the brake attachment pin within the piston housing and the brake reaction rod.
