No: 10/92

Ref: EW/G92/08/16

Aircraft Type and Registration: Robinson R22 Beta, G-OSHL

Location: Near Roade, Northamptonshire

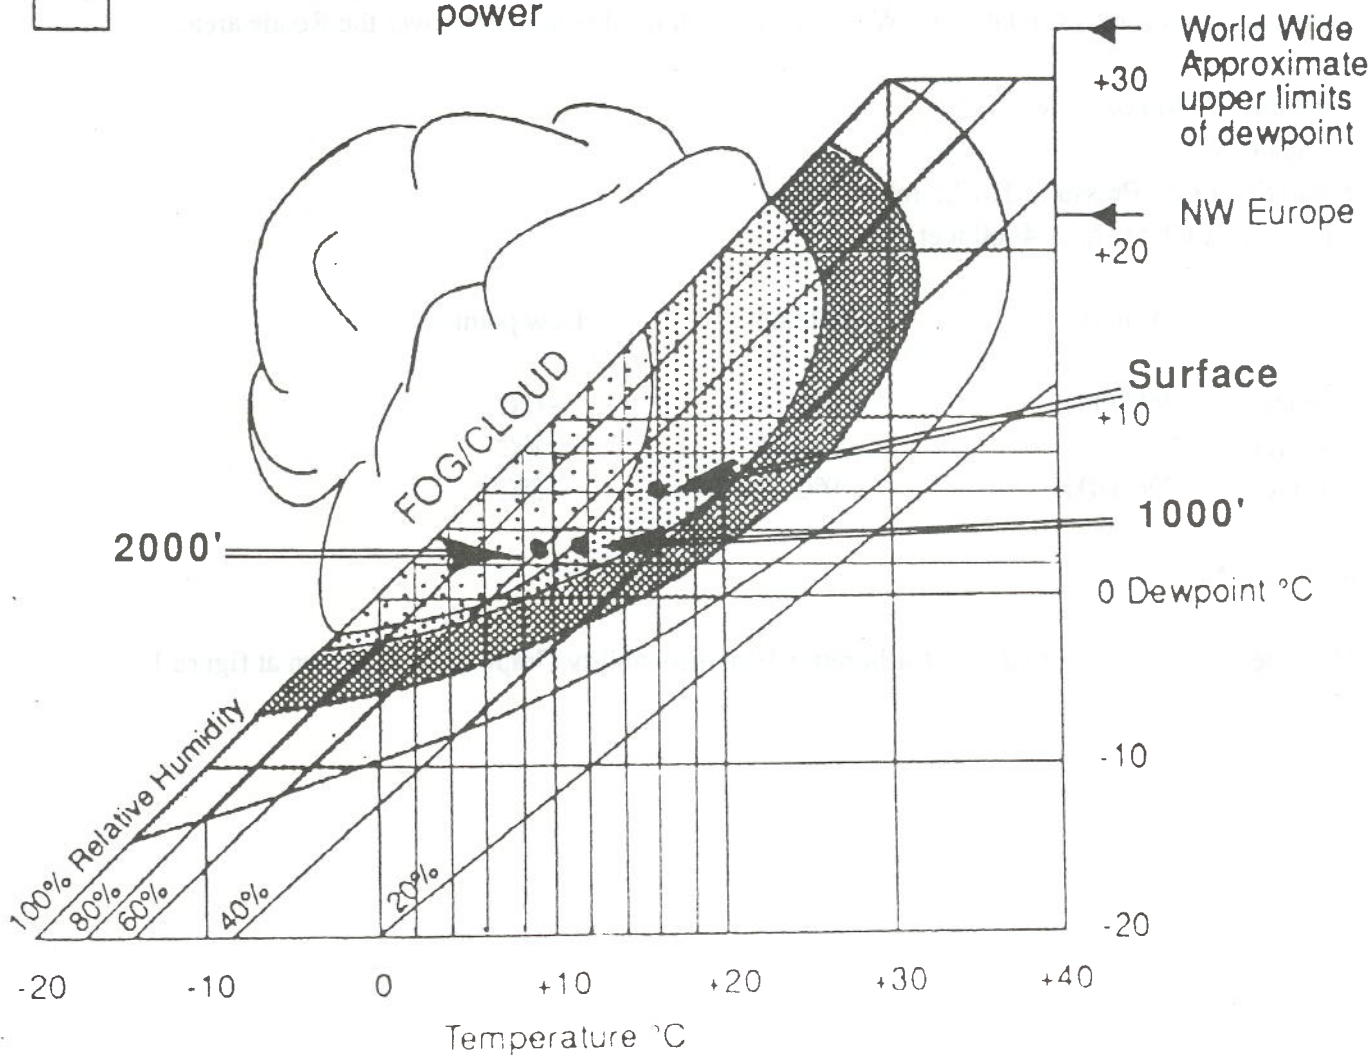
FIGURE 1. CARBURETTOR ICING PROBABILITY GRAPH

These readings were plotted on a Carburettor Icing Probability Graph and are shown at figure 1.
