ACCIDENT

Aircraft Type and Registration:	Pegasus Quantum 15, G-BZJF	
No & Type of Engines:	1 Rotax 582-40 piston engine	
Year of Manufacture:	2000	
Date & Time (UTC):	26 August 2007 at 1920 hrs	
Location:	Knotting Wood, near A6 Northamptonshire	
Type of Flight:	Private	
Persons on Board:	Crew - 1	Passengers - 1
Injuries:	Crew - 1 (Fatal)	Passengers - 1 (Fatal)
Nature of Damage:	Aircraft destroyed	
Commander's Licence:	National Private Pilot's Licence	
Commander's Age:	38 Years	
Commander's Flying Experience:	37 hours (all of which were on type) Last 90 days - 8 hours Last 28 days - 2 hours	
Information Source:	AAIB Field Investigation

Synopsis

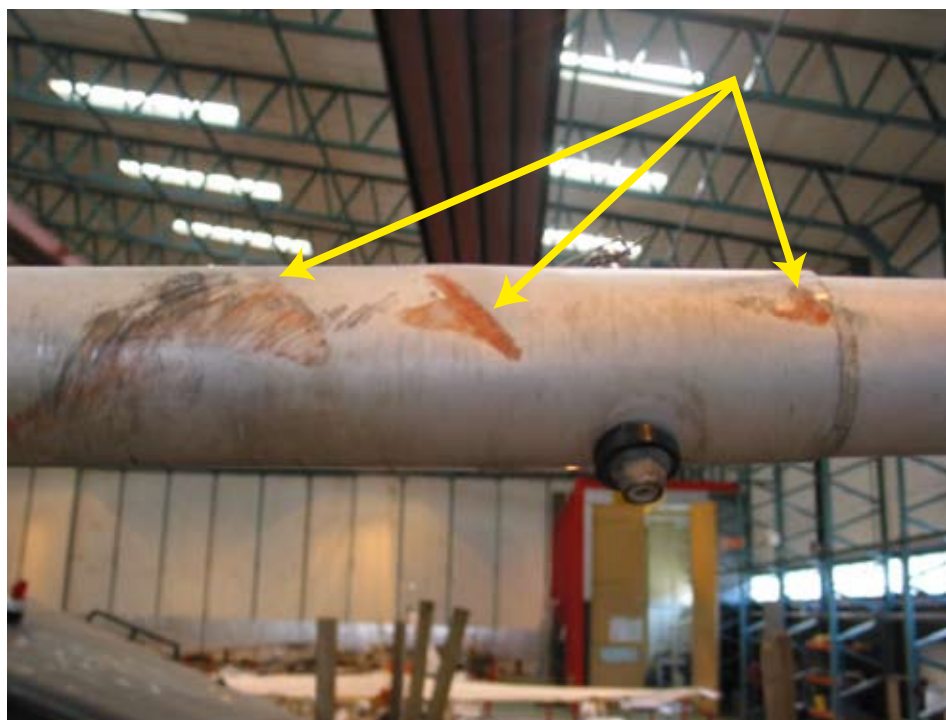
Figure 2

The front strut had failed, with the upper and lower portions remaining attached to the wing and the trike, respectively. The pilot had sustained a wound to the front of his head, consistent with having struck the fractured end of the upper portion of the strut. The monopole had failed at the locking clamp location, leaving an approximately 150 cm long section of it attached to the wing; the rest of the monopole was still attached to the trike. Multiple paint transfer marks, indentations on the rear of the wing keel tube and cuts in the fabric of the fin were indicative of the propeller blades having struck the rear of the wing whilst the propeller was turning (Figure 2).

Propeller strike marks on wing keel tube
