ACCIDENT

Aircraft Type and Registration:	Pegasus Quantum 15, G-BZJF	
No & Type of Engines:	1 Rotax 582-40 piston engine	
Year of Manufacture:	2000	
Date & Time (UTC):	26 August 2007 at 1920 hrs	
Location:	Knotting Wood, near A6 Northamptonshire	
Type of Flight:	Private	
Persons on Board:	Crew - 1	Passengers - 1
Injuries:	Crew - 1 (Fatal)	Passengers - 1 (Fatal)
Nature of Damage:	Aircraft destroyed	
Commander's Licence:	National Private Pilot's Licence	
Commander's Age:	38 Years	
Commander's Flying Experience:	37 hours (all of which were on type) Last 90 days - 8 hours Last 28 days - 2 hours	
Information Source:	AAIB Field Investigation

Synopsis

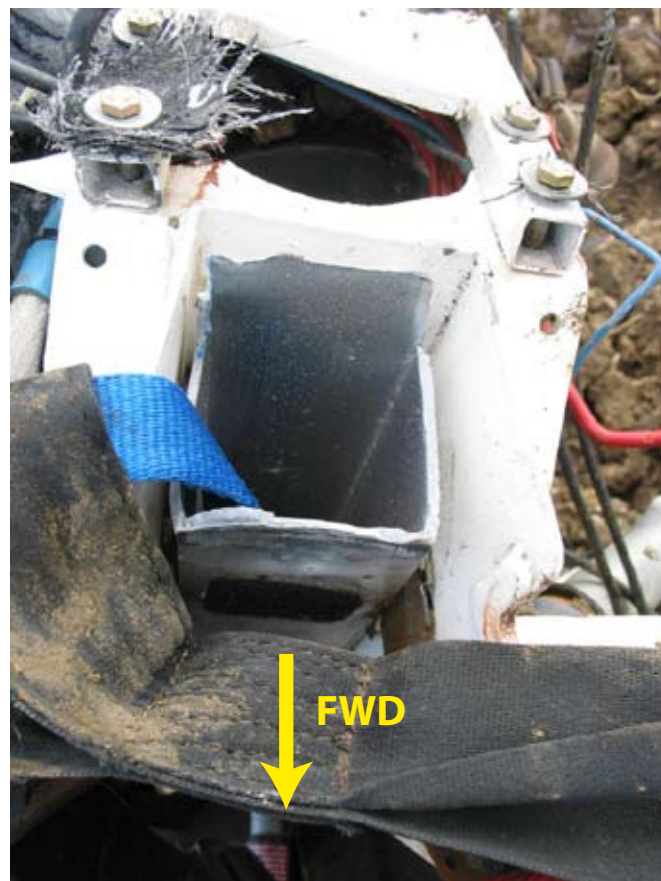
From the deformation of the material in the area of the failure (Figure 3), it was evident that the monopole had been exposed to large bending loads in the fore and aft directions prior to failure. The stitching in the upper loop of the safety strap had subsequently failed in overload, causing the wing and trike to separate in the air.

Figure 3
Monopole failure
