## ACCIDENT

<b>Aircraft Type and Registration:</b>	Pegasus Quantum 15, G-BZJF	
<b>No &amp; Type of Engines:</b>	1 Rotax 582-40 piston engine	
<b>Year of Manufacture:</b>	2000	
<b>Date &amp; Time (UTC):</b>	26 August 2007 at 1920 hrs	
<b>Location:</b>	Knotting Wood, near A6 Northamptonshire	
<b>Type of Flight:</b>	Private	
<b>Persons on Board:</b>	Crew - 1	Passengers - 1
<b>Injuries:</b>	Crew - 1 (Fatal)	Passengers - 1 (Fatal)
<b>Nature of Damage:</b>	Aircraft destroyed	
<b>Commander's Licence:</b>	National Private Pilot's Licence	
<b>Commander's Age:</b>	38 Years	
<b>Commander's Flying Experience:</b>	37 hours (all of which were on type) Last 90 days - 8 hours Last 28 days - 2 hours	
<b>Information Source:</b>	AAIB Field Investigation

## Synopsis

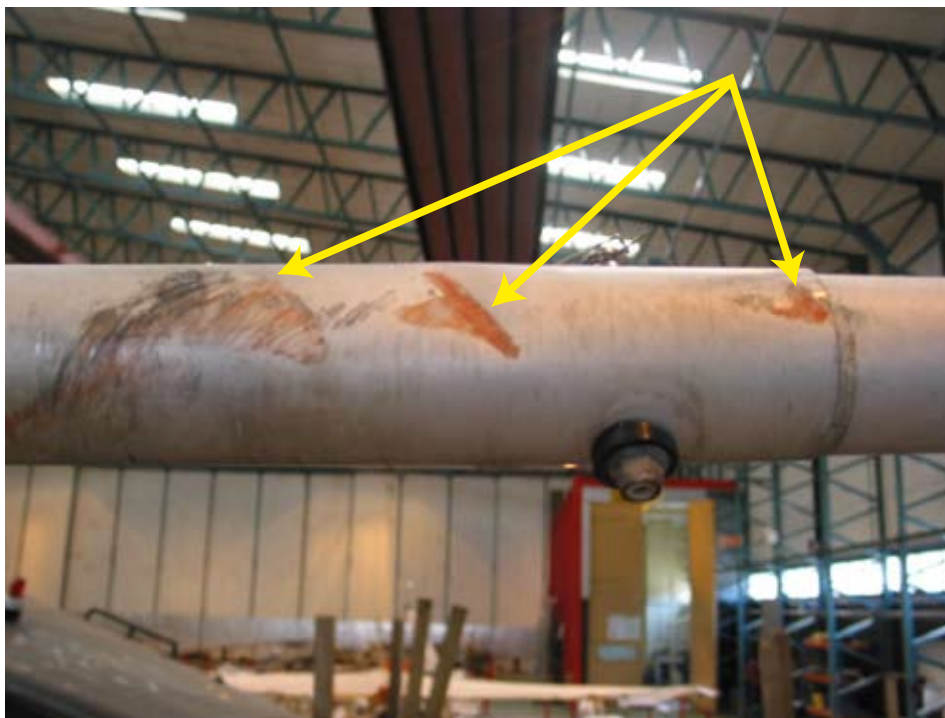
**Figure 2**

The front strut had failed, with the upper and lower portions remaining attached to the wing and the trike, respectively. The pilot had sustained a wound to the front of his head, consistent with having struck the fractured end of the upper portion of the strut. The monopole had failed at the locking clamp location, leaving an approximately 150 cm long section of it attached to the wing; the rest of the monopole was still attached to the trike. Multiple paint transfer marks, indentations on the rear of the wing keel tube and cuts in the fabric of the fin were indicative of the propeller blades having struck the rear of the wing whilst the propeller was turning (Figure 2).

Propeller strike marks on wing keel tube

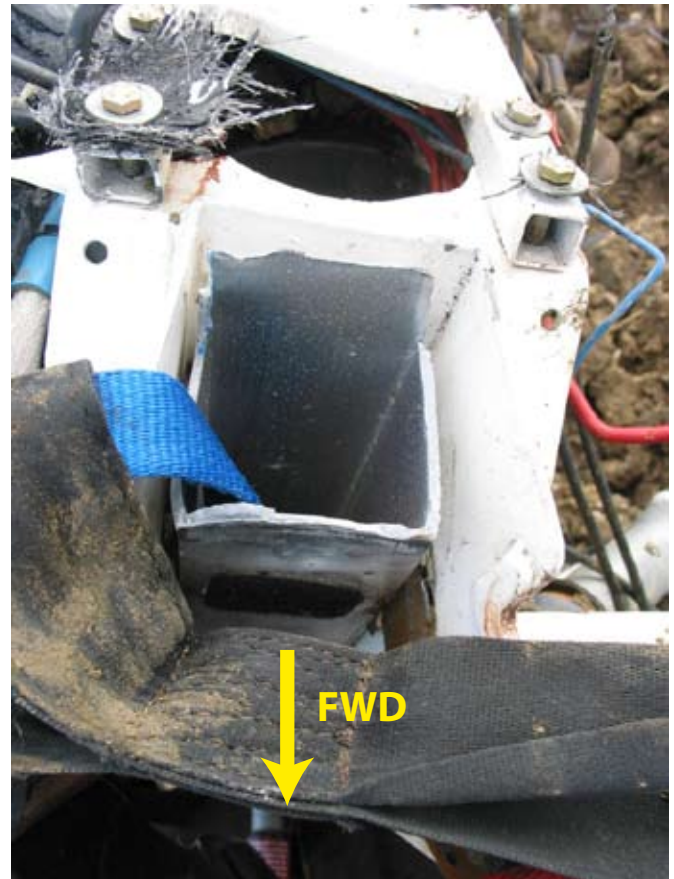
From the deformation of the material in the area of the failure (Figure 3), it was evident that the monopole had been exposed to large bending loads in the fore and aft directions prior to failure. The stitching in the upper loop of the safety strap had subsequently failed in overload, causing the wing and trike to separate in the air.

**Figure 3**  
Monopole failure
