**ACCIDENT**

<b>Aircraft Type and Registration:</b>	Lindstrand LBL 210A hot air balloon, G-BZDE	
<b>No &amp; type of Engines:</b>	None	
<b>Year of Manufacture:</b>	2000	
<b>Date &amp; Time (UTC):</b>	16 April 2006 at 1814 hrs	
<b>Location:</b>	Near Bordon, Hampshire	
<b>Type of Flight:</b>	Public Transport (Passenger)	
<b>Persons on Board:</b>	Crew - 1	Passengers - 10
<b>Injuries:</b>	Crew - None	Passengers - None
<b>Nature of Damage:</b>	Scorching and abrasion damage to balloon envelope	
<b>Commander's Licence:</b>	Commercial Pilot's Licence (Balloons)	
<b>Commander's Age:</b>	49 years	
<b>Commander's Flying Experience:</b>	827 hours (of which 141 were on category B balloons) Last 90 days - 12 hours Last 28 days - 6 hours	
<b>Information Source:</b>	AAIB Field Investigation

**Synopsis**

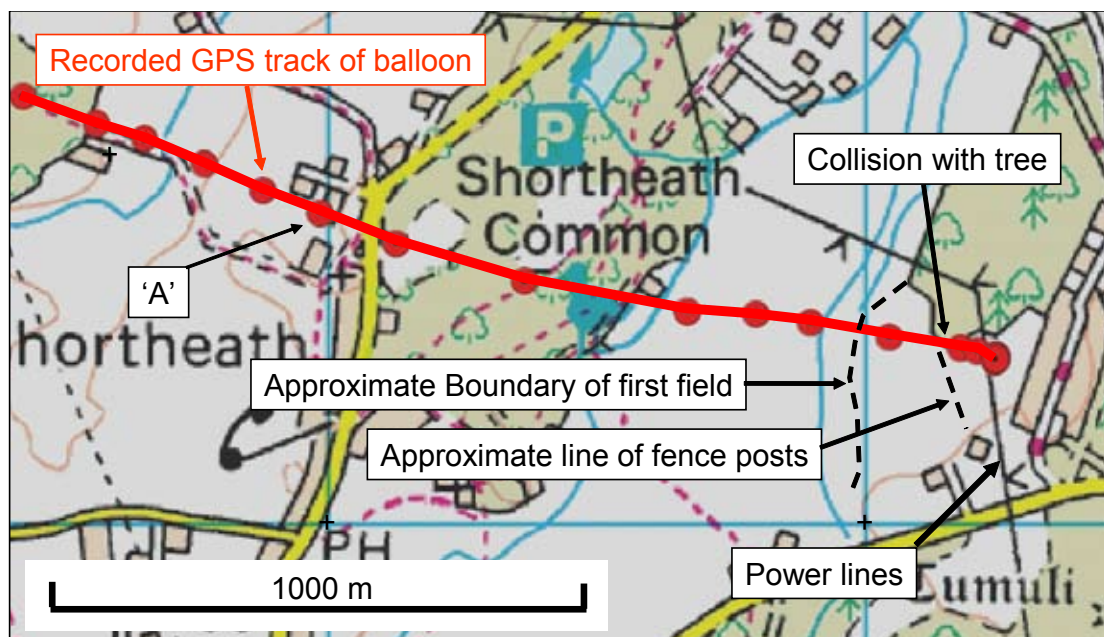
Figure 1

The accident events centred on two adjoining fields on the western outskirts of the town of Bordon (Figure 1). Originally a single field, it was divided into two by fence posts. Although this gave the appearance that the fields were physically separate, there were in fact no wires between the posts. The westerly field was the larger of the two, bounded at its western edge by a hedgerow which contained a number of moderately sized trees. A wooded area protruded into the two fields from the north, forming a 'V' shape, at the point of which was the large tree which the balloon basket struck shortly before contacting the power lines. The distance from the tree to the centreline of the power lines, in the direction of flight of the balloon, was 89 m. The protruding wooded area formed a 'neck' across the fields divided by the fence posts.

'A' at Figure 1) saw the balloon pass directly overhead at low altitude. The witness reported hearing the balloon's burner, and had the impression that it had climbed slightly to clear the narrow low ridge on which his house stood. After passing, it continued at low altitude in the direction of the accident site before disappearing from view behind trees.
