## Jetstream 31, G-EEST

<b>AAIB Bulletin No: 12/2004</b>	<b>Ref: EW/C2003/09/04</b>	<b>Category: 1.1</b>
<b>Aircraft Type and Registration:</b>	Jetstream 31, G-EEST	
<b>No &amp; Type of Powerplants:</b>	2 Garrett AiResearch TPE331-10UGR-516H turboprop engines driving McCauley propellers	
<b>Year of Manufacture:</b>	1987	
<b>Date &amp; Time (UTC):</b>	17 September 2003 at 1447 hrs	
<b>Location:</b>	Wick Airport, Scotland	
<b>Type of Flight:</b>	Public Transport (Passenger)	
<b>Persons on Board:</b>	Crew - 3	Passengers - 4
<b>Injuries:</b>	Crew - None	Passengers - None
<b>Nature of Damage:</b>	Right propeller, right main landing gear, right rear wingspar, left wing and fuselage	
<b>Commander's Licence:</b>	Airline Transport Pilot's Licence	
<b>Commander's Age:</b>	54 years	
<b>Commander's Flying Experience:</b>	7,885 hours (1,195 on type)	
	Last 90 days - 160 hours	
	Last 28 days - 23 hours	
<b>Information Source:</b>	AAIB Field Investigation

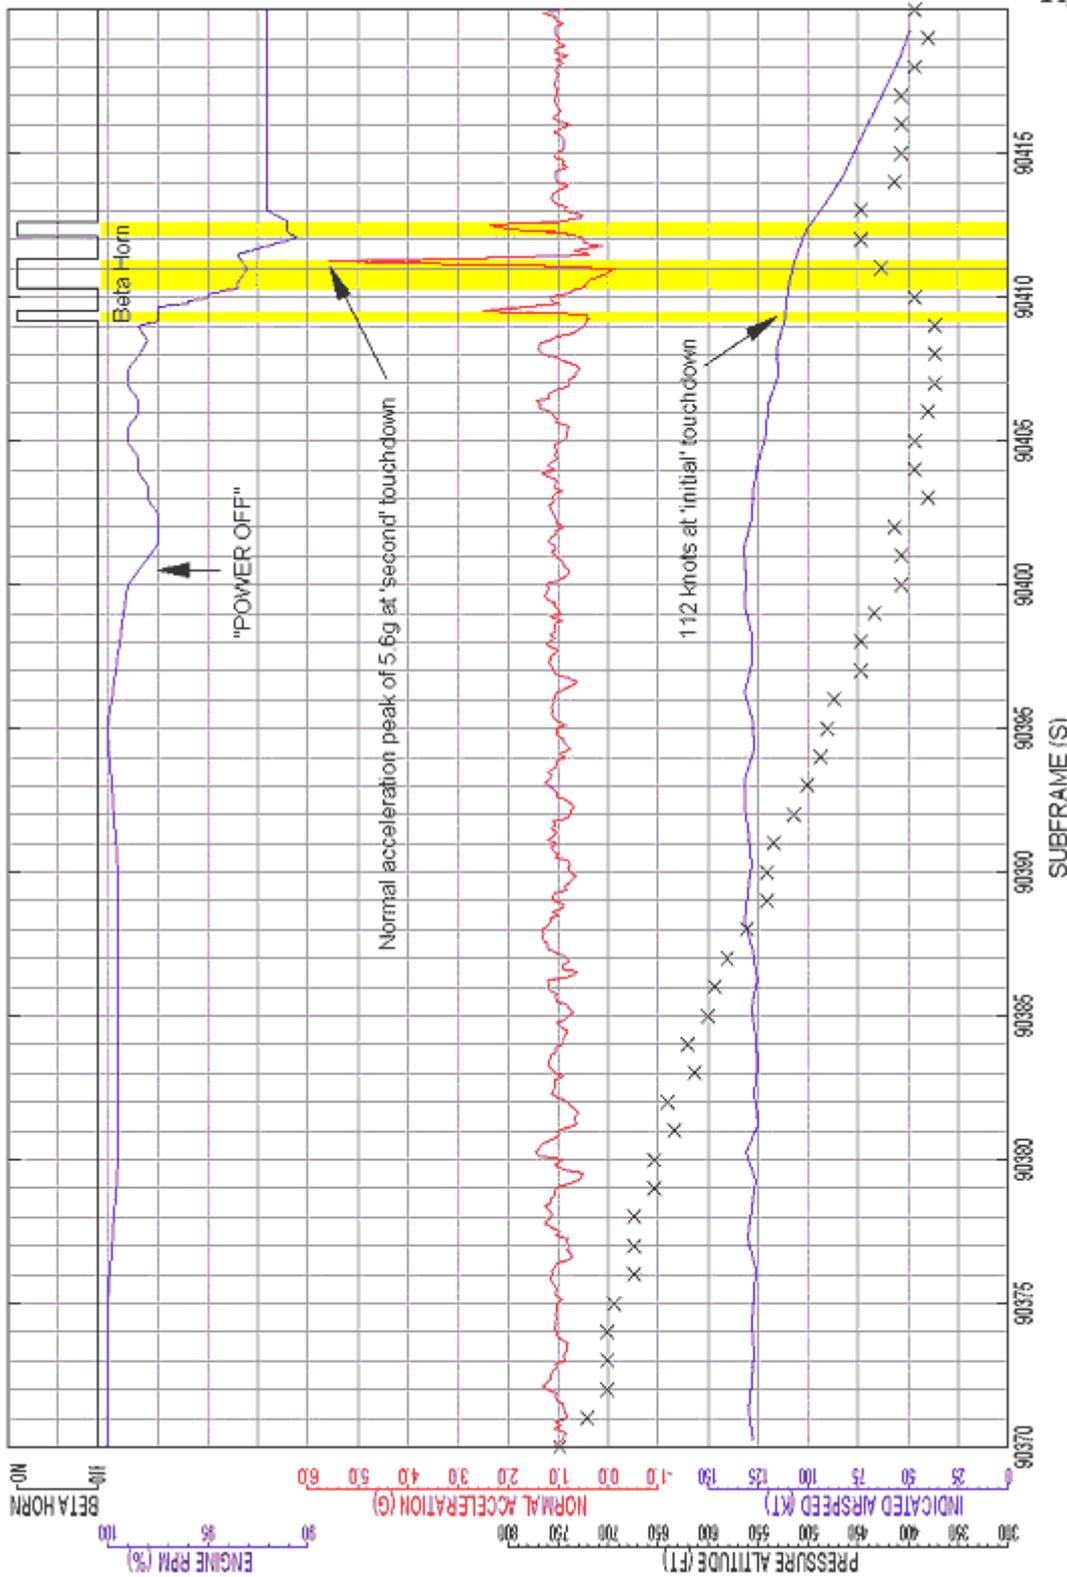
Figure 1

A time-history of the relevant parameters during the landing at Wick is shown in Figure 1. The figure starts at 40 seconds before touchdown; with the landing checks completed and the engines at 100% RPM. The aircraft was descending at about 700 feet/minute and 130 KIAS. At just under nine seconds before touchdown, both engine RPMs started reducing as the commander called "POWER OFF", initially dipping to 97% and finally stabilising at about 98%. As the power was reduced, the descent rate slowed to about 250 feet/minute before the aircraft levelled off at a pressure altitude of 375 feet, three seconds before touchdown. Also, the speed began to decay at a rate of 2.5 knot/second, reducing to 112 KIAS at touchdown, 9 kt above  $V_{REF}$ . The recorded normal acceleration at touchdown was 2.5g.

Salient CVR derived/FDR Parameters  
(Accident to G-EEST on 17 September 2003 at Wick Airport)

At 0.28 seconds prior to touchdown, the beta warning horn started sounding and continued to do so until touchdown. There was then a pause of about 0.8 seconds, during which time the normal acceleration fell to just under 1g before the beta horn sounded again, this time for just over one second. As the horn sounded, the normal acceleration continued to fall to just below 0g and then rose rapidly reaching a peak of 5.6g. A second pause of about 0.8 seconds followed during which the

normal acceleration again fell, this time to 0.5g, before the horn sounded one final time (for 0.5 seconds). As the horn sounded, the normal acceleration rose to 2.3g, falling to a nominal 1g once the horn stopped. Throughout this period of horn soundings, the engine RPMs and aircraft speed continued to fall. There was also a 75 feet rise in the pressure altitude (at 1,400 feet/minute); an unreliable number particularly if the aircraft was pitching, potentially introducing position errors in the altitude pressure sensing system. Knowledge of aircraft pitch attitude, which was unavailable, would be required to determine if these errors existed.

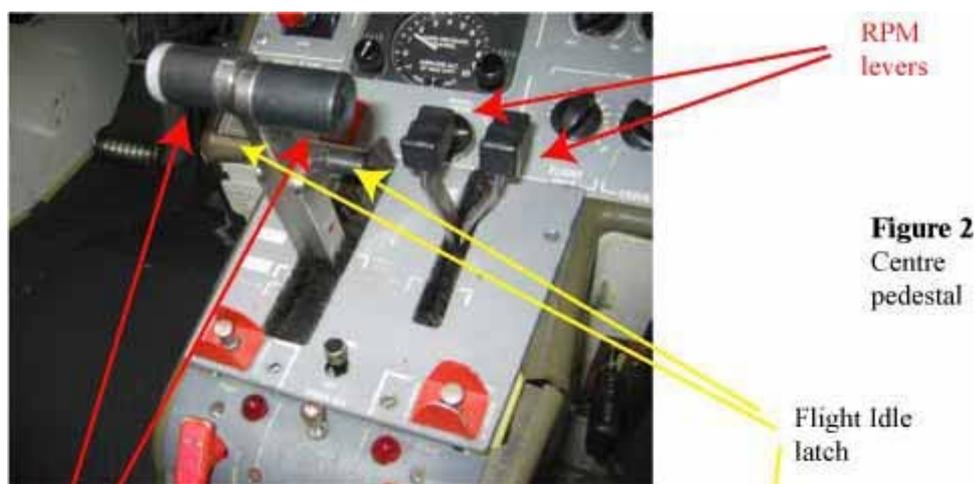
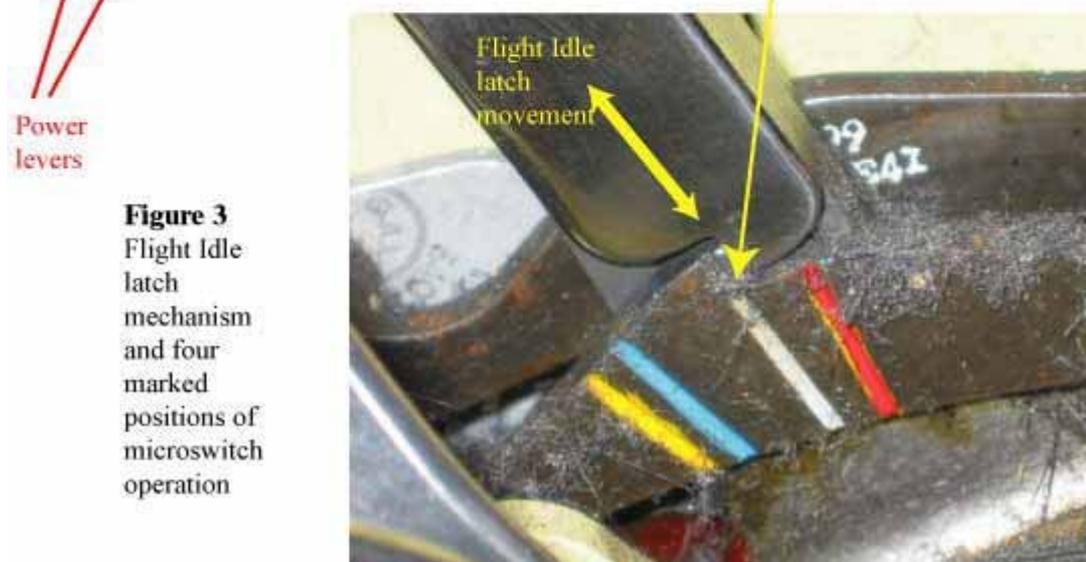
Each power lever activates four microswitches that operate at selected positions and which are colour coded to match that of an associated segment on the control pedestal guide plate (see Figure 3). The first microswitch (red) provides an input to the landing gear audio warning. The lowest available power setting in flight is FLIGHT IDLE and unintentional movement of either power lever below this position is prevented by a latch mechanism. Any movement of either power lever below the flight idle position into the ground (beta mode) range will operate the second microswitch (white) and result in a high pitch audio warning tone on the flight deck if the nose landing gear 'weight-on-wheel' microswitch is not made. As either power lever is retarded further, a third microswitch (blue) allows the automatic lift dump to operate and the final microswitch (yellow) illuminates the REV caption on the instrument panel to indicate a propeller reverse pitch selection.

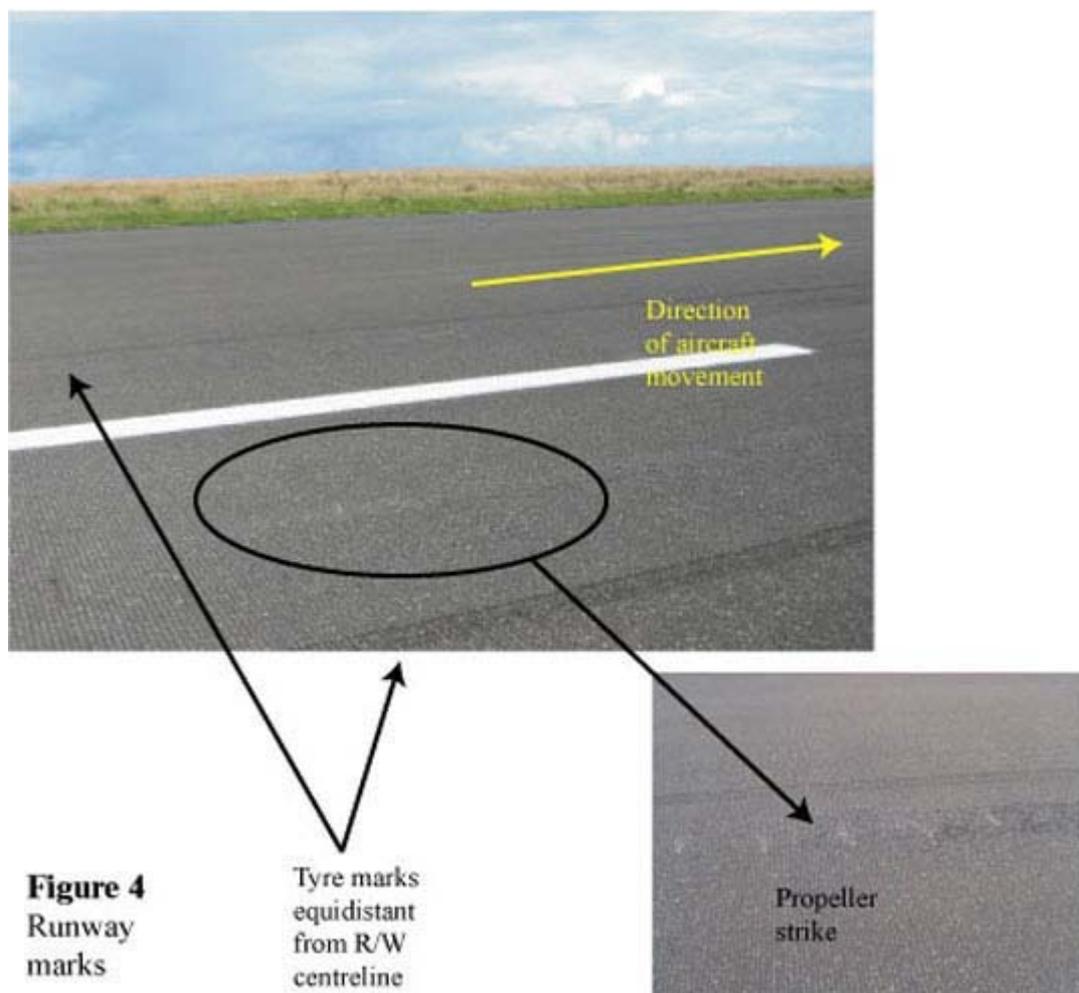
A set of tyre marks consistent with the track of the main landing gear of a Jetstream 31 were identified beginning at a position approximately 675 metres beyond the displaced threshold of Runway 31 (see Figure 4). The marks were approximately equidistant either side of the centreline and in line with the runway heading. To the left of the right hand tyre mark, approximately 0.85 metres towards the centreline, five propeller strikes were evident with a mean spacing of 0.53 metres. No other runway marks associated with this accident were identified.

The groundspeed at the time the propeller strikes were made was estimated to be 96 kt using the formula given in the ICAO Manual of Accident Investigation and assuming 94% propeller RPM at the second touchdown.

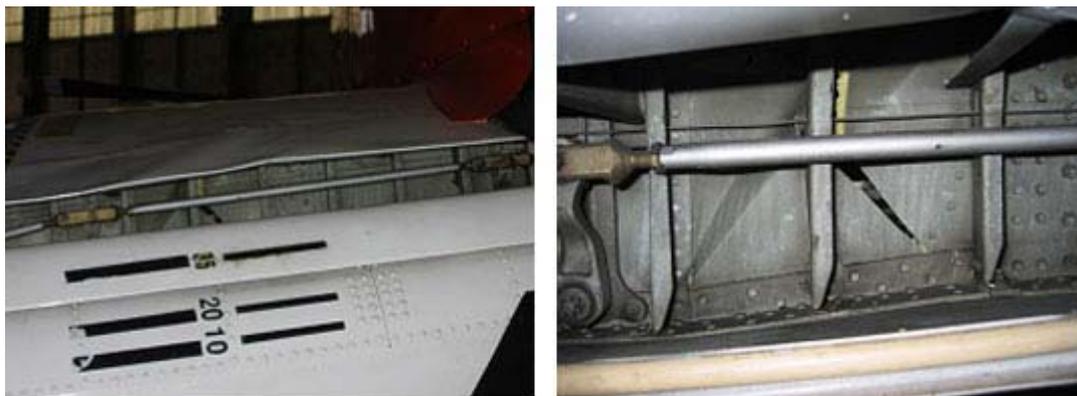
The aircraft structure was examined in accordance with the heavy landing checks in the Aircraft Maintenance Manual (AMM) 05-50-10 601. Structural damage consistent with a heavy landing was evident on the right hand side of the aircraft; there was a crease in the right hand fuselage skin above the main spar below one of the cabin windows. Both upper and lower right hand wing skins showed evidence of buckling and on the inner rear spar, both top and bottom booms had cracked and the web had buckled and sheared between Wing Stations (WS) 70 and 83 (see Figure 5). The damage had caused fuel leaks from the underside of the left wing near the main landing gear, from the left main landing gear forward mounting structure, and on the upper surface of the right wing.

**Figure 5** Structural damage to upper wing skin and rear spar
