**SERIOUS INCIDENT**

<b>Aircraft Type and Registration:</b>	Saab-Scania SF340B, G-LGNE
<b>No &amp; Type of Engines:</b>	2 General Electric CO CT7-9B turboprop engines
<b>Year of Manufacture:</b>	1989
<b>Date &amp; Time (UTC):</b>	17 January 2009 at 0830 hrs
<b>Location:</b>	Runway 24 at Benbecula Airport, W Isles, Scotland
<b>Type of Flight:</b>	Commercial Air Transport (Passenger)
<b>Persons on Board:</b>	Crew - 3                      Passengers - 10
<b>Injuries:</b>	Crew - None                      Passengers - None
<b>Nature of Damage:</b>	Abrasion of aluminium skin and mounting bracket
<b>Commander's Licence:</b>	Airline Transport Pilot's Licence
<b>Commander's Age:</b>	37 years
<b>Commander's Flying Experience:</b>	5,924 hours (of which 1,155 were on type) Last 90 days - 114 hours Last 28 days - 20 hours
<b>Information Source:</b>	AAIB Field Investigation

**Synopsis**

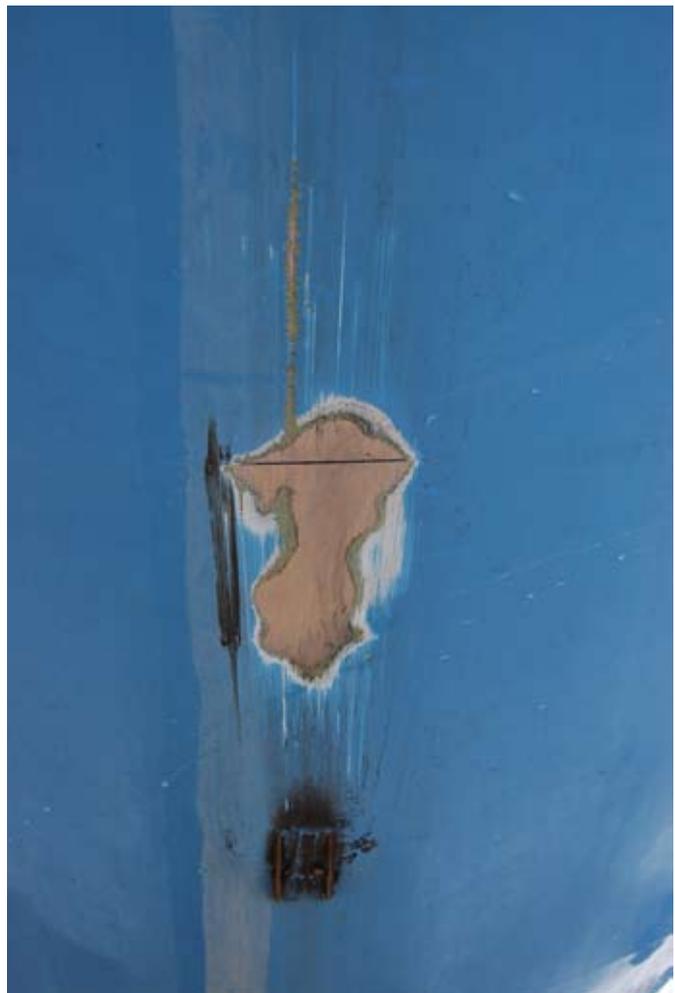
**Figure 1**

The attachment bracket on the underside of the rear fuselage onto which a length of tubing known as a 'pogo stick' is secured when the aircraft is parked, was worn away. The 'pogo stick', when attached, hangs down in order to prevent the aircraft tipping back onto its tail when loading passengers and freight. As this was not available, the freight was offloaded first, followed by the passengers, in order to keep the nosewheel in positive contact with the ground. At no time during the flight was there any indication that the aircraft CG was outside the permitted limits for landing and takeoff.

Damage to the rear fuselage is shown in Figure 1.

Damage to the underside of the aircraft tail

The misloading of the aircraft occurred due to a failure in communication during the aircraft loading procedure. The flight closure message was not received by the dispatcher and the change of passenger seating was not passed to the crew. This led to an aft CG index significantly outside the permitted takeoff, landing and in-flight limits, and the underside of the tail contacting the runway surface on landing.
