Airbus A320-200, G-MONY, 13 April 1996

AAIB Bulletin No: 8/96 Ref: EW/C96/4/14 Category: 1.1

INCIDENT

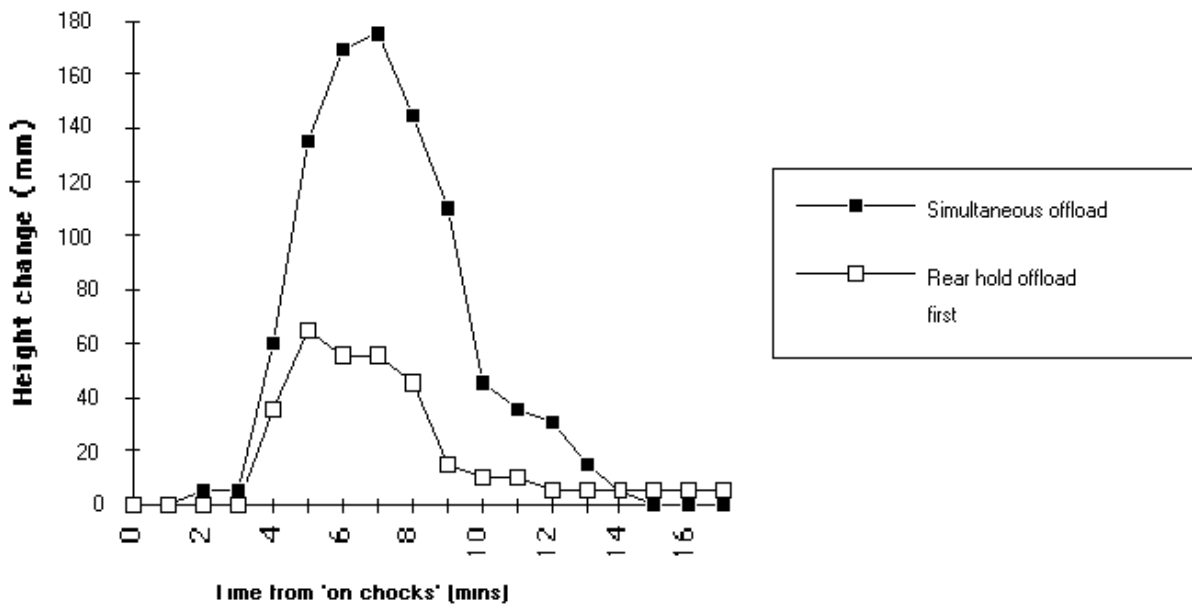
A320-200 MOVEMENT OF NOSE GEAR DATUM

Two trials were conducted to measure the changes in height of the aircraft fuselage adjacent to the nose landing gear (directly in-line with the forward passenger door). Measurements were taken at one minute intervals. In trial No 1 the front and rear holds of the aircraft were unloaded simultaneously whilst the passengers were disembarking through the forward door only. The conditions for trial No 2 were the same except that the rear hold was unloaded first (the procedure specified by the company). The results from these trials were compared with tabulated information supplied by Airbus in their operations manual (Chapter 2.3 page 1) under the title 'AIRPLANE CHARACTERISTICS'. The table gives details of heights above ground for various points along the aircraft's length under empty operating weight conditions with a C of G at 22%; at maximum ramp weight with a C of G at 18.6% and at maximum ramp weight with a C of G at 41%. The results of the trials and the relevant manufacturers figures are included below:

Simultaneous offload: Aircraft landing weight = 60,473 kg; ZFW CG=35.5%; (pax=174, bags=205)

Rear hold offload: Aircraft landing weight = 60,043kg; ZFW CG=32.2%; (pax=169, bags=187)

The manufacturers data above gives details of the forward doorsill height at the three conditions stated. It does not however give an indication as to the total range of movement of the door height during weight changes. The manufacturers data implies that, at worst, the maximum amount of height change is 7 cm. On the other hand measurements taken from the trials shows that the maximum amount of total movement that can be expected, during a routine disembarkation, is at least 17.5 cm.

It is therefore recommended that Airbus provide A320 operators with information on the maximum amount of door (both front and rear) sill height movement that can be expected, during aircraft weight changes, in order that airbridges, without auto levelling devices, and fixed height mobile steps can be positioned accordingly so as to avoid aircraft structural damage.
