# Airbus A320-200, G-MONY, 13 April 1996

## AAIB Bulletin No: 8/96 Ref: EW/C96/4/14 Category: 1.1

#### INCIDENT

Aircraft Type and Registration: Airbus A320-200, G-MONY

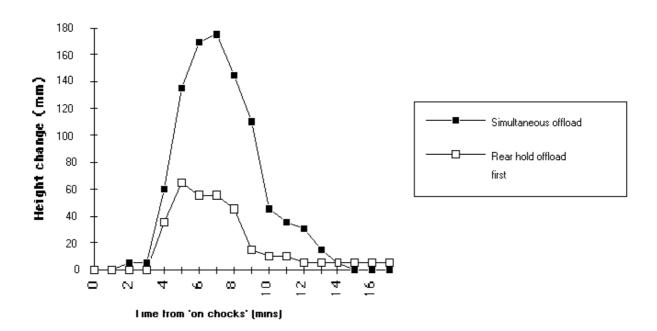
#### A320-200 MOVEMENT OF NOSE GEAR DATUM

Two trials were conducted to measure the changes in height of the aircraft fuselage adjacent to the nose landing gear (directlyin-line with the forward passenger door). Measurements were takenat one minute intervals. In trial No 1 the front and rear holdsof the aircraft were unloaded simultaneously whilst the passengerswere disembarking through the forward door only. The conditions for trial No 2 were the same except that the rear hold was unloaded first (the procedure specified by the company). The results from these trials were compared with tabulated information supplied Airbus in their operations manual (Chapter 2.3 page 1) under the title 'AIRPLANE CHARACTERISTICS'. The table gives details of heights above ground for various points along the aircraft's length under empty operating weight conditions with a C of G at 22%; at maximum ramp weight with a C of G at 18.6% and at maximum ramp weight with a C of G at 41%. The results of the trials and the relevant manufacturers figures are included below:

Simultaneous offload: Aircraftlanding weight = 60,473 kg; ZFW CG=35.5%; (pax=174, bags=205)

Rear hold offload: Aircraft landing weight = 60,043kg; ZFW CG=32.2%; (pax=169, bags=187)

The manufacturers data above gives details of the forward doorsill height at the three conditions stated. It does not howevergive an indication as to the total range of movement of the doorheight during weight changes. The manufacturers data implies that, at worst, the maximum amount of height change is 7 cm. On the other hand measurements taken from the trials shows that the maximum amount of total movement that can be expected, during a routine disembarkation, is at least 17.5 cm.

It is therefore recommended that Airbus provide A320 operators with information on the maximum amount of door (both front andrear) sill height movement that can be expected, during aircraftweight changes, in order that airbridges, without auto levellingdevices, and fixed height mobile steps can be positioned accordinglyso as to avoid aircraft structural damage.
