**INCIDENT**

<b>Aircraft Type and Registration:</b>	AS332L2 Super Puma, G-CHCF	
<b>No &amp; Type of Engines:</b>	2	Turbomeca MAKILA 1A2 turboshaft engines
<b>Year of Manufacture:</b>	2001	
<b>Date &amp; Time (UTC):</b>	20 November 2007 at 2057 hrs	
<b>Location:</b>	Aberdeen Airport, Scotland	
<b>Type of Flight:</b>	Training	
<b>Persons on Board:</b>	Crew - 3	Passengers - None
<b>Injuries:</b>	Crew - None	Passengers - N/A
<b>Nature of Damage:</b>	None	
<b>Commander's Licence:</b>	Airline Transport Pilot's Licence	
<b>Commander's Age:</b>	50	
<b>Commander's Flying Experience:</b>	13,199 hours (of which 2,040 were on type) Last 90 days - 118 hours Last 28 days - 37 hours	
<b>Information Source:</b>	AAIB Field Investigation

**Synopsis**

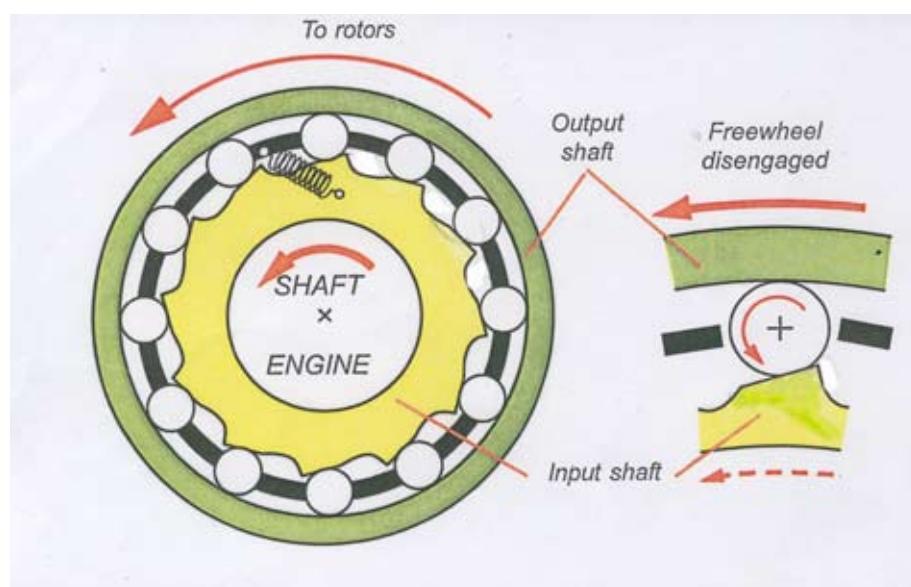
**Figure 1**

'Ramp and roller' freewheel unit

The freewheel anti-rotation stops had failed as a result of the roller cage rotating into them with significant force and all the rollers showed signs of deformation and mechanical damage. The shaft exhibited signs of significant mechanical wear on the ramps together with some burring of the ramp lips, produced when they had been 'over-ridden' by the rollers. Metallurgical examination confirmed that there were no material abnormalities within the freewheel shaft, the rollers or the roller cage. No evidence of a failure was identified during the inspection of the right engine which may have contributed to the failure of the right freewheel unit.

Excessive wear to the freewheel shaft ramps resulted in the freewheel rollers overriding the ramps, disengaging the engine from the main rotor gearbox. No metallurgical defects were identified within the freewheel unit. The gearbox had been overhauled in November 2005, prior to the release of Eurocopter RL 214, in accordance with the applicable limitations and procedures in force at that time. The possibility of an in-service freewheel failure has been significantly reduced by the introduction of RL 214. Eurocopter, in Alert Service Bulletin 01.00.74, identified all the AS332L2 main rotor gearboxes which were exposed to a potential freewheel failure with a defined timescale

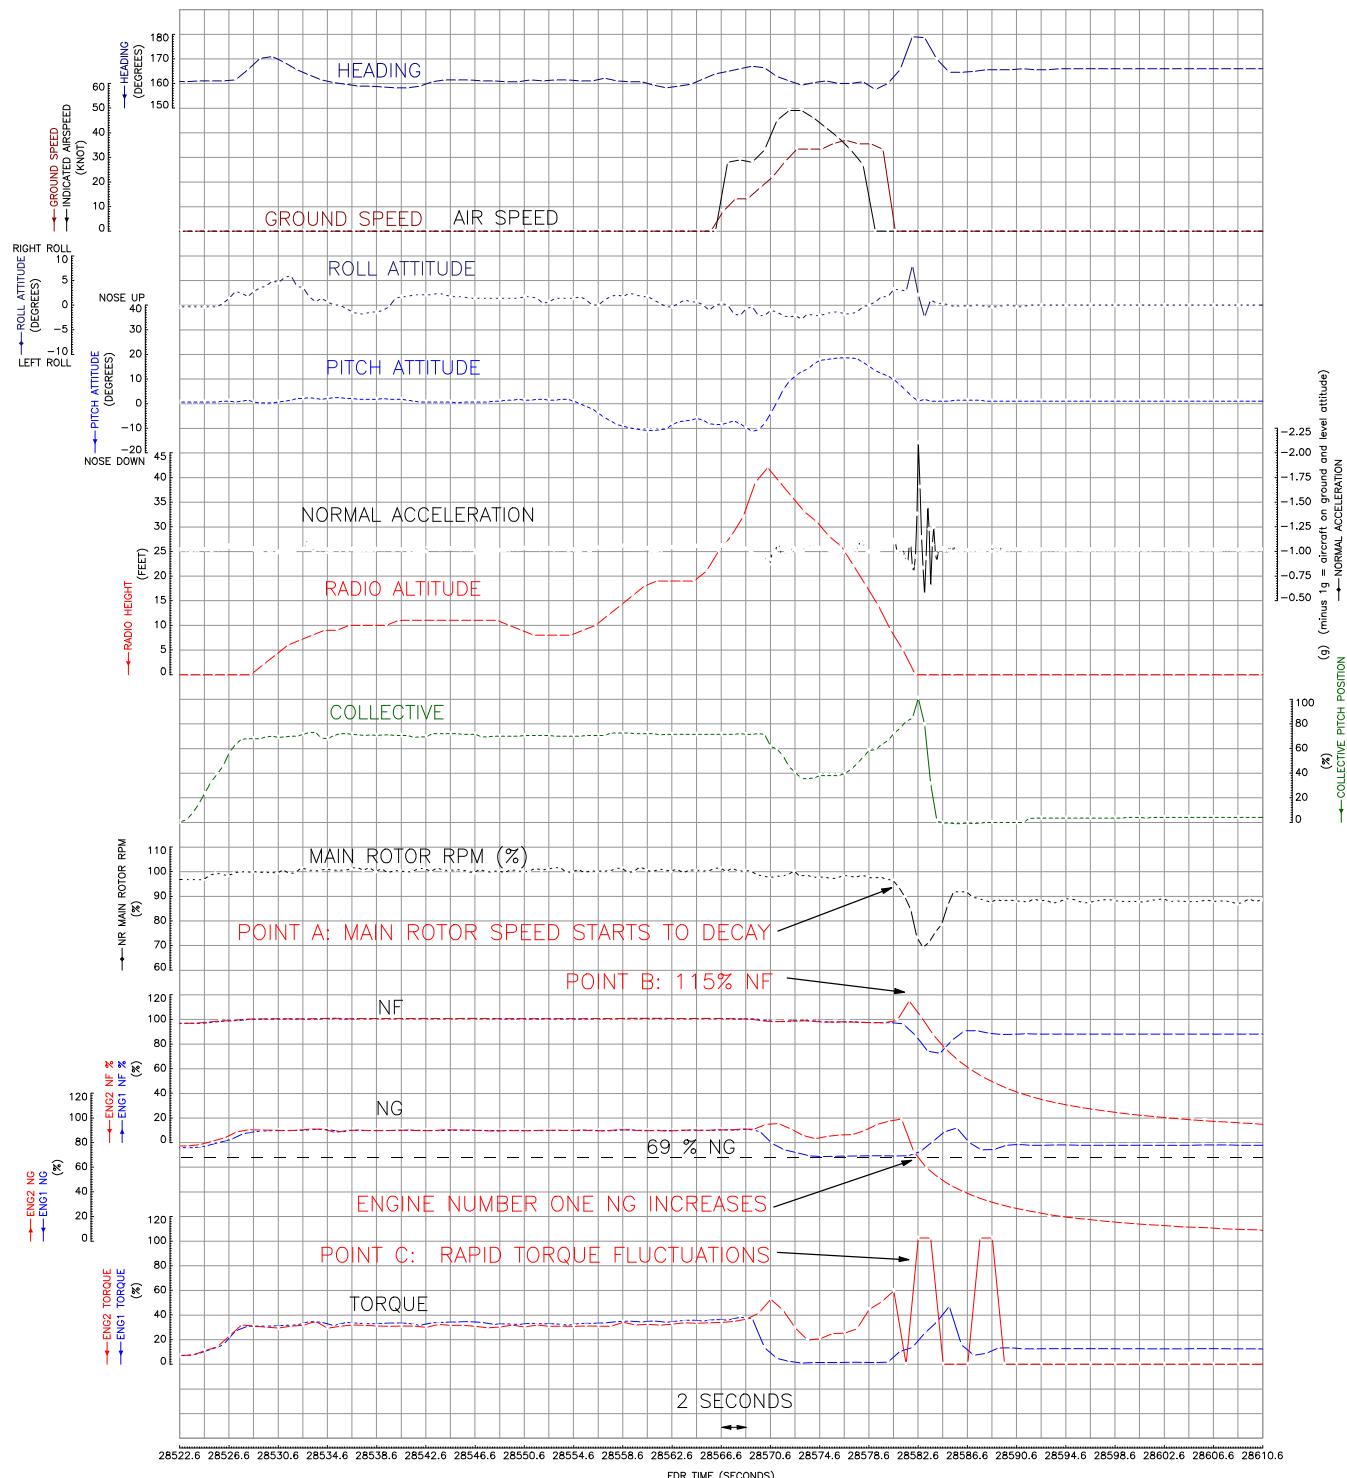
**Figure 2**  
Salient FDR Parameters

During the transition, the commander activated the TIS to simulate the failure of the left engine when the helicopter was at 39 ft, at which time the airspeed was about 28 kt. Initially everything appeared normal, but at a height of about 10 ft, the right engine  $N_f$  speed rapidly increased to 115%, before the engine was automatically shutdown and the main rotor speed started to decay. (See points A and B, Figure 2). Almost immediately, the low rotor speed aural warning activated and the commander took control of the helicopter, just before it landed firmly. As the right engine had started to run down, the left engine responded with an increasing  $N_g$  speed. By the time the left engine had reached its normal operating speed, the helicopter had already landed. From the point at which the right engine had started to rundown, the left engine had taken about three seconds to increase from the TIS setting of 69% to 91%  $N_g$ . The main rotor speed had decayed from about 97% to about 73% in two seconds.

When the right engine had started to rundown, the engine torque indication had rapidly decreased and increased twice (See point C, Figure 2). The indications were later attributed to a misalignment of the torque sensing components, which had become misaligned as a result of the freewheel unit failure.
