ACCIDENT

Aircraft Type and Registration:	BAe.ATP, G-MANH
No & Type of Engines:	2 Pratt & Whitney Canada PW126 turboprop engines
Year of Manufacture:	1989
Date & Time (UTC):	9 April 2011 at 0147 hrs
Location:	Cardiff Airport
Type of Flight:	Commercial Air Transport (Cargo)
Persons on Board:	Crew - 2 Passengers - None
Injuries:	Crew - None Passengers - N/A
Nature of Damage:	Both right main landing gear tyres, gear leg components, hydraulic pipes and flap/nacelle fairings damaged
Commander's Licence:	Airline Transport Pilot's Licence
Commander's Age:	56
Commander's Flying Experience:	10,138 hours (of which 1,379 were on type) Last 90 days - 85 hours Last 28 days - 28 hours
Information Source:	AAIB Field Investigation

Synopsis

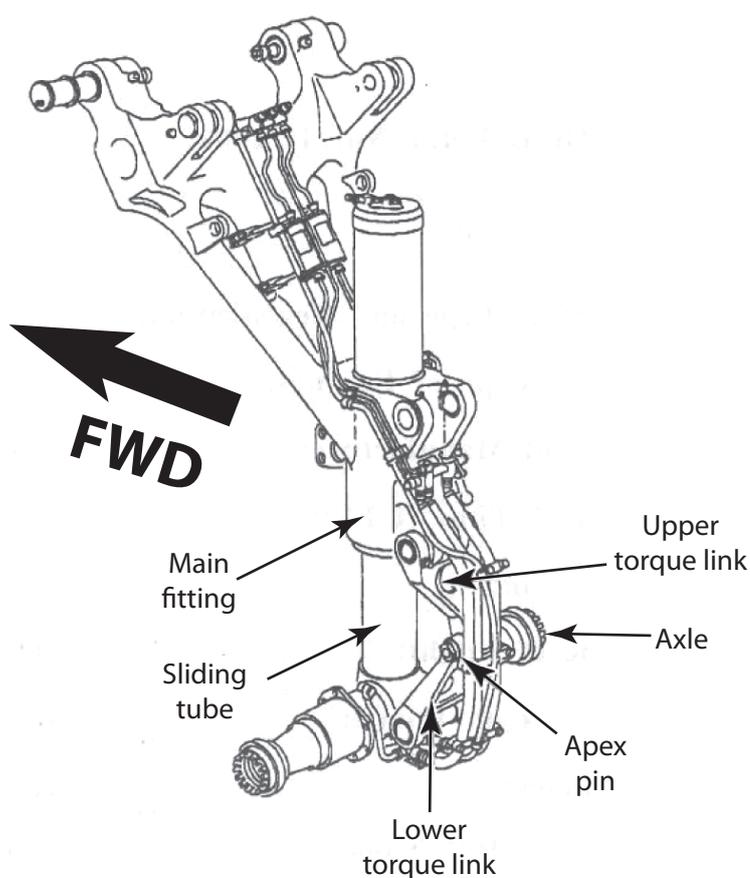
Figure 1

The main landing gear leg of the ATP has conventional torque links attaching the sliding tube (sometimes known as the sliding member) and axle assembly, together with the wheels and brakes, to the upper section (main fitting) of the leg. The link system constrains the axle against rotating in the horizontal plane.

General view of leg with wheels and brakes removed

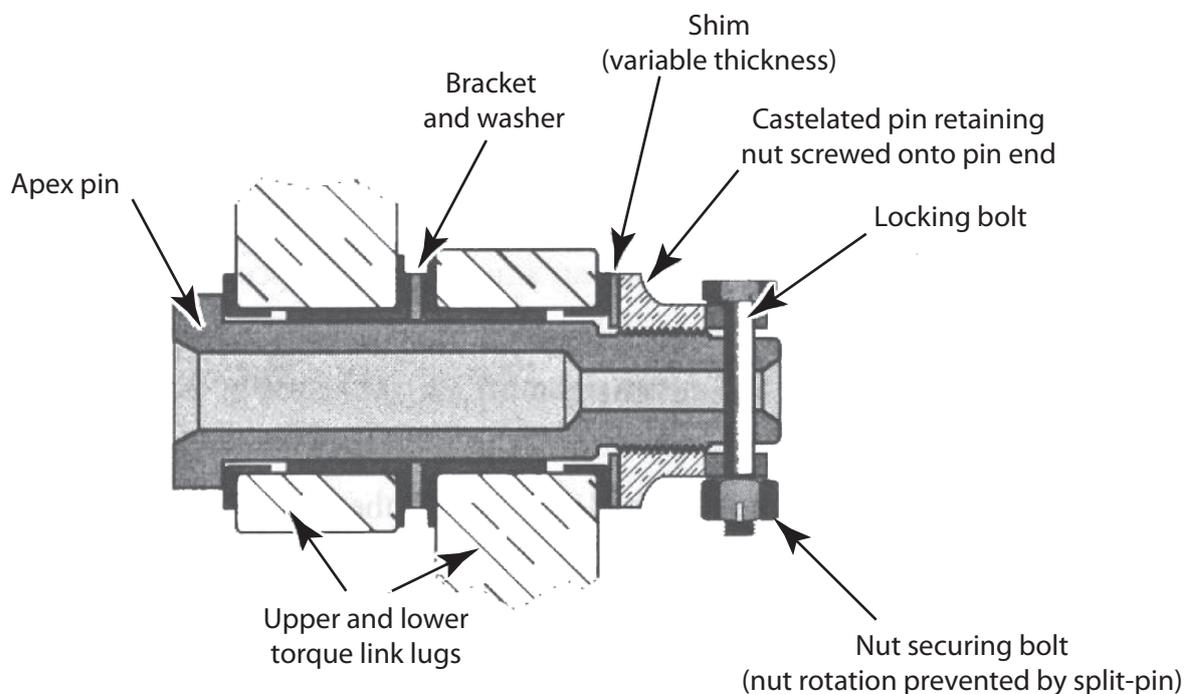
Figure 2

The lugs at the aft end of each link have bushed horizontal bores. The apex pin attaching the aft lugs together is secured in position by a large castellated nut screwed onto a threaded end portion of the pin. The pin also passes through a bracket and a washer fitted between the lugs and a shim positioned beyond the lug of the upper link directly secured by the castellated nut. (The bracket locates flexible hydraulic pipes routing to and from the brake units.) The castellated nut is prevented from rotating on the pin threads by a small diameter threaded locking bolt passing through the castellations and through one of two bores in the pin. These are orientated at 90° to the pin axis and 90° to one another. The shim thickness is varied to enable the backlash of the installed apex pin to be controlled on assembly, since the axial position of the castellated nut on the threads of the apex pin is dictated by the presence of the locking bolt and can only be varied in discrete steps corresponding to approximately $1/12$ of a

Section through apex pin, torque link lugs, castellated nut and locking bolt

The condition of the internal thread forms in the castellated nut and the external threads on the pin were consistent with corrosion having removed material from

the flanks of the thread forms in the nut and on the pin. This combination had apparently reduced the depth of mutual engagement to the point where the threaded joint was unable to carry its design axial load. The destruction of the locking bolt, the presence of internal axial grooves created within the nut (apparently by the fractured end faces of the locking bolt) and damage to the crests of the engaging thread forms, were all features consistent with axial separation of the castellated nut from the pin.

It was clear that axial loading had failed the corrosion weakened thread engagement. This had initially transferred the end load, applied via the lugs to the castellated nut, from their design support medium - the threaded joint between the pin and castellated nut - to the locking bolt (normally intended purely to prevent rotation of the castellated nut on the pin).

The nature of the visible damage to the ends of the surviving mid section of the locking bolt (being approximately conical / spherical in shape) was consistent with a sequence of discrete double shear loads being applied with different angular orientations by the castellated nut, after failure of its thread engagement, on the pin. This in turn was consistent with the bolt rotating in its bore in the pin between a series of shear load applications.

The landing gear manufacturer is replacing the existing SB with a new one to require regular removal of the nut from the pin to check for end float of the threads thereby avoiding the presence of corrosion from preventing float and thereby masking any deterioration

of the thread form. It further requires an inspection of apex pin and nut threads for corrosion and replacement of both components if any is present. The likelihood that some surface damage was inflicted on the thread forms of the pin and/or the nut during assembly of the unit on G-MANH is to be addressed by introducing a jointing compound on the thread forms during future assembly operations. The unit assembly drawings are to be amended by the landing-gear manufacturer to reflect this modified procedure. The locking bolt, nut and split pin are to be discarded at each inspection and replaced with new items.
