No: 12/92 Ref: EW/C92/8/3 Category: 4

Aircraft Type and Registration: DC-9-83 (MD-83), G-JSMC

Location: Runway 26L London Gatwick Airport, Sussex

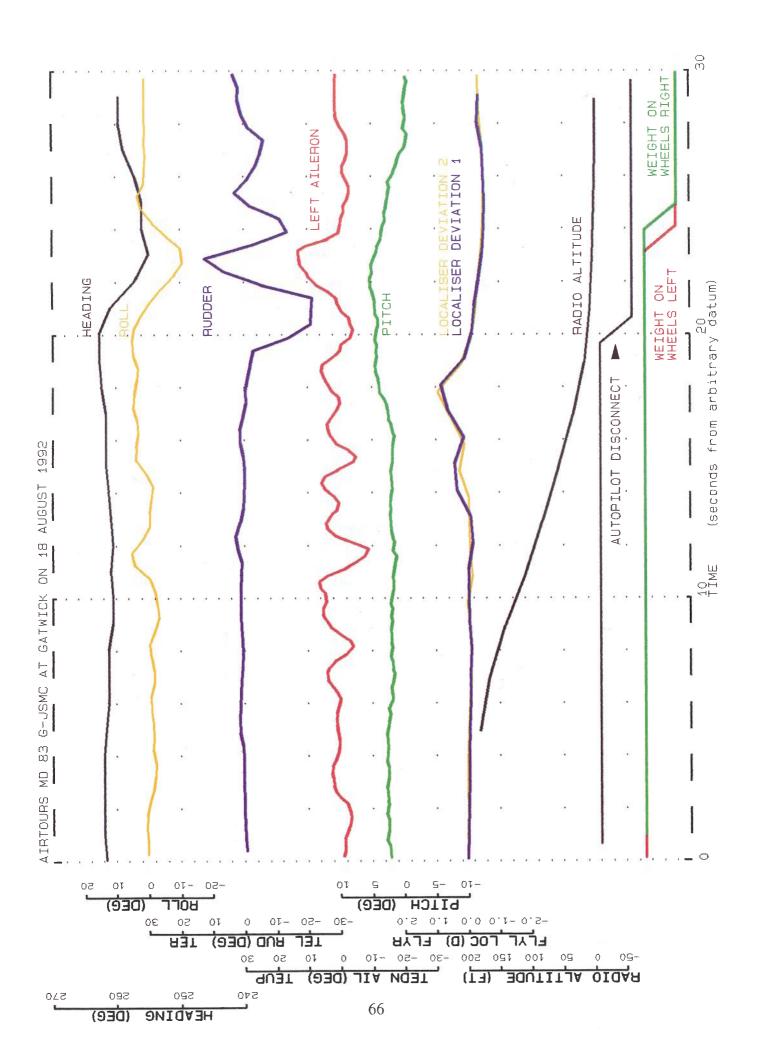
Figure 1 shows some of the parameters during the final approach with the aircraft lined up at 200 feet onto R/W 26 at Gatwick, Flap 40 and Landing Gear DOWN selected; the Autopilot in use was No 2. At about 100 feet Radio Altimeter the localiser started to show a Fly Right indication,

and the aircraft drifted to the right as shown by the recorded magnetic heading. By 18 seconds the aircraft was still drifting to the right, the localiser deviation showed a Fly Right signal of almost 1 dot at between 15 and 33 feet Radio Altimeter, and the EPR started to reduce from 1.2.

The localiser deviation then returned to centre and the rudder position moved to around 21.6° trailing edge left at 20 seconds (maximum rudder deflection is $\pm 23^{\circ}$). The autopilot was disconnected at about 20 seconds; it is not possible to determine the exact time of disconnect as the autopilot discrete is sampled only once per second. The heading started to reduce from 262.6° M at 20 seconds, to a minimum of 255° M at 23 seconds, co-incident with a roll attitude of 10.8° left wing down. Touchdown occurred on the left gear at between 23 and 24 seconds, with the right gear touching about one second later.
