**ACCIDENT**

<b>Aircraft Type and Registration:</b>	Gazelle HT.MK3, G-CBXT (XW898)	
<b>No &amp; Type of Engines:</b>	1 Turbomeca Astazou IIIN2 turboshaft engine	
<b>Year of Manufacture:</b>	1974	
<b>Date &amp; Time (UTC):</b>	1 November 2008 at 0928 hrs	
<b>Location:</b>	Winchcombe, Gloucestershire	
<b>Type of Flight:</b>	Private	
<b>Persons on Board:</b>	Crew - 1	Passengers - 2
<b>Injuries:</b>	Crew - 1 (Fatal)	Passengers - 2 (Fatal)
<b>Nature of Damage:</b>	Aircraft destroyed	
<b>Commander's Licence:</b>	Private Pilot's Licence (Helicopter)	
<b>Commander's Age:</b>	55 years old	
<b>Commander's Flying Experience:</b>	305 hours (of which 122 <sup>1</sup> were on type) Last 90 days - 5 hours Last 28 days - 1 hour	
<b>Information Source:</b>	AAIB Field Investigation

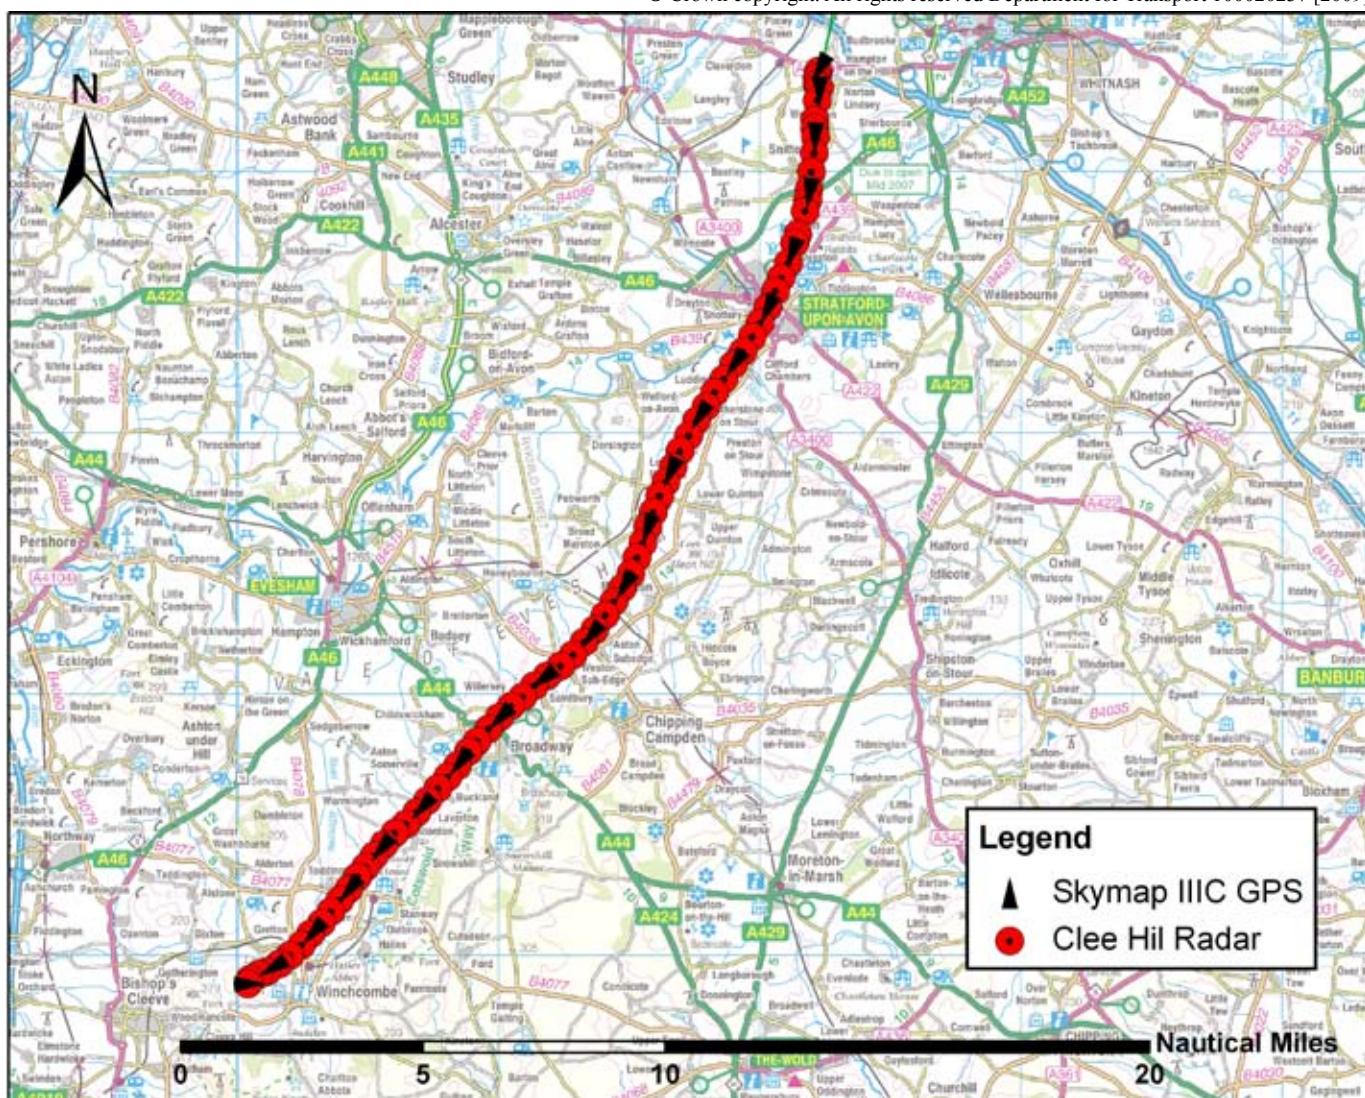
Figure 1

The recorded track starts near the village of Norton Lindsey, Warwickshire, with G-CBXT 120 ft above the ground and finishes approximately 100 m away from the accident site. At this point, the aircraft was 150 ft above the ground, with a ground speed of 33 kt and heading in an easterly direction. The radar track (in red) and GPS points (in black) are illustrated in Figure 1.

Radar and GPS tracks

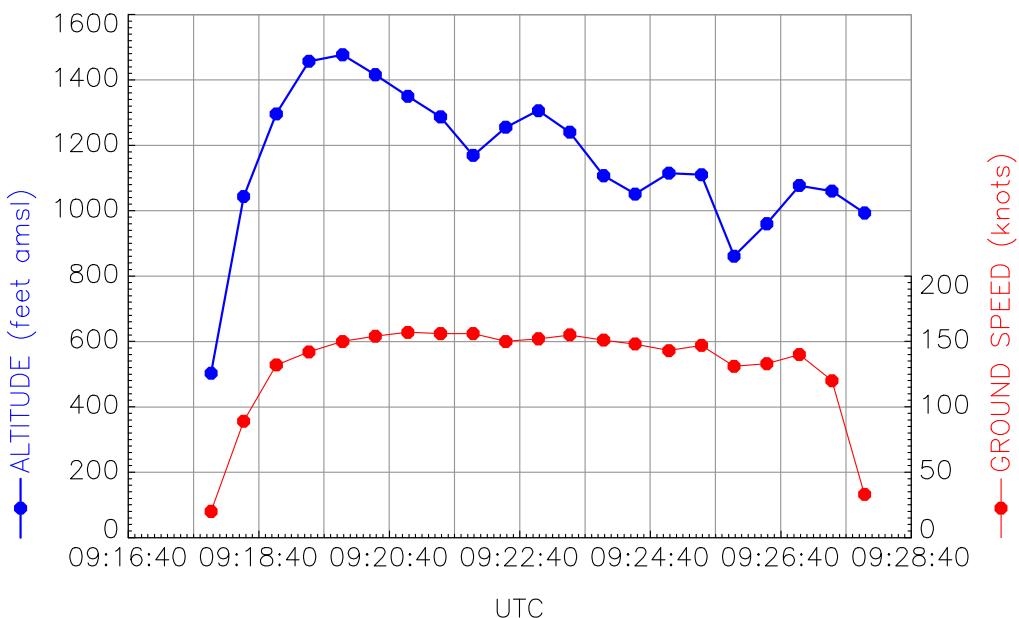
The ground speed during the majority of flight was approximately 150 kt with G-CBXT climbing to just under 1,500 ft amsl after takeoff, and then gradually descending throughout the rest of the flight although there were several 100-200 ft climbs (see Figure 2).

**Figure 2**  
Accident track altitude and ground speed from GPS

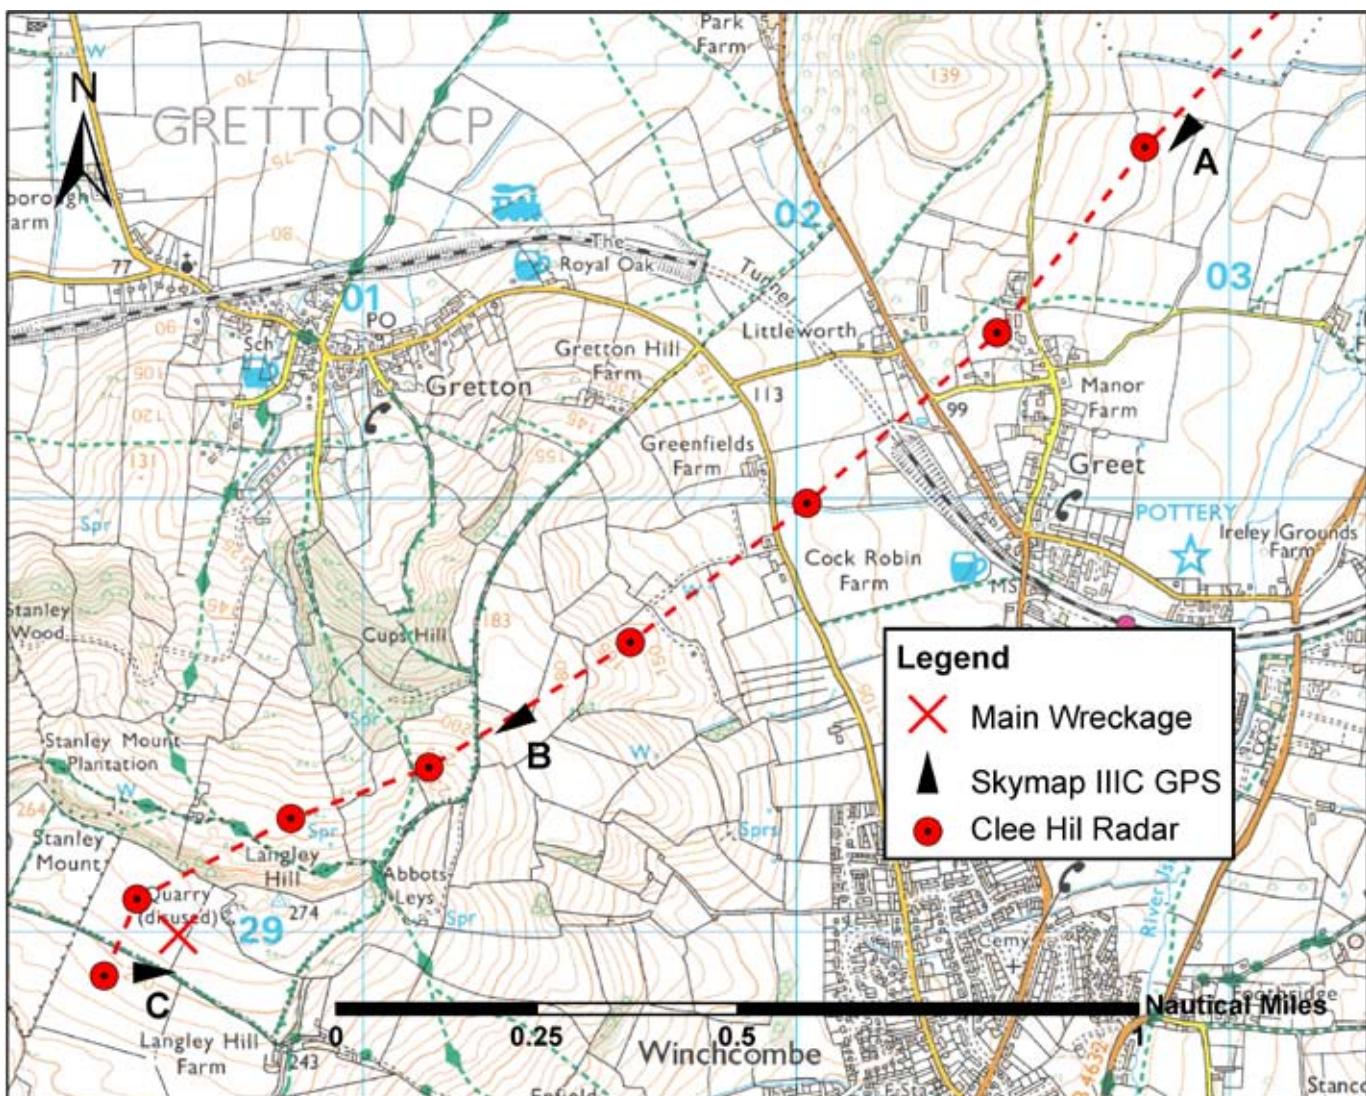
A close-up of the end of the accident-flight track is given at Figure 3 and shows G-CBXT decelerating and descending as it flew towards and passed over the ridge extending westwards from Langley Hill (899 feet amsl) at approximately 160 feet agl.

**Figure 3**  
Close-up of the end of accident-flight track

The aftercast indicated that in the immediate vicinity of the accident site patches of stratus were likely to have formed on high ground to give SCT or BKN stratus with a base of 700 ft to 980 ft amsl and tops at about 1,000 ft amsl. As depicted in Figure 2, the helicopter's altitude gradually reduced as it tracked south-west from Norton Lindsey to Langley Hill. This is likely to indicate that the cloud base lowered and the helicopter descended to remain VMC below the cloud. The accident site was 850 ft amsl, and from the statement made by the horse rider, Langley Hill would have been in cloud at the time of the accident. Given the heights the helicopter was flying at before the accident, it was likely to have been in IMC from point A, shown in Figure 3, or shortly afterwards.

The helicopter was tracking 239° at Point B in Figure 3. The accident site ground marks indicate that the helicopter was on a track of 020° at impact. This indicates that the pilot had turned through about 220° and may have been attempting to regain VMC from the direction the helicopter had originated, as he was taught in his PPL(H) training. However, the pilot was not qualified to fly in IMC, and would have lacked the practice to fly accurately on instruments.

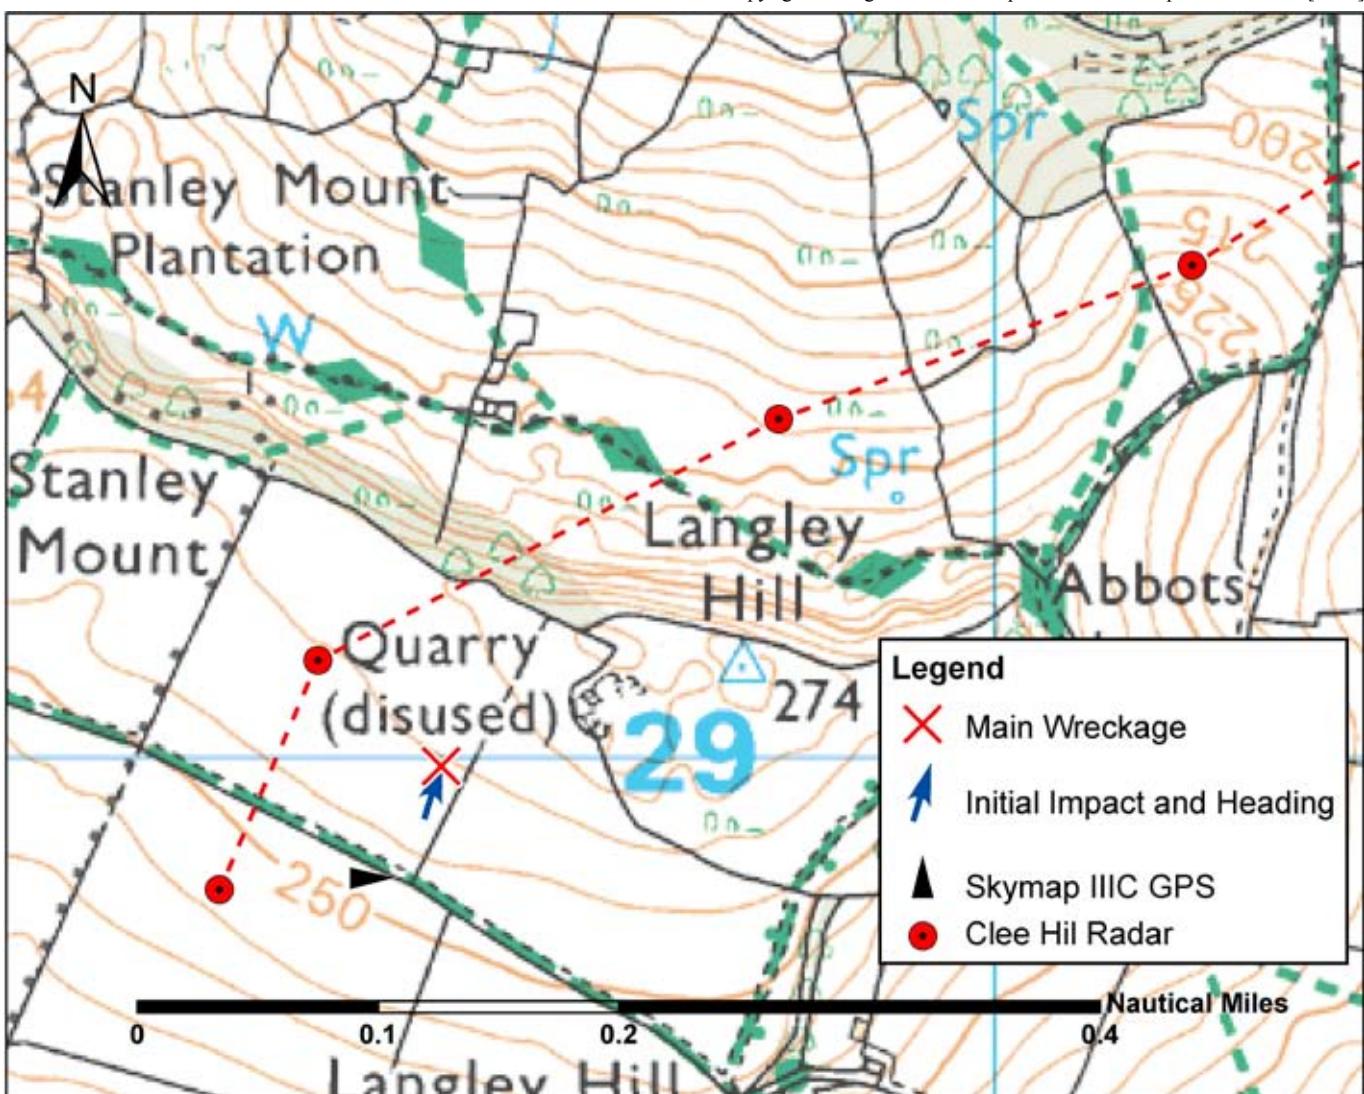
Figure 4 show the relation of the last portion of the track with the crash site.

**Figure 4**  
Crash site position with direction of ground marks
