# AAIB Bulletin S5/2014

## *SPECIAL*

### ACCIDENT

| <b>Aircraft Type and Registration:</b> | BAE Systems Jetstream 31, G-GAVA | |

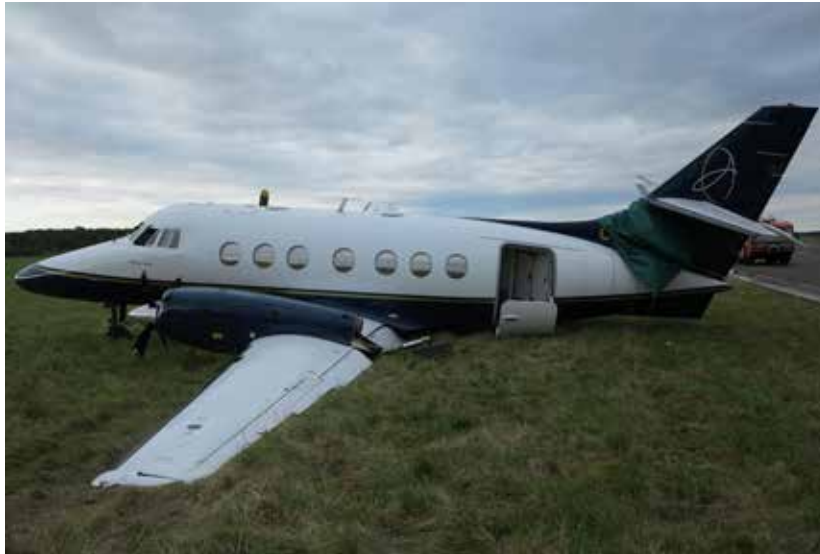
**Figure 1**

The aircraft touched down at 1836 hrs with an IAS of 102 kt and a peak normal acceleration of 1.3 g, and the commander moved the power levers aft to GROUND IDLE followed by REVERSE. As the aircraft decelerated, the commander moved the power levers forward to GROUND IDLE and asked the co-pilot to move the rpm levers to TAXI. At an IAS of 65 kt, eight seconds after touchdown, the left wing dropped suddenly, the aircraft began to yaw to the left and the commander was unable to maintain directional control with either the rudder or the nosewheel steering tiller. The aircraft ran off the left side of the runway and stopped on the grass having turned through approximately 90°. The left landing gear had collapsed and the aircraft had come to a halt resting on its belly, right landing gear and left wing (Figure 1).

The aircraft as it came to rest

The commander pulled both FEATHER levers, to ensure that both engines were shut down, and switched the electrics master switch to EMERGENCY OFF. The co-pilot transmitted "TOWER..... [CALLSIGN]" and the controller replied "[CALLSIGN] COPIED, EMERGENCY SERVICES ON THEIR WAY". The commander instructed the co-pilot to evacuate the aircraft. The co-pilot entered the main cabin where he found that the passenger appeared to be uninjured. The co-pilot considered evacuating the aircraft through the emergency exit on the starboard side of the cabin but judged that the main exit on the port side at the rear of the cabin would be the best option. The cabin door released normally but would not open completely because the sill of the doorway was at ground level (Figure 1). Nevertheless, all occupants were able to evacuate the aircraft through the main exit.

The blades on the left engine propeller had been badly damaged. The left aileron balance horn separated from the aircraft after it left the runway, becoming lodged in the soft ground. The left wingtip had sustained abrasion damage, resulting in a fuel leak from this area. The baggage pannier and anti-collision beacon on the underside of the fuselage also sustained considerable abrasion damage.

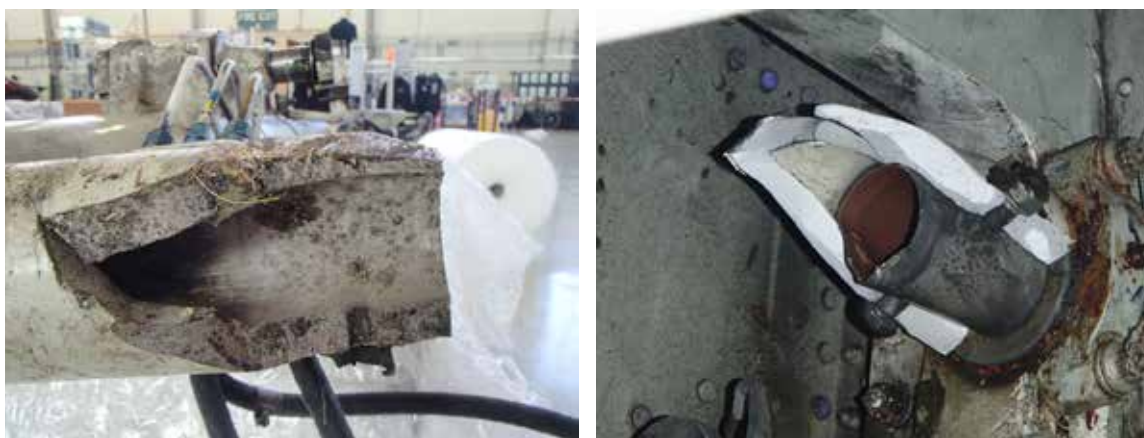
**Figure 2**

The left landing gear had broken away from its trunnions as a result of the failure of the forward yoke pintle housing; two sections of the pintle housing stayed attached to the pintle spigot (Figure 2). However, the landing gear remained attached to the aircraft by the radius arm (retraction jack) and hydraulic pipelines.

Left main landing gear yoke forward pintle

Preliminary metallurgical examination of the fracture faces on G-GAVA's left landing gear has established that the failure initiated at the top outer edge of the forward yoke pintle and that the crack propagated axially along the top of the pintle, before final overload failure occurred. The presence of corrosion has been identified at the crack initiation site. The forward face of the yoke pintle housing exhibits rotational wear marks and corrosion pitting. There is also evidence of rotational wear marks on both the forward and aft faces of the special washer; further work is required to fully understand the origin of these marks. There was no visual evidence of the presence of gasket material on either of the mating faces of the washer or pintle housing although some gasket material was present on the top machined flat of the housing. Additionally the fracture faces exhibit considerable similarities to those from the G-CCPW accident. This provides strong evidence that the crack initiated due to stress corrosion cracking.

Rotational wear is evident on the mating faces of the forward yoke pintle and the special washer. Further work is being undertaken to determine the origin of this wear and also whether rotational wear on the forward face of the special washer may be related to fouling of the bearing locking pins. There is no visual evidence of gasket material on the mating faces of the yoke pintle and the special washer; however, it is not yet known whether the gasket material was omitted during installation or had been forced out by the rotating washer. Gasket material is evident on the machined flat of the yoke pintle housing, however this area would be expected to be cleaned to facilitate the regular visual inspections in this area.

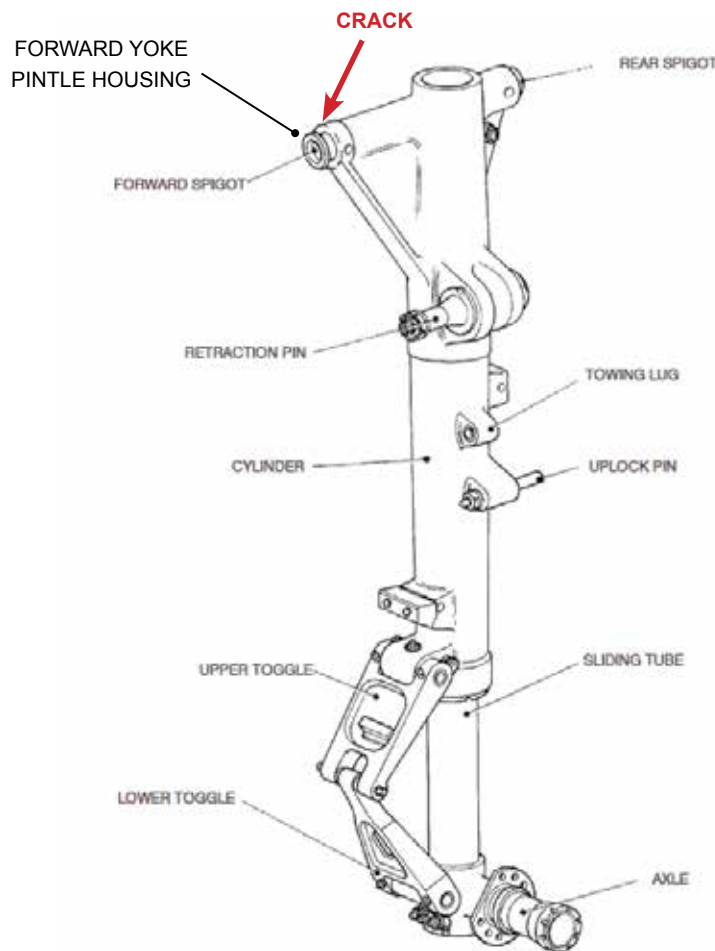
**Figure 3**

The landing gear is attached to the airframe by trunnions that fit into steel spigots that are bolted to the inside of the yoke pintles. The upper surfaces of the pintles are machined flat to introduce a weak link that, in the event of the landing gear being subjected to a force outside of its design limits, will fail without damaging the fuel tanks. During the accident, the forward yoke pintle failed along this machined flat (Figure 3).

Jetstream 31 main landing gear leg
