<b>Aircraft Type and Registration:</b>	SZD 50-3 Puchacz Glider, HCD	
<b>No &amp; Type of Engines:</b>	N/A	
<b>Year of Manufacture:</b>	1992	
<b>Date &amp; Time (UTC):</b>	18 January 2004 at 1320 hrs	
<b>Location:</b>	700 metres NW of Husbands Bosworth Village, Leicestershire	
<b>Type of Flight:</b>	Training	
<b>Persons on Board:</b>	Crew - 2	Passengers - None
<b>Injuries:</b>	Crew - 2 (Fatal)	Passengers - N/A
<b>Nature of Damage:</b>	Glider destroyed	
<b>Commander's Licence:</b>	British Gliding Association Assistant Instructor Rating	
<b>Commander's Age:</b>	65 years	
<b>Commander's Flying Experience:</b>	1,120 gliding hours (of which nine were on type) Last 90 days - 10 hours Last 28 days - 1.5 hours	
<b>Information Source:</b>	AAIB Field Investigation

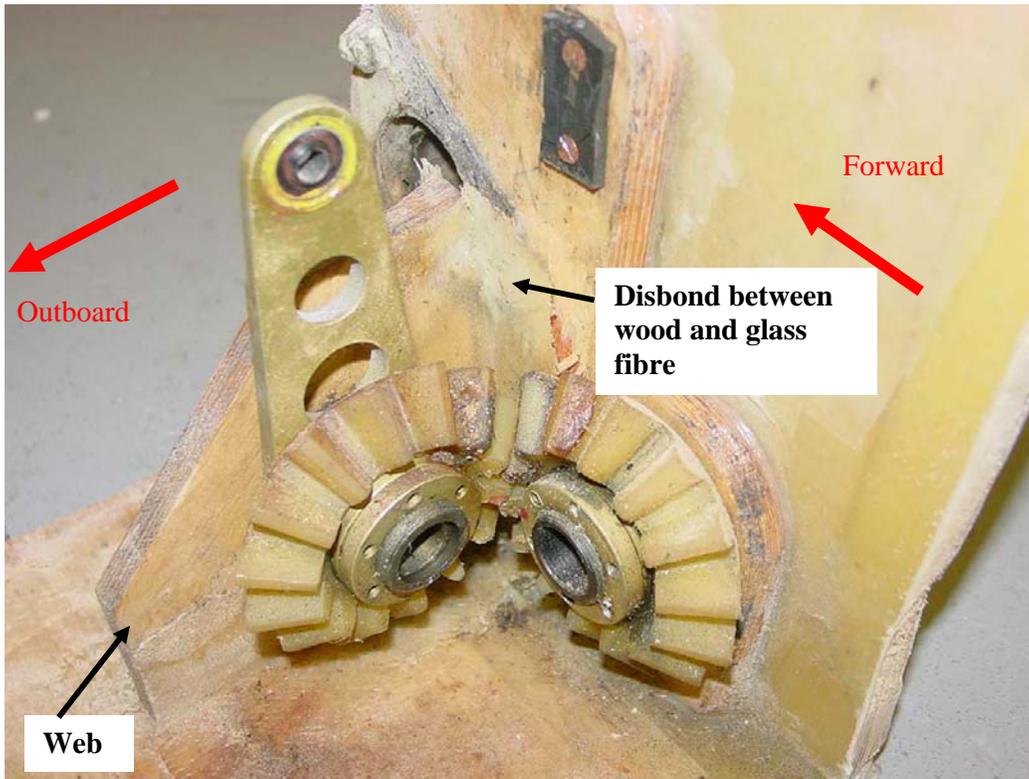
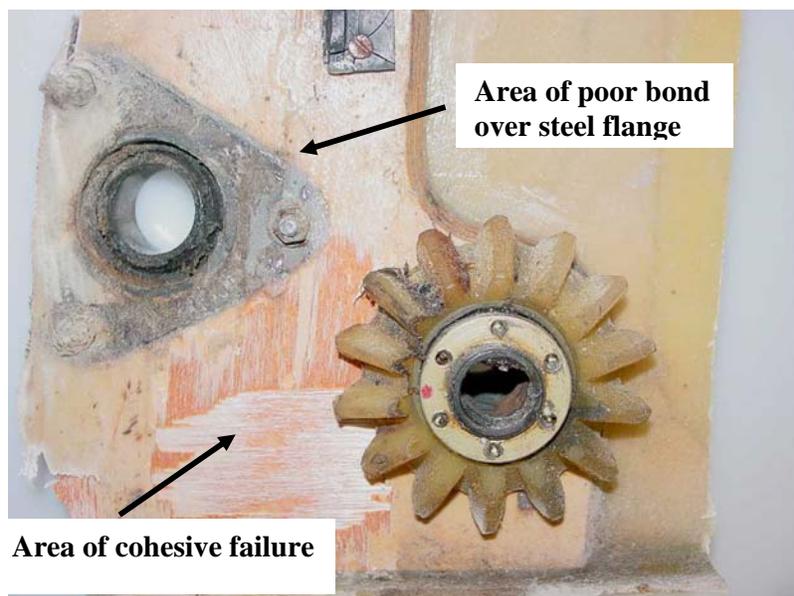
It was found that a plywood web supporting one of the bevel gears in the left airbrake system had become disbonded from the inner surface of the wing root rib, see Figure 1. This had allowed the web/gear wheel assembly to lean away from the mating gear, resulting in the gear wheel teeth no longer being in full engagement. In addition, the reaction forces between the teeth acted to push the web-mounted wheel further away when the airbrake mechanism was operated, with an associated risk of the teeth coming momentarily out of engagement and in consequence, a loss of synchronisation.

The bevel gear assembly and the surrounding structure were examined by the composites department of QinetiQ (formerly the Royal Aerospace Establishment) at Farnborough. The plywood web had been attached to the root rib by means of adhesive applied to glass fibre cloth that overwrapped both the web and rib. Examination of the disbonded area revealed two distinct areas: one was a clean, cohesive fracture within the surface plies of the wood, with the fracture surfaces being clean,

indicating that the fracture was new. The nature of the failure suggested a peeling action, indicating a span-wise load direction. The other area had been poorly bonded and had partially covered a steel flange that formed part of a fitting on the root rib. A gap was evident between the glass fibre cloth and the rib, with a long-term accumulation of dirt, indicating that this had most probably arisen during manufacture.

The failure of the bonded joint occurred in tension, rather than shear, which would have required loading to have been applied in the span-wise direction. At the moment the aircraft nose struck the ground, it is likely that considerable deflection of the wings occurred, in the form of either a downward bending, or a shock wave which travelled along the span. Since the airbrake control rods were mounted above the main spar, these would be loaded in tension when the wing was deflected downwards, which in turn would have acted to unlock the over-centre mechanism and thus allow the associated airbrake to deploy. If the deflection was excessive, it is likely that the tensile snatch load in the control rods could have caused the bonded joint to fail.

The reaction forces between the gear teeth loaded the gear support web in a manner that imposed a shear force in the bond between the web and wing root. Since the bond would have been inherently stronger in shear than in tension, it increases the probability that the failure occurred as a result of wing deflection at impact, as opposed to a progressive failure over a period of time. Nevertheless, it was not possible to be completely certain on this issue. The dissimilar arrangement of the left and right bevel gear support structure meant that the web that was the focus of this examination was used only on the left side. It was considered that as a result, the left side gear support was less robust than the right. However, both sides are difficult to inspect, the only access being via holes in the wing root web. A Safety Recommendation (2004-68) is made later in this report to the BGA concerning inspections of the airbrake bevel gear mechanism in the left wing.

**Figure 1.** Details of the left hand airbrake bevel gear assembly, after being cut out of the aircraft

Below: view of inner rib after removal of web

It is recommended that the British Gliding Association require regular inspections to be conducted on the left wing bevel gear support structure associated with the airbrake actuation system of the SZD Puchacz glider, paying particular attention to the bond between the gear support web and the inner face of the wing root rib.
