Aircraft Type and Registration: Piper PA-28RT-201 Cherokee Arrow IV, G-BMVE

Date & Time (UTC): 31 October 1992 at 1835 hrs

Location: Cardiff Airport, Wales

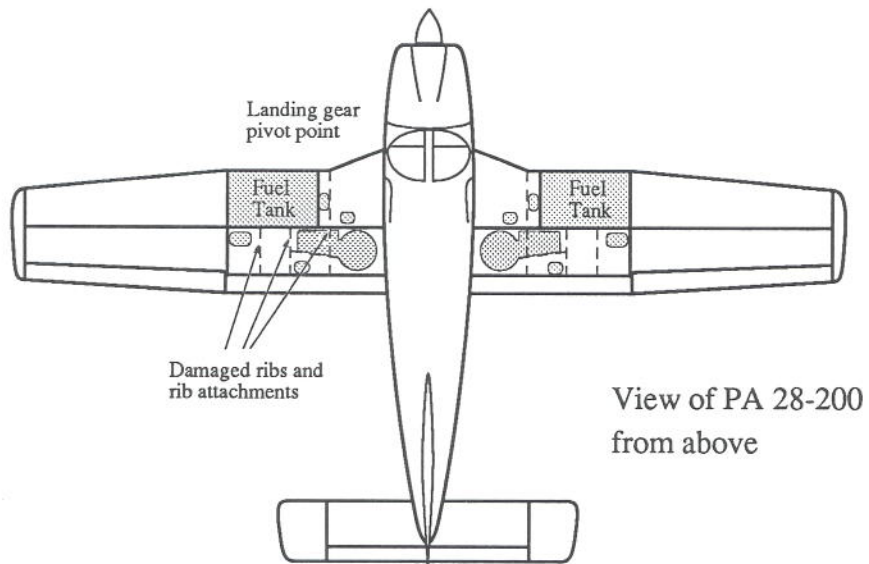
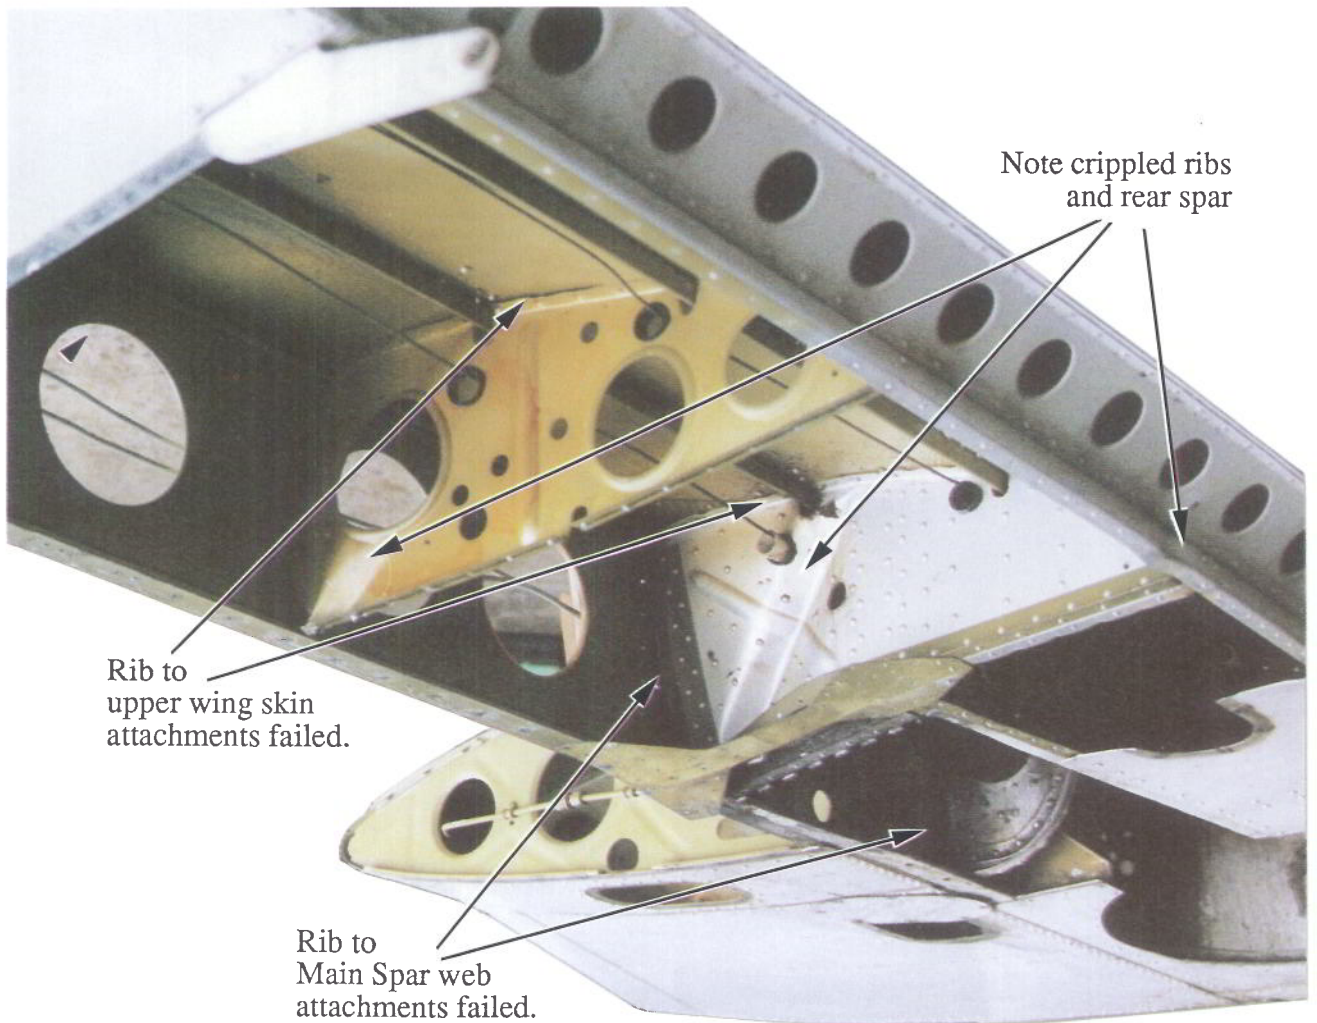
The wing was removed from the aircraft and after further external examination, the wing lower skin was removed from the area behind the fuel tank. Further inspection then revealed evidence of very severe overstressing damage to the box structure aft of the main spar. The damage was mainly outboard of the landing gear attachments, but the rib inboard of the leg attachment had also partially failed along its attachment to the main spar. The damage was consistent with the effects of an instantaneous rearwards force, of some magnitude, on the left mainwheel.

View looking inboard and forwards on underside of left wing with landing gear and lower wing skin removed
