**SERIOUS INCIDENT**

<b>Aircraft Type and Registration:</b>	Bombardier DHC-8-402 Dash 8, G-ECOF	
<b>No &amp; Type of Engines:</b>	2 Pratt & Whitney Canada PW150A turboprop engines	
<b>Year of Manufacture:</b>	2008	
<b>Date &amp; Time (UTC):</b>	21 July 2011 at 1036 hrs	
<b>Location:</b>	Approximately 25 nm south-west of Carlisle at FL240	
<b>Type of Flight:</b>	Commercial Air Transport (Passenger)	
<b>Persons on Board:</b>	Crew - 4	Passengers - 47
<b>Injuries:</b>	Crew - None	Passengers - None
<b>Nature of Damage:</b>	None	
<b>Commander's Licence:</b>	Airline Transport Pilot's Licence	
<b>Commander's Age:</b>	55 years	
<b>Commander's Flying Experience:</b>	8,010 hours (of which 1,960 were on type) Last 90 days - 141 hours Last 28 days - 48 hours	
<b>Information Source:</b>	AAIB Field Investigation

**Synopsis**

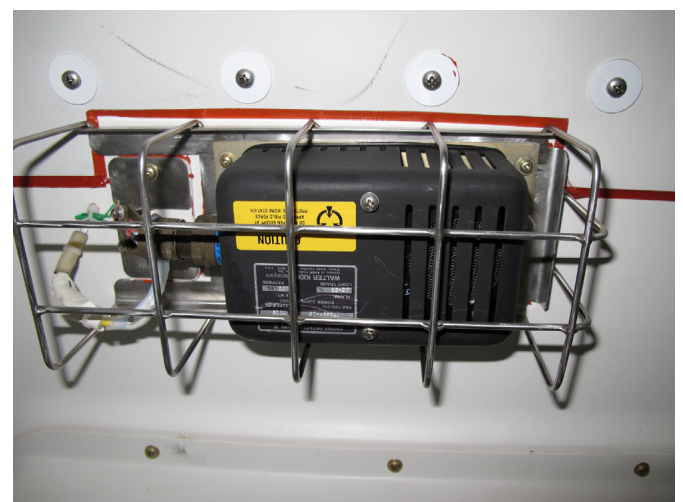
**Figure 4**

The forward baggage compartment smoke detector is mounted above the external door and is protected by a wire cage (Figures 2 and 4). The smoke detector contains a photo-electric sensor which detects a change in light beam intensity when smoke passes through it.

Forward baggage compartment smoke detector

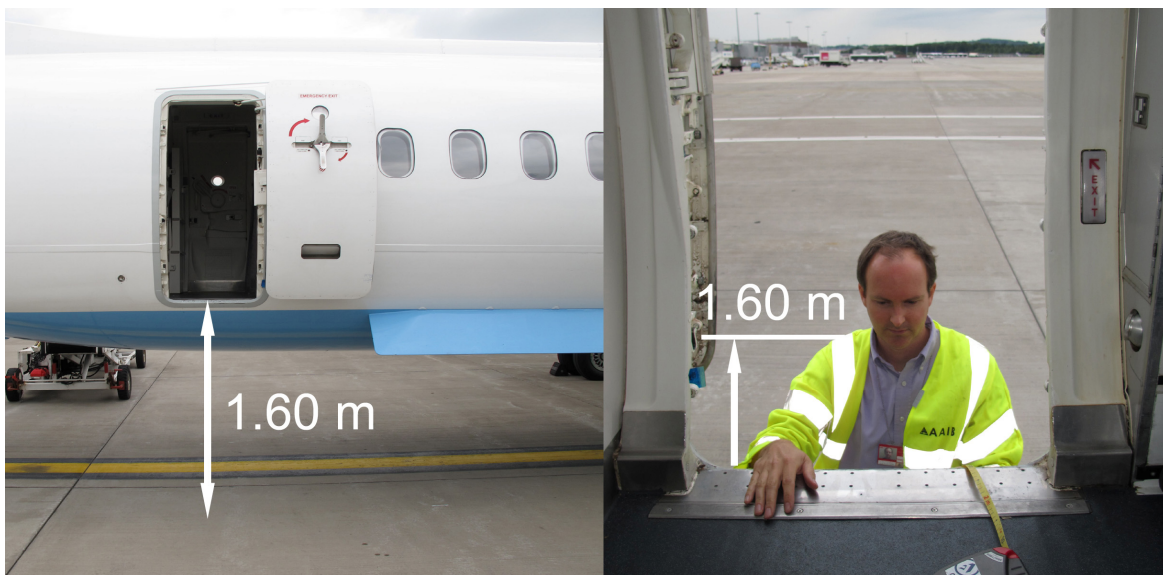
**Figure 5**  
Height of rear exit doors

rapid disembarkation<sup>7</sup>. There are no evacuation slides fitted to any of the doors. The distance to the ground from the base of the rear doors is 1.60 m (Figure 5) and it is 1.28 m from the right front door. The EASA certification requirements relevant to this aircraft type state that an emergency slide is required if the distance from the exit to the ground is greater than 1.80 m (Certification Specification CS 25.810).

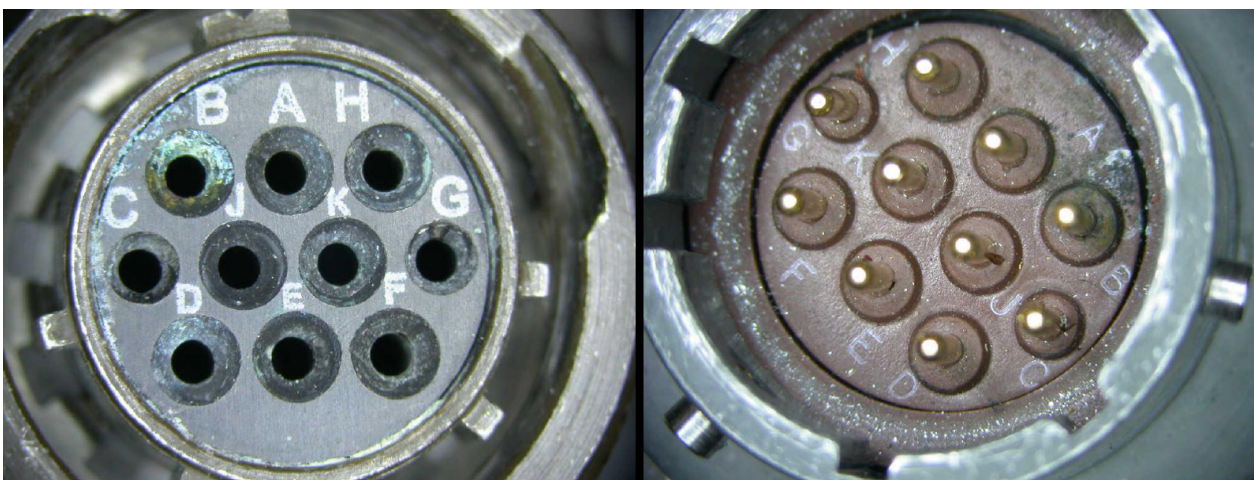
**Figure 6**

The manufacturer stated that if the deposits surrounding pin B were products of corrosion then this would indicate that moisture had been present, and if moisture caused a short circuit between pin B and the connector shell it would trigger a self-test. This would create the same effect as pressing the forward test button on the Fire Protection Panel, and would trigger the smoke warnings and arm the extinguishers.

The smoke detector was taken to an independent company specialising in electrical failure investigation. Using a scanning electron microscope with elemental x-ray analysis they determined that the deposits surrounding pin B on the smoke detector and on the corresponding hole B of the socket were products of corrosion. There was also evidence of corrosion deposits in several of the other socket holes.

Smoke detector socket (left) and plug (right) – corrosion deposits visible at hole B and pin B

Using a sensitive high-resistance meter, the resistance between pin B and the connector shell was measured while blowing humid air at it, allowing it to dry and then repeating. The initial resistance was measured at 400,000 M $\Omega$ , but it reduced to as low as 4 M $\Omega$  after blowing humid air at it. For reference, pin A was measured at 200,000 M $\Omega$  and this value did not change with humidity.

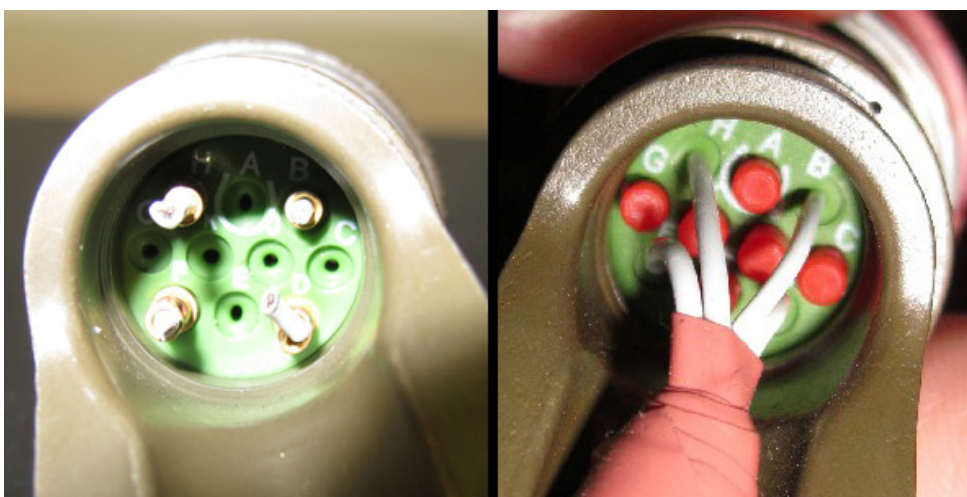
**Figure 7**

The smoke detector connector is a MIL-standard connector, designed to MIL-C-26482 which, if used correctly, has a high degree of environmental resistance. However, this only applies if all holes in the socket are filled with either a wire or a blanking pin. The blanking pins were found to be missing from the socket connected to the forward smoke detector on G-ECOF. Figure 7 shows the back of another socket revealing the four wires and red plastic blanking pins fitted in the unused holes. With open holes airborne moisture would have been able to enter the socket and reach the pins. The forward smoke detector is installed upside down at about a 45° angle which results in pin B being located at the bottom where any moisture is likely to collect.

G-ECOF smoke detector socket (left) with blanking pins missing; another socket (right) showing installation of red blanking pins

The type of connector used on the smoke detector is normally resistant to moisture ingress but the lack of blanking pins in the unused sockets meant that moisture in the air could reach the pins. The fact that the corrosion was primarily present at pin B, the pin at the lowest point, was consistent with the theory that moisture had collected there.

At the end of this investigation the aircraft operator initiated an inspection programme of the forward and aft baggage compartment smoke detector connectors on all their Q400 aircraft to ensure that blanking pins were in place. As part of the inspection the condition of the connector pins would be assessed. The operator expected to have all aircraft inspected by mid-February 2012. A routine task to check for blanking pins would also be added to the aircraft’s base maintenance ‘C’ check.

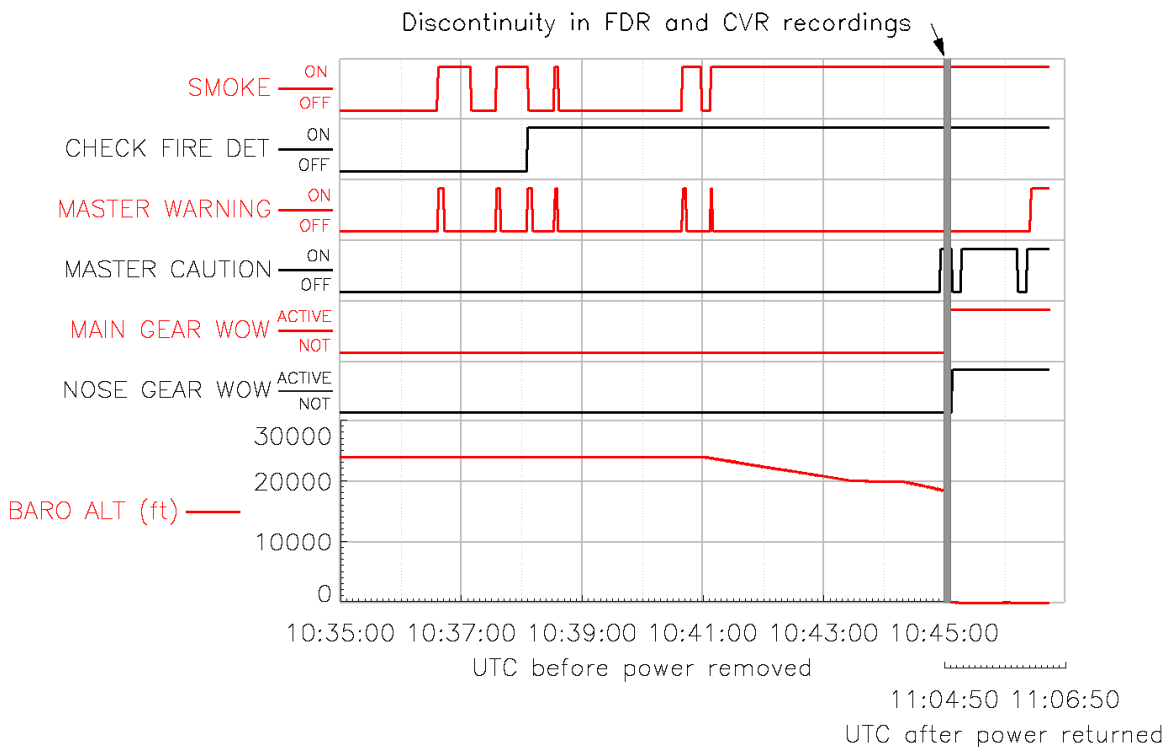
**Figure 8**  
Salient FDR parameters

The salient FDR parameters (Figure 8) show that the SMOKE light on the CWP illuminated at 1036 hrs and went off approximately 33 seconds later. The light came on and went off again a further three times before coming on and staying on at 1041 hrs. The end of the second period of the SMOKE light being on was marked by the CHECK FIRE DET light illuminating and staying on. The MASTER WARNING light illuminated briefly every time either the SMOKE or CHECK FIRE DET light illuminated. The MASTER CAUTION light illuminated just before the generators were shut down.
