INCIDENT

Aircraft Type and Registration:	Miles M-65 Gemini 1A, G-AKKH	
No & Type of Engines:	2 Blackburn Cirrus Minor II piston engines	
Year of Manufacture:	1947	
Date & Time (UTC):	24 August 2002 at 1300 hrs	
Location:	Old Warden Aerodrome, Bedfordshire	
Type of Flight:	Private	
Persons on Board:	Crew - 1	Passengers - 1
Injuries:	Crew - None	Passengers - None
Nature of Damage:	Left Propeller separated from aircraft in flight	
Commander's Licence:	Basic Commercial Pilot's License	
Commander's Age:	59 years	
Commander's Flying Experience:	4,950 hours (of which 30 were on type)	
Information Source:	Field Investigation

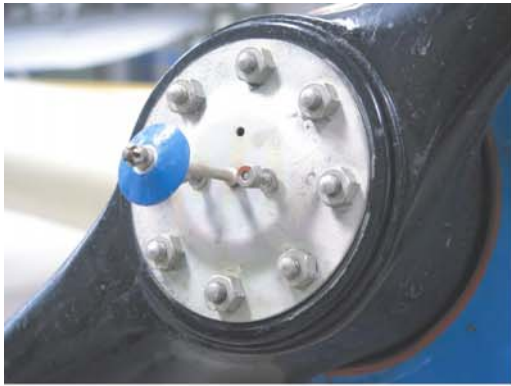
A review of the information available for the fitting of wooden propellers onto Cirrus Minor engines showed that there was some ambiguity over the correct assembly of the propeller onto the hub. The cross-section drawing of the propeller and hub assembly in the Cirrus Minor, Series II manual showed Belleville (dished) washers fitted between the propeller retaining nuts and boss flange plate. However, another illustration, showing the components needed for the assembly, and also the illustrated parts list showed no requirement for Belleville washers to be fitted; the propeller of the right engine was found to have been assembled onto its hub without Belleville washers.

Figure 1a:-
Right propeller installation
(Spinner and lock plate removed)
Note NO Belleville washers

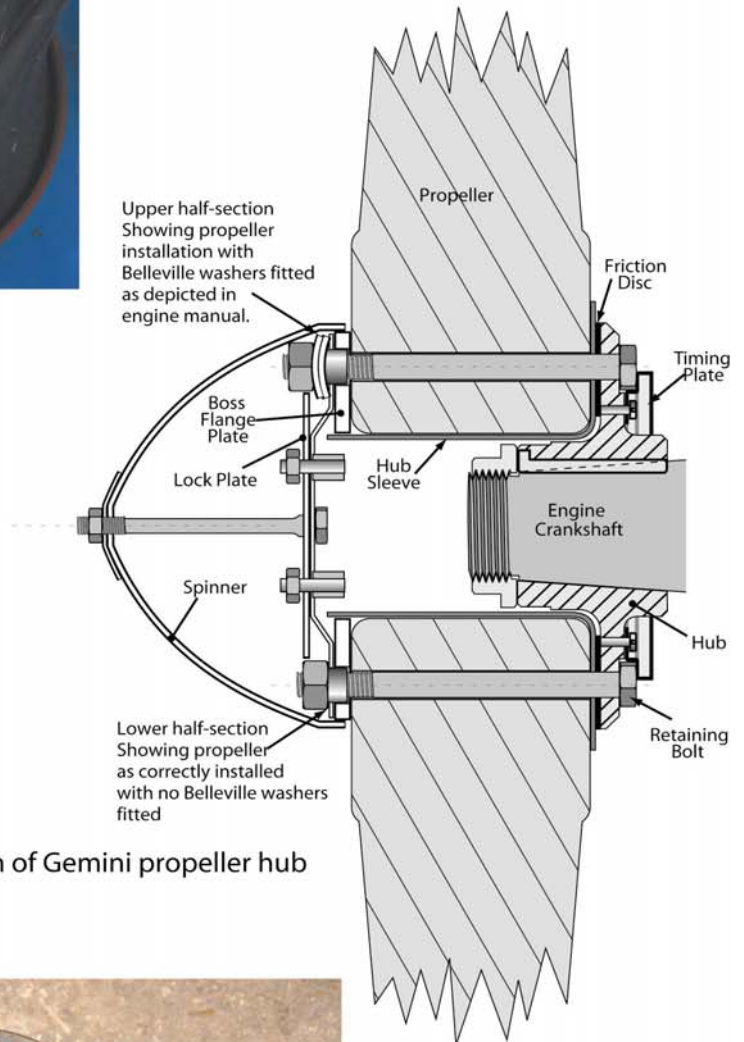
Figure 1:-
Cross section of Gemini propeller hub

The propeller hub is fitted to the engine crankshaft on a keyed taper and secured by a nut and lock-washer. The eight propeller retaining bolts pass forward through the hub flange; these are retained loosely in place by the timing plate, which is a light, formed disc secured onto the rear of the hub. The hub sleeve, which centres the propeller, mounts on the hub with a friction disc interposed between the hub and sleeve flanges to transmit the engine torque to the sleeve. The propeller is clamped between the sleeve flange and the propeller boss flange plate; a thick plate which seats over the sleeve but is not keyed to it. The propeller retaining nuts have plain extensions which locate into the holes in the boss flange plate through which the retaining bolts pass. These nuts also retain the spinner back plate against the forward face of the boss flange plate. The retaining nuts are tightened to the required torque and are then turned on until the first available flat lies tangential to a circle about the hub centre and a nut locking plate is attached to the forward face of the spinner back plate. The torque to which the propeller retaining nuts should be tightened is not specified but has been established by practice at 18 lb.ft.

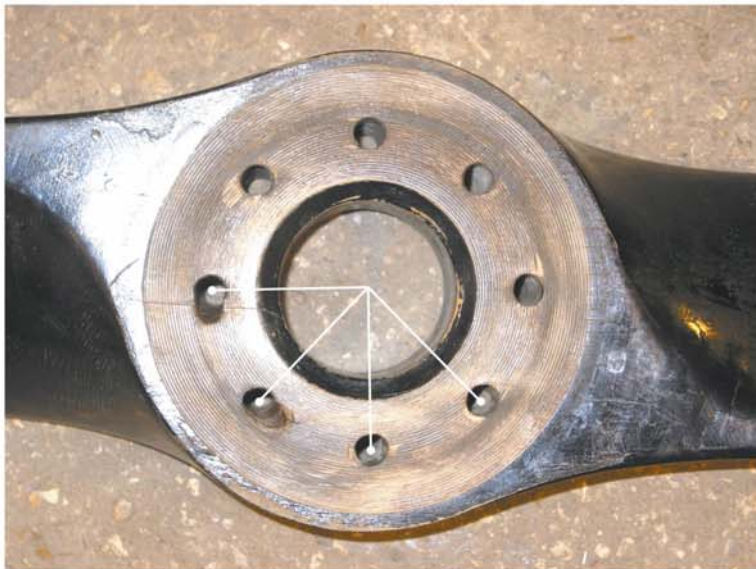
The back face of the wooden propeller boss showed slight signs of heat build up and most of the bolt holes showed evidence of some hammering and polishing of the bores, close to the back face, on both the advancing and retreating sides. Two adjacent holes had been severely stretched in the driven (counter-clockwise looking forward) direction, this stretching reaching forward into both

holes to about half the depth of the boss (Figure 2). All the other bolt holes in the propeller boss showed varying degrees of surface polishing and stretch.

Figure 2:- Aft face of left propeller (note elongated holes)
