ACCIDENT

Aircraft Type and Registration:	Pierre Robin HR100/200B, G-CBFN	
No & Type of Engines:	1 Lycoming IO-360-A1D6 piston engine	
Year of Manufacture:	1971	
Date & Time (UTC):	29 May 2005 at 1651 hrs	
Location:	Blackbushe Airport, Hampshire	
Type of Flight:	Private	
Persons on Board:	Crew - 2	Passengers - None
Injuries:	Crew - 2	Passengers - N/A
Nature of Damage:	Damage to right wing leading edge, nose landing gear and nose structure	
Commander's Licence:	Private Pilot's Licence	
Commander's Age:	45 years	
Commander's Flying Experience:	163 hours (of which 34 were on type) Last 90 days - 4 hours Last 28 days - 4 hours	
Information Source:	Aircraft Accident Report Form submitted by the pilot, further enquiries by the AAIB and metallurgical examination

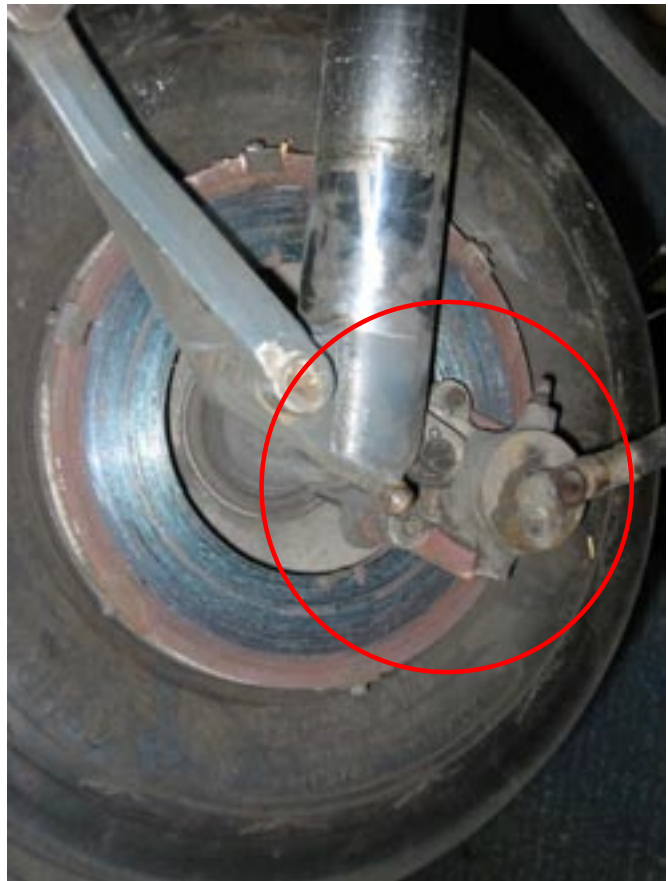
Figure 1

Landing gear showing brake piston, disc and pads

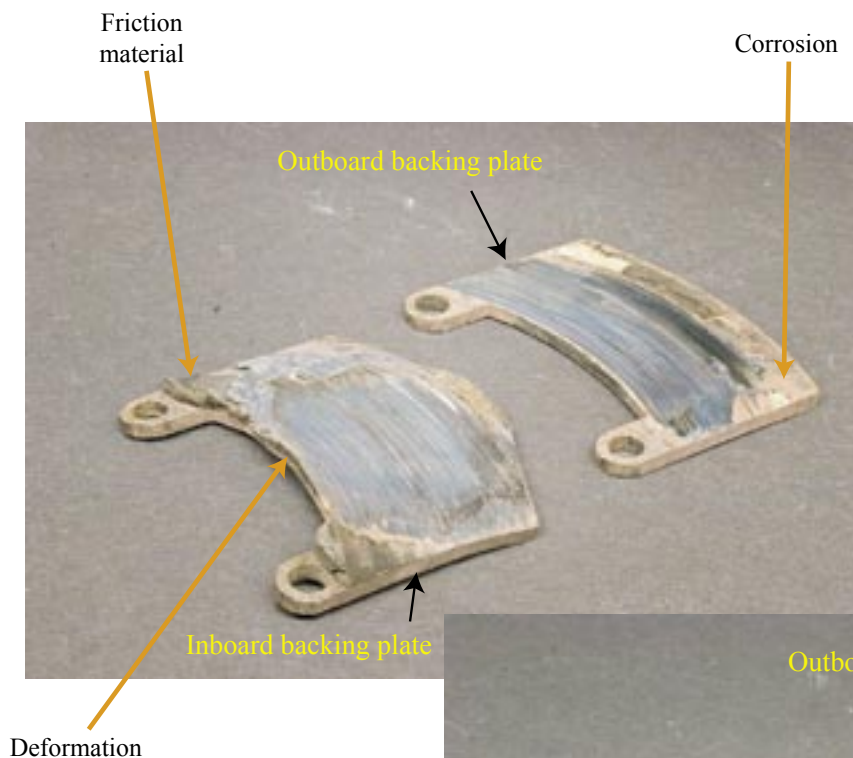
The brakes were examined by the AAIB following the aircraft's recovery to a repair agency and subjected to further metallurgical examination at QinetiQ. Examination showed extensive damage to both sets of brake pads; the inboard (piston side - see Figures 2 & 3) backing plate of each brake exhibited evidence of metal smearing and material build-up towards one edge. There was some evidence of small amounts of friction material remaining on the backing plates along the edges at the inner radius of contact on the brake disc (Figures 2 and 3), and there was also evidence of deformation of the backing plates themselves.

Figure 2
Brake pads (left)

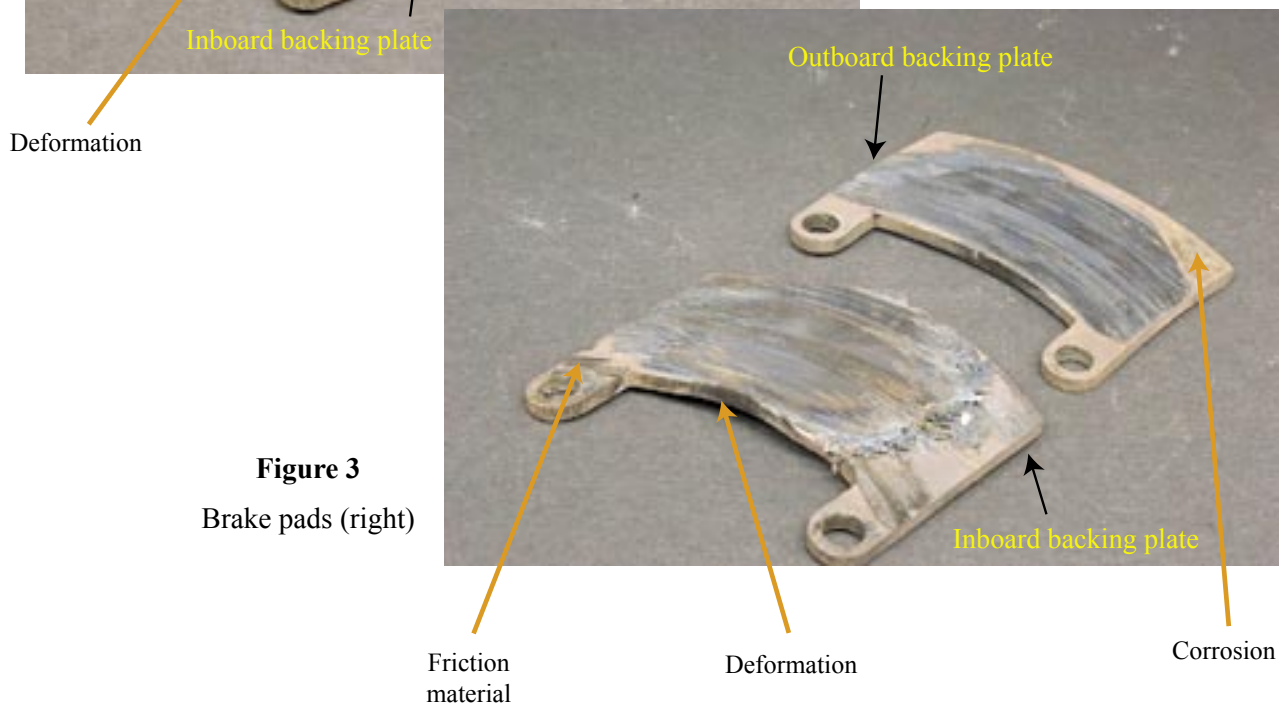
Figure 3
Brake pads (right)

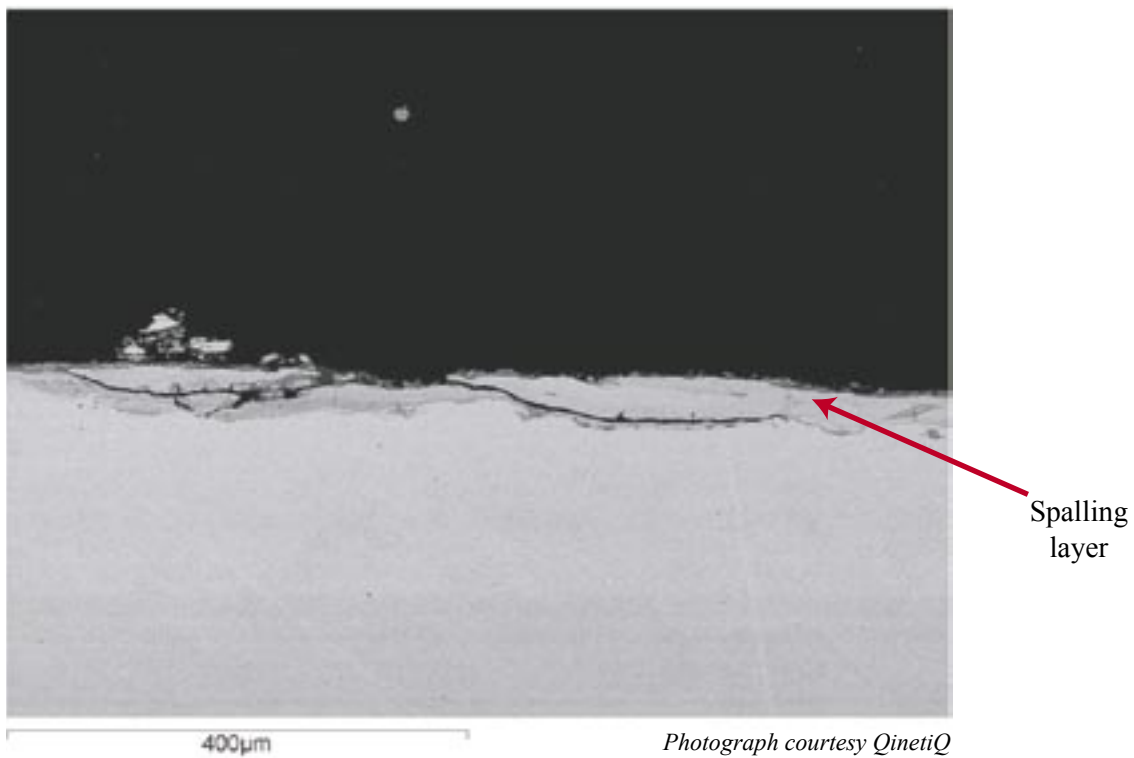
Figure 4

Spalling describes the flaking of a surface where cracks run parallel to the surface, in this case due to the oxide layer (see Figure 4). They found

Cross Section through a smooth area of the right inner backing plate

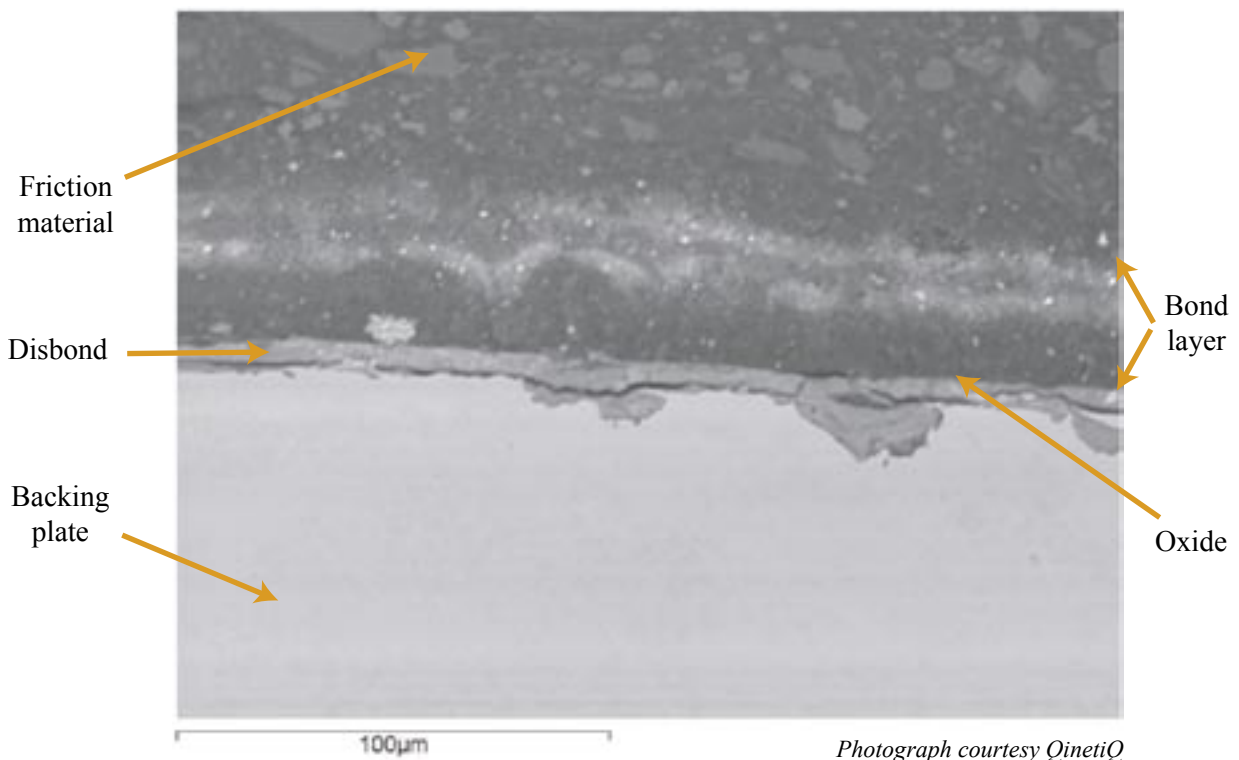
**Figure 5**

'approximately 40 µm thick with the friction material appearing to be well bonded to it. A layer of surface oxide was present between the backing plate and bond layer approximately 7 µm thick, which appeared to have separated from the backing plate. This indicates that the friction material was not bonded to the backing plate in this area.' (see Figure 5)

Cross Section through the bond line of the right inner backing plate
