No: 8/92

Aircraft Type and Registration: Boeing 747SP-31, N601AA

Location: Stand L29, Terminal 3, London Heathrow Airport

Nature of Damage: Puncture of inboard upper surface of left wing

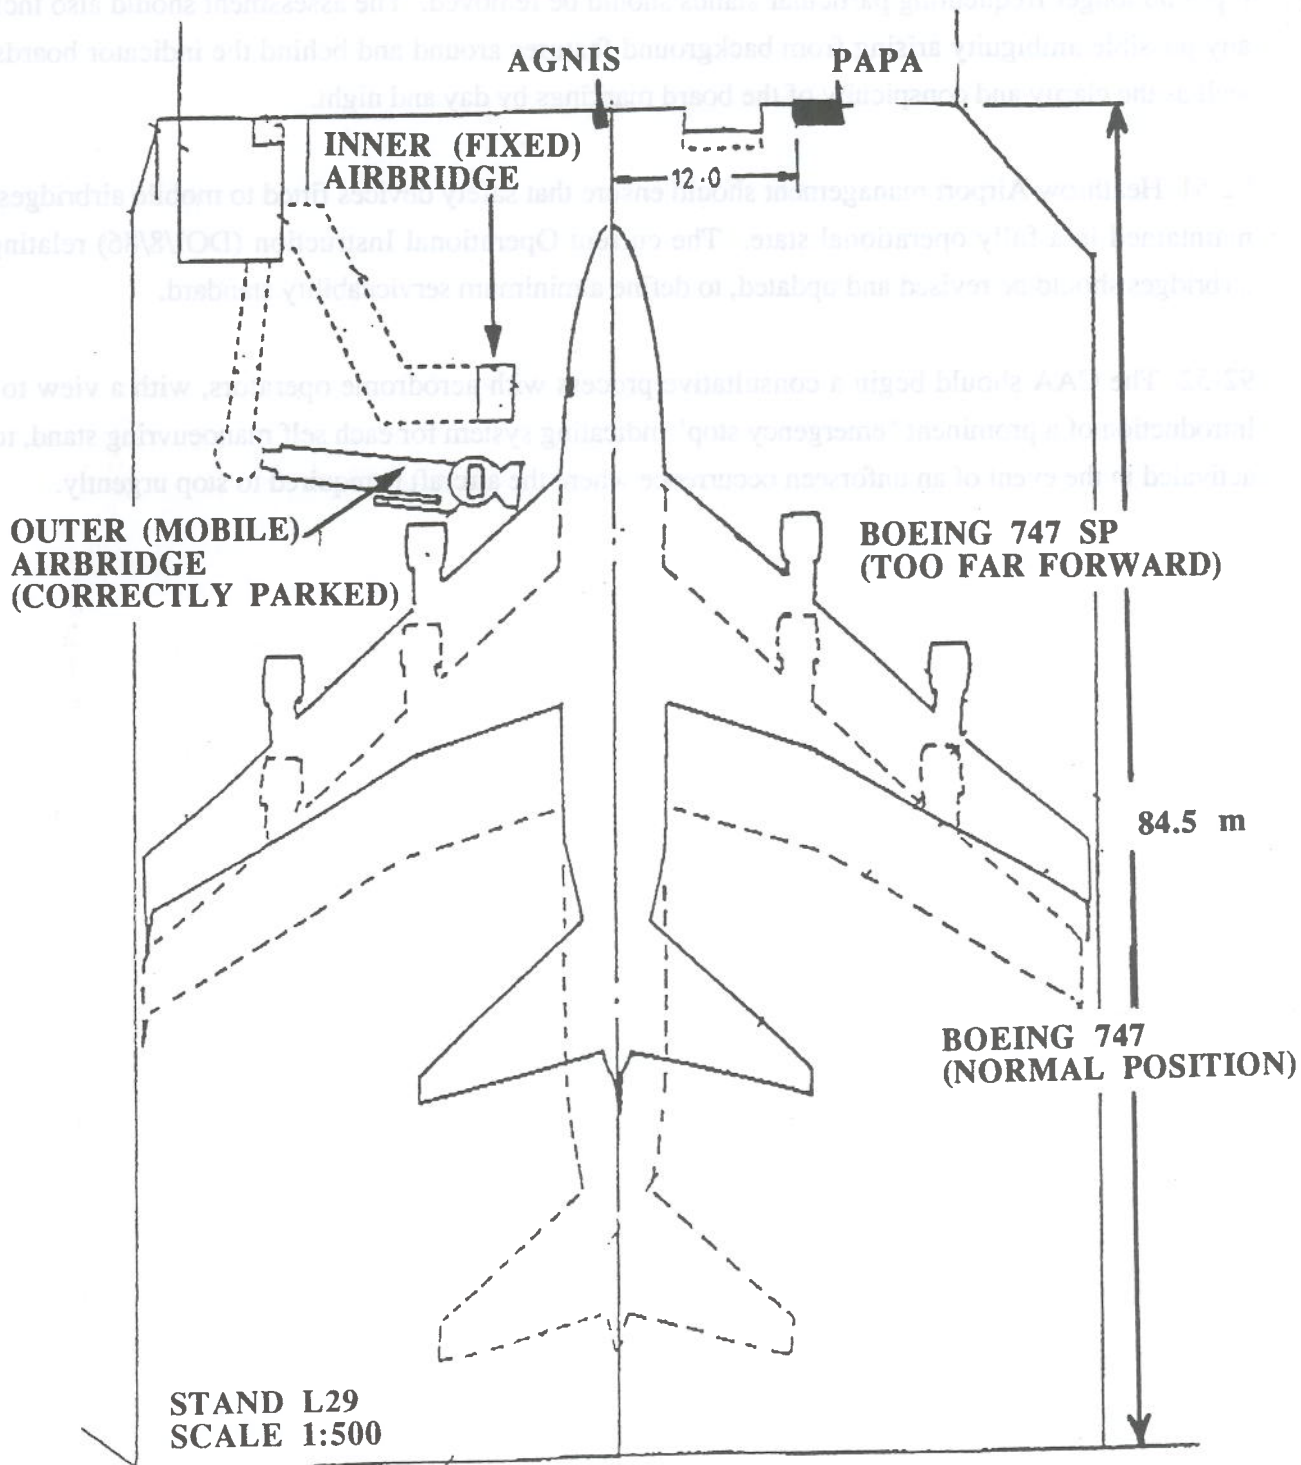
FIGURE 1. GENERAL LAYOUT AND BOEING 747 PARKING POSITION

The required parking position for the bogie of the mobile airbridge was marked on the ground in yellow paint as a box slightly larger than the bogie itself. At the time of the collision, the bogie had not been entirely within the box; its position put the bridge 0.5 metre nearer the aircraft centreline and one metre further out towards the approaching aircraft than normal. A further erosion of the optimal clearances resulted from the aircraft not being absolutely aligned with the marked centreline; although the nosegear was on the centreline, at the point of contact the fuselage was offset towards the bridge by about 0.3 metre.

A drawing of the stand, showing general layout and the relative parking positions for the two Boeing 747 variants is shown in Figure 1.

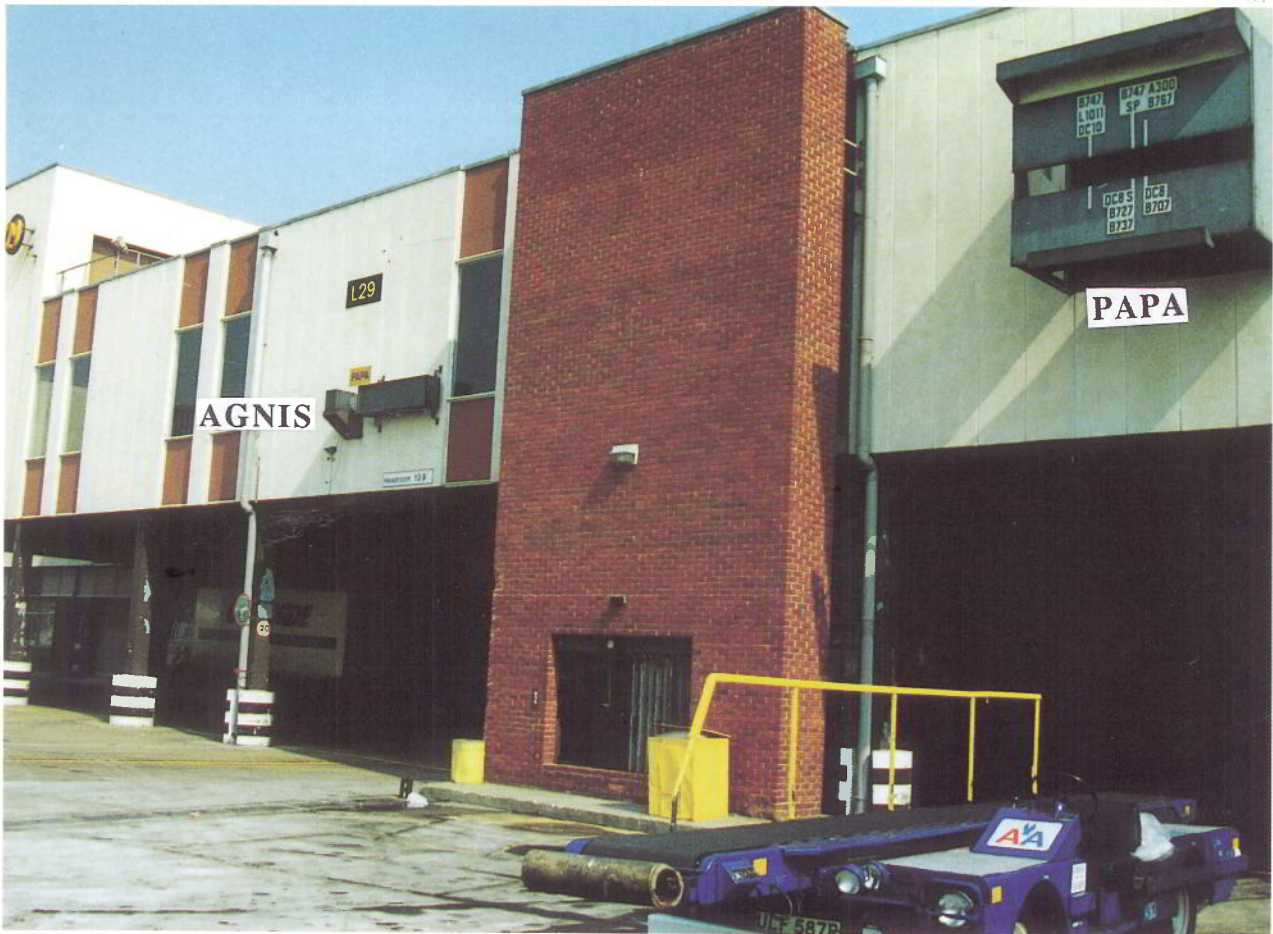
FIGURE 2 GENERAL ARRANGEMENT OF AGNIS AND PAPA UNITS

The parking system in use on this particular stand was self manoeuvring (without the aid of a marshaller), facilitated by use of an AGNIS (Azimuth Guidance - Nose In Stands) for stand centreline guidance, coupled with a PAPA (Parallax Aircraft Parking Aid) for correct stopping location guidance. This system is used on the majority of stands at Heathrow. A photograph of the units is given in Figure 2.

The PAPA indicator is (generally) located out to the right of the parking position. An advisory board is located by the AGNIS position, to inform the pilot that the PAPA system is in use. Once again, the PAPA board is set up so that the pilot in the left seat can manoeuvre the aircraft to the correct stopping position. This position is attained by moving the aircraft slowly forward until a vertical fluorescent tube light (mounted behind the board and viewed through a horizontal slot in the face of the board) is aligned with the vertical white line painted on the face of the board. Because many different types of aircraft occupy each of the stands in turn, there are generally several vertical white lines on the face of each board, corresponding to different types of aircraft, some being marked singly and some as groups.

In this particular case, neither pilot had used the system on previous visits to Heathrow, having had manual marshalling guidance onto stand. On this occasion, the left seat pilot noted that the leftmost line on the PAPA board was marked for use by the B747, and proceeded to park the aircraft in the correct alignment with this position, moving to the most forward parking position available on this particular stand. However, the second of the 3 vertical strips marked on the PAPA board was annotated for use by 6 types of aircraft - one of them being the B747 SP. This parking position would have resulted in the aircraft remaining somewhat further out in the parking area. The marking of the board however indicated the letters SP below the B747 rather than the more usual left to right type designations used for all other types.

92-50 Heathrow Airport management should carry out a survey of stand entry guidance system marking, with a view to reducing the number of stopping positions displayed, and removing any possible ambiguity which may exist. This should include standardising the labelling for the B747 SP

to allow it to be read from left to right when viewed from the flight deck. Labels depicting aircraft types no longer frequenting particular stands should be removed. The assessment should also include any possible ambiguity arising from background features around and behind the indicator boards, as well as the clarity and conspicuity of the board markings by day and night.

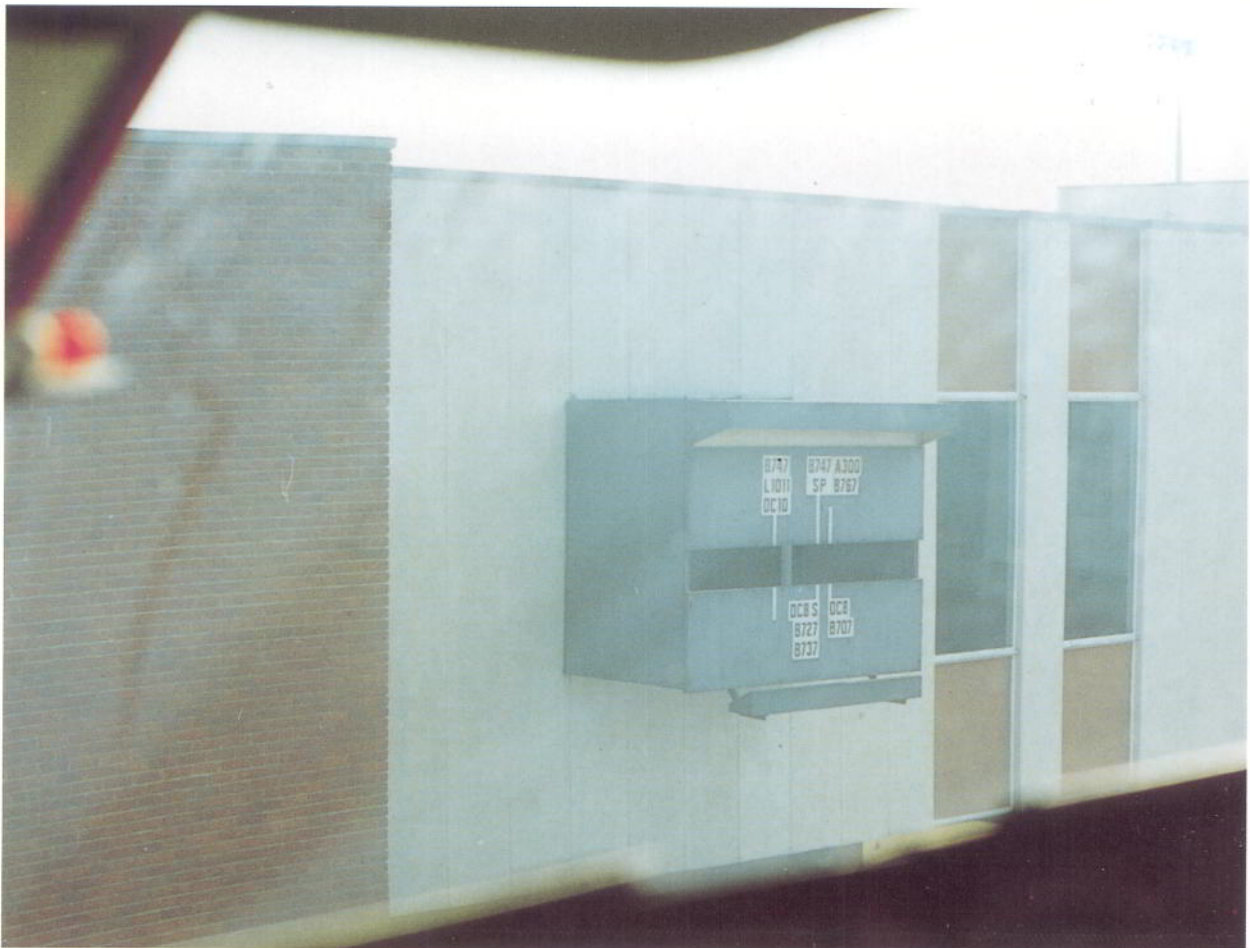
**FIGURE 3 VIEW FROM THE LEFT FLIGHT DECK SEAT TOWARDS PAPA UNIT
(WITH AIRCRAFT PUSHED BACK SLIGHTLY FROM ORIGINAL POSITION)**

On inspection of the aircraft flight deck, it was noted that the front windshields were contaminated and smeared, reducing clarity of vision (Figure 3). It was also calculated that, at the time of the occurrence, the position of the sun would have been such as to appear just above the PAPA board position when viewed from the flight deck. Cockpit window cleaning is generally carried out by ground personnel at crew request, and the last recorded window cleaning was noted in the Technical Log on 26 March, two weeks prior to the accident, although contamination may of course occur at any time in flight.
