AIRCRAFT ACCIDENT REPORT 5/2008

Air Accidents Investigation Branch

**Report on the accident to
Boeing 737-300, registration OO-TND
at Nottingham East Midlands Airport
on 15 June 2006**

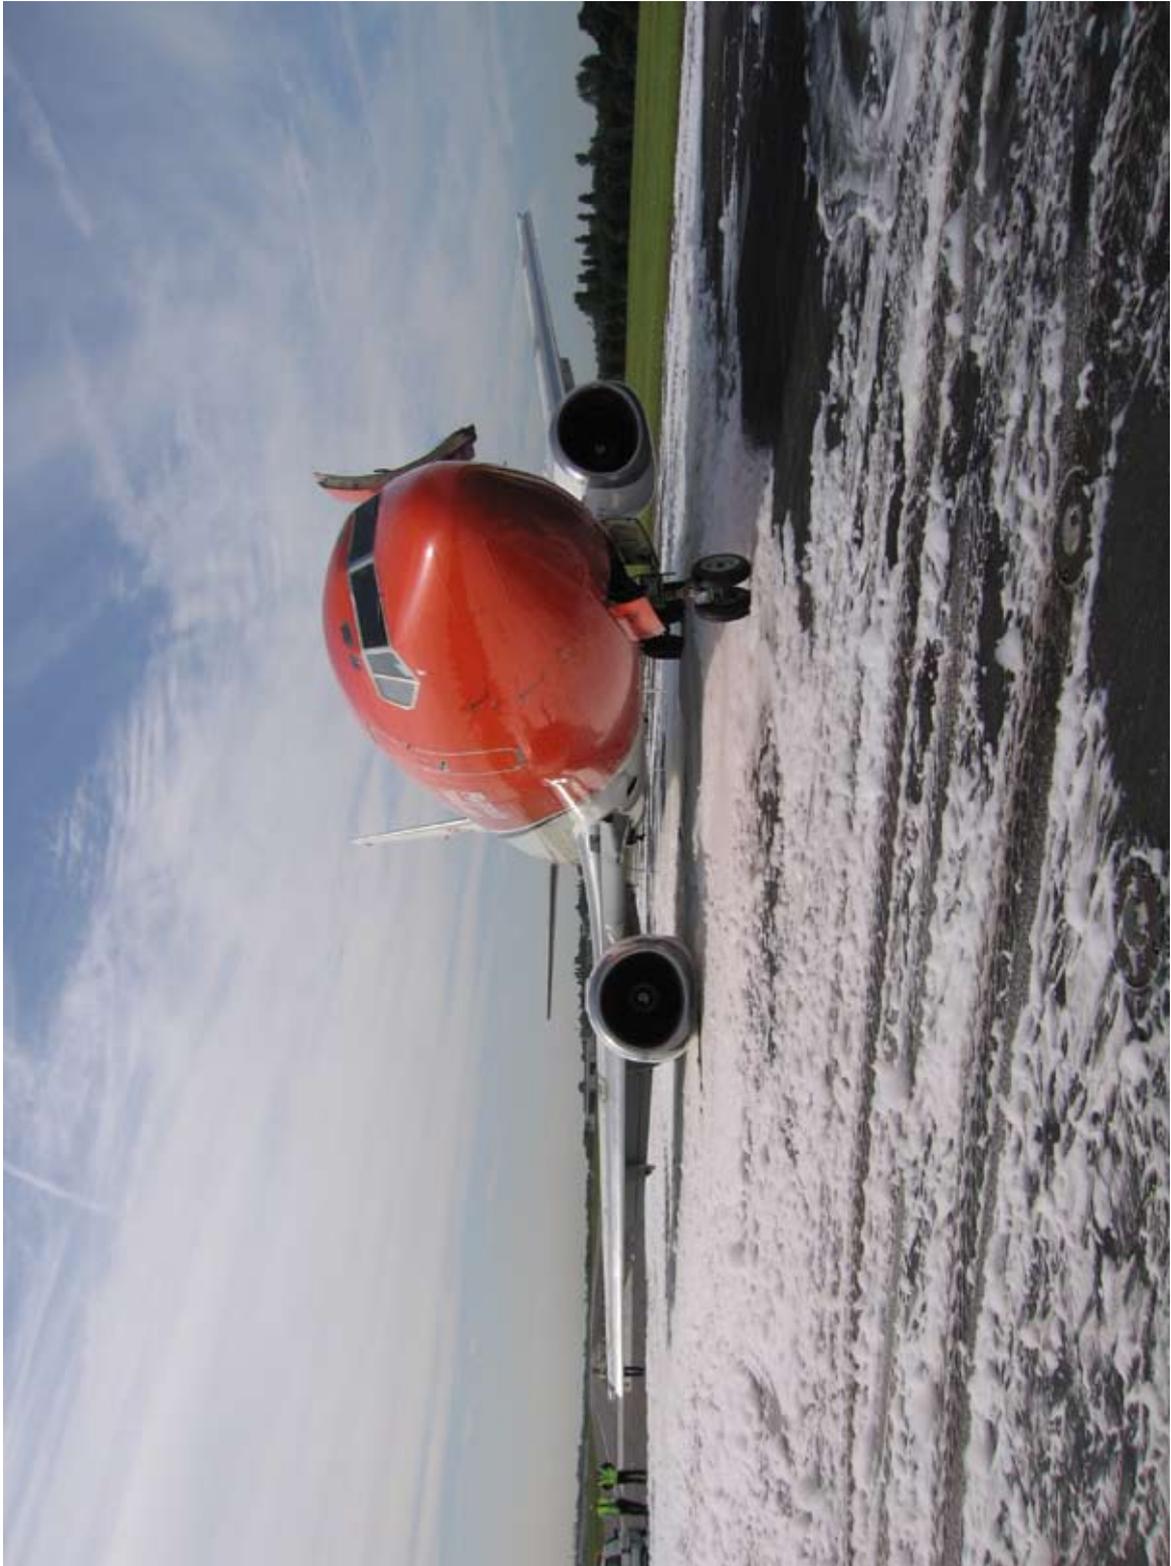
OO-TND after landing at Birmingham International Airport

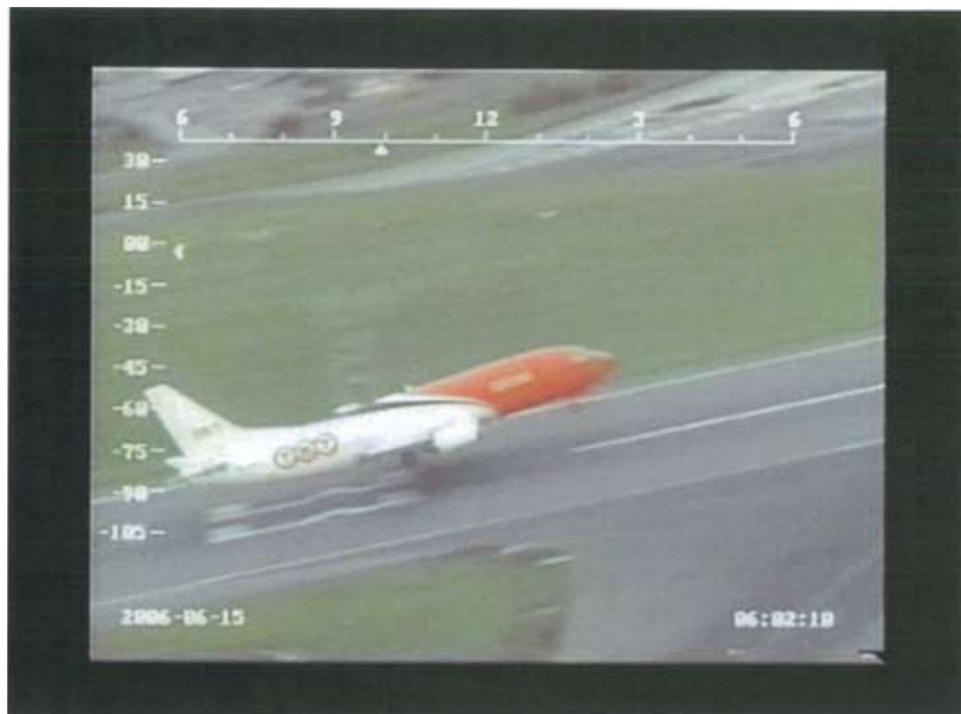
Figure 1

The aircraft touched down just to the left of the runway centreline and came safely to a stop on the centreline at 0602 hrs, Figure 1.

OO-TND about to touch down on Runway 33 at Birmingham

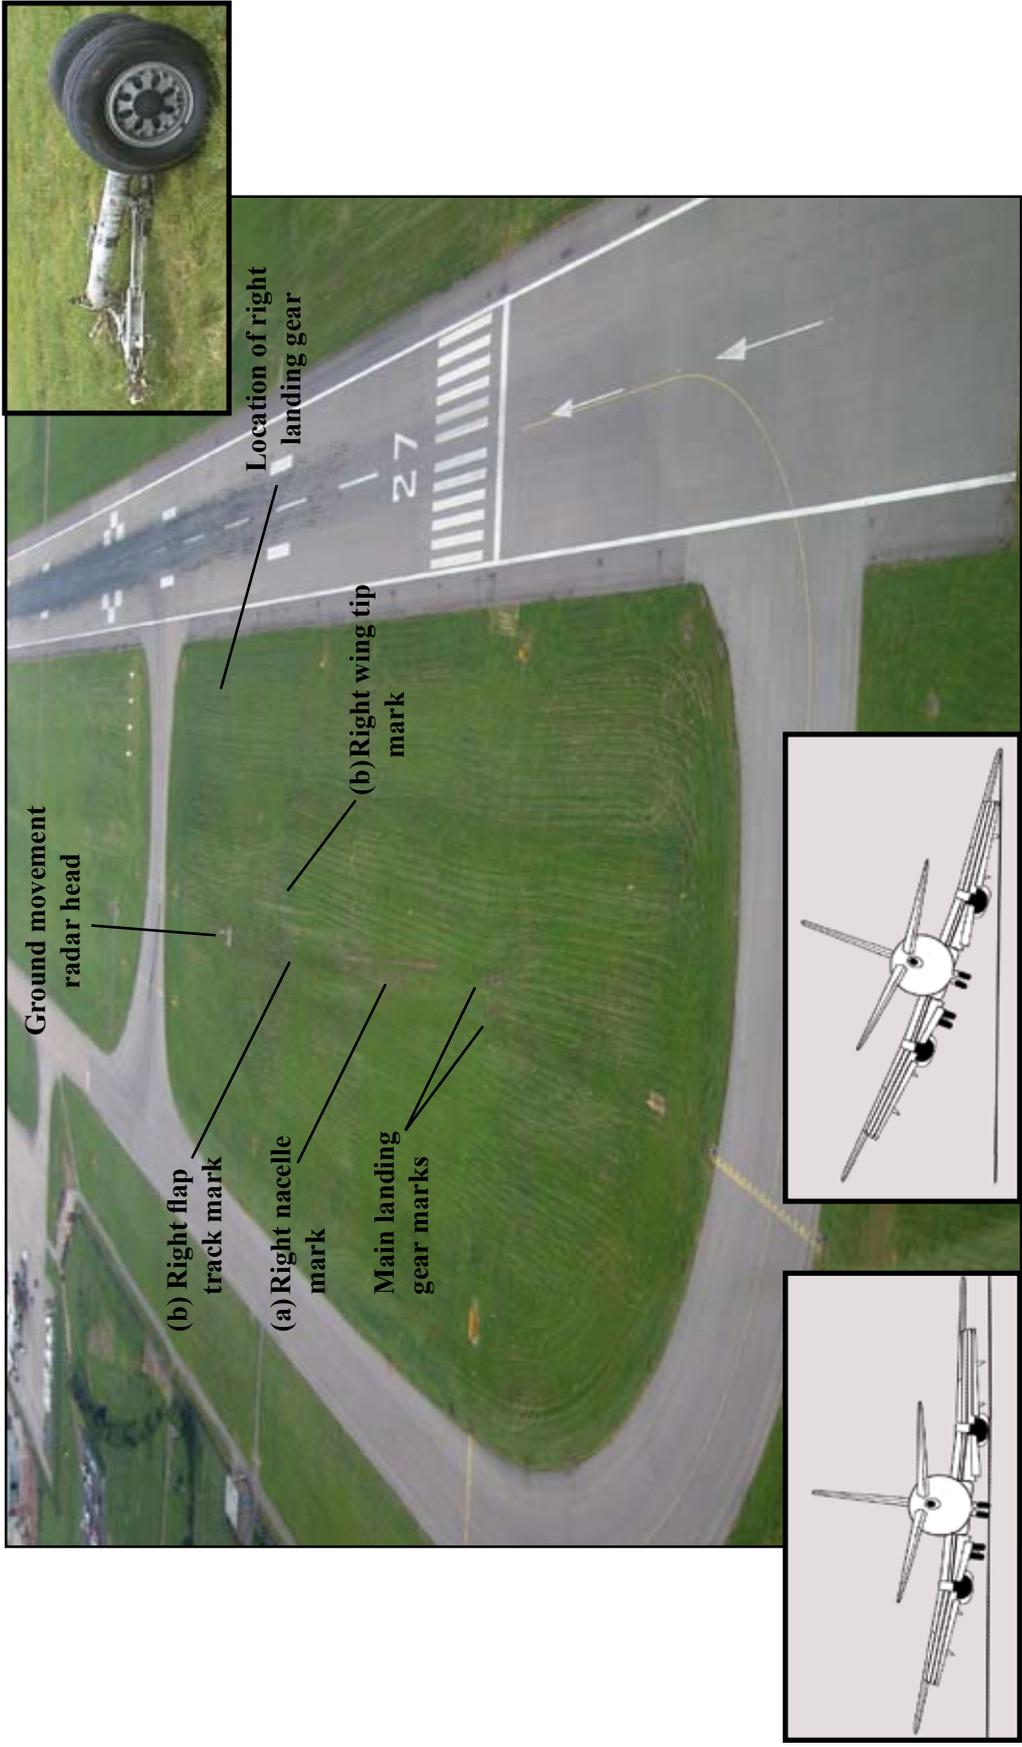
Figure 7

The main landing gear wheel furrows continued for 5.5 m, at which point the left main landing gear wheels appeared to have lifted up and run along the surface for a further 14 m. The right main landing gear tracks stopped at the end of the wheel furrows, indicating the most likely point at which the leg separated from the aircraft. Debris was found in the area immediately beyond these furrows. This consisted of pieces of landing gear door, cables, hydraulic lines from the landing gear leg, and the right main landing gear up-lock actuator, Figure 8.

Two impact craters were evident which were consistent with having been made by the detached landing gear leg. The first crater was 57 m beyond the end of the furrows made by the right main landing gear wheels, the second 100 m beyond. The right main landing gear unit and the landing gear retraction actuator were found 190 m beyond the point of separation, and 36 m from the left shoulder of Runway 27.

Ground marks made by OO-TND at East Midlands Airport

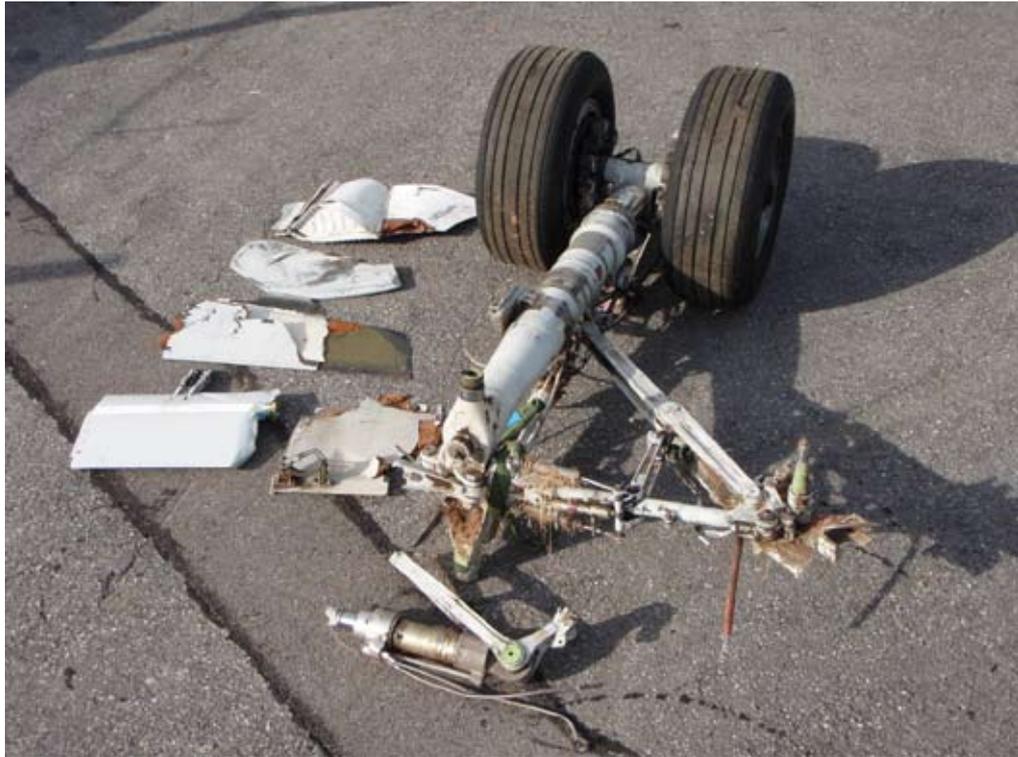
Figure 8

OO-TND debris recovered at East Midlands Airport

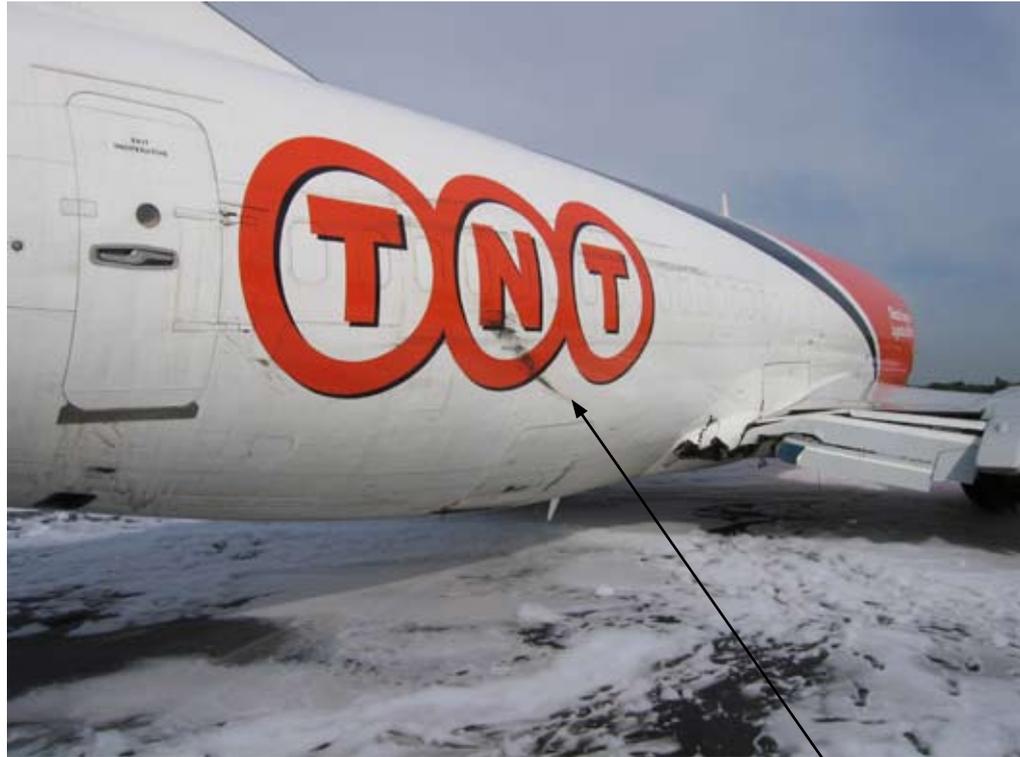
Figure 9

Structural damage had occurred to the right inboard trailing edge flap, and further damage and tyre marks were present on the side of the fuselage, aft of the right wing. This was consistent with the right landing gear leg having struck the fuselage after becoming detached. At their highest point, these marks were close to the line of blanked out windows, Figure 9, and it was apparent that the departed leg had come close to striking the horizontal stabiliser.

Details of flap damage and tyre marks on rear fuselage
