INCIDENT

Aircraft Type and Registration:	Slingsby T67M260 Firefly, G-BYOB	
No & Type of Engines:	1 Lycoming AEIO-540-D4A5 piston engine	
Year of Manufacture:	1999	
Date & Time (UTC):	3 August 2007 at 1030 hrs	
Location:	Stapleford Tawney Airport, Essex	
Type of Flight:	Training	
Persons on Board:	Crew - 2	Passengers - None
Injuries:	Crew - None	Passengers - N/A
Nature of Damage:	Left brake pedals disconnected	
Commander's Licence:	Commercial Pilot's Licence	
Commander's Age:	58 years	
Commander's Flying Experience:	6,900 hours (of which 156 were on type) Last 90 days - 70 hours Last 28 days - 39 hours	
Information Source:	AAIB Field Investigation

Synopsis

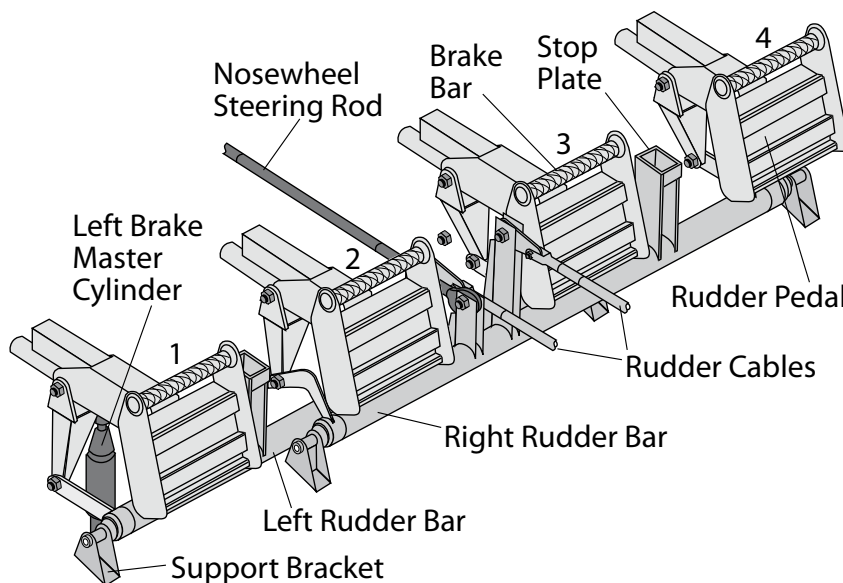
Figure 2

Primary flight controls are conventional, operated by dual cockpit controls. Rudder/brake pedal assemblies are numbered from 1 to 4 across the aircraft from left to right (Figure 2). The pedals are mounted on crank arms welded to two rotatable cross-shafts in the cockpit, known as rudder bars, with the left pedal of each pair (Nos 1 and 3) fixed to the left bar and the right pedals (Nos 2 and 4) fixed to the right bar. A crank arm on each bar is connected by a cable-fairlead system to operating levers attached to the rudder. The two bars are thus interconnected by the loop formed by the cables and the pivoting rudder. Two springs maintain the rudder bars centralised when the pedals are unloaded. An adjustable primary stop provided for each rudder bar limits the forward rotation of the bar (ie forward displacement of the respective pedals); these stops form the primary travel limiters for the system.

Rotation of the rudder bars also steers the nosewheel leg, via a control rod driven by a crank arm fixed to the right bar (Figure 2).

If the maximum allowable nosewheel angle to the right is exceeded while the aircraft is being towed, the steering control rod rotates the right rudder bar forward onto its stop. At the same time the left rudder bar, connected to the right bar by the loop formed by the cable and rudder, is rotated backwards. A further exceedence of the permitted steering angle would apply excessive loads to

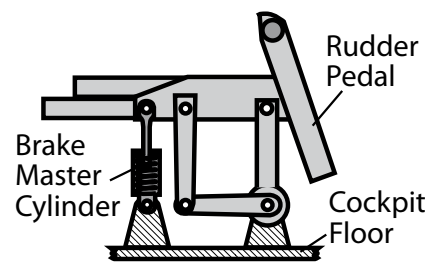
Figure 3

For each pedal, a pin-jointed parallelogram-type linkage pivoted to the respective rudder bar (Figure 3) maintains

the vertical orientation of the pedal constant as it is displaced fore and aft to operate the rudder (Figure 4). The linkage allows each pair of pedals to be pivoted, by pushing a brake bar at the top of one of the pedals, to drive the master cylinder piston (Figure 5) and hence apply hydraulic pressure to the brake on the respective main wheel.

the right rudder bar stop and could cause it to deform as a result. The rearward over-travel of the left rudder bar would result in the No 1 pedal mechanism applying an upward load to the left brake master cylinder, which would be bottomed, and additional excessive loading on the pedal mechanism can result. The aircraft manufacturer believed that this could damage the left rudder bar support brackets, the floor at the bracket attachment points, and/or the left brake master cylinder.

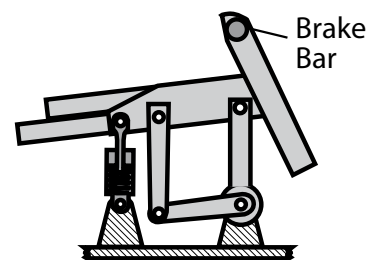
Figure 5

Examination by the operator's maintenance organisation revealed that the left wheelbrake cylinder had detached from the No 1 pedal mechanism. It was also found that the composite floor panel had suffered delamination damage in the area where the left mounting bracket for the left rudder bar attached and that the bracket had tilted to the left as a result. The aircraft manufacturer considered that both damage features had been caused by overload as a result of exceeding the maximum nosewheel steering angle while towing.
