## ACCIDENT

<b>Aircraft Type and Registration:</b>	Flight Design CTSW, G-CFAZ	
<b>No &amp; Type of Engines:</b>	1 Rotax 912 ULS piston engine	
<b>Year of Manufacture:</b>	2007	
<b>Date &amp; Time (UTC):</b>	8 October 2008 at 0855 hrs	
<b>Location:</b>	Saddleworth Moor, Lancashire	
<b>Type of Flight:</b>	Private	
<b>Persons on Board:</b>	Crew - 1	Passengers - None
<b>Injuries:</b>	Crew - 1 (Fatal)	Passengers - None
<b>Nature of Damage:</b>	Aircraft destroyed	
<b>Commander's Licence:</b>	Private Pilot's Licence	
<b>Commander's Age:</b>	41 years	
<b>Commander's Flying Experience:</b>	123 hours (of which 29 were on type) Last 90 days - 11 hours Last 28 days - 0 hours	
<b>Information Source:</b>	AAIB Field Investigation

### Synopsis

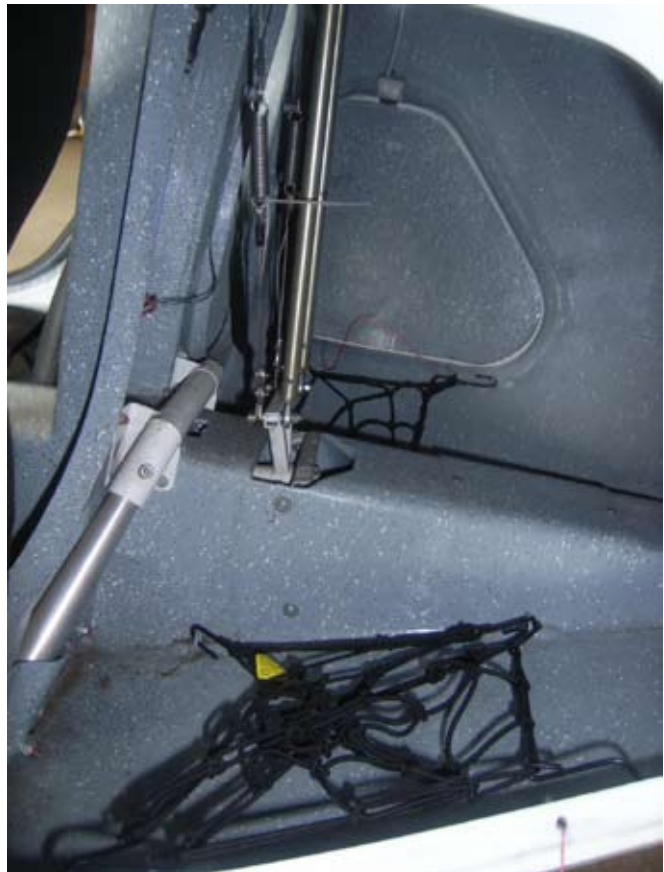
**Figure 1**  
G-CFAZ baggage restraint

The fuselage is of carbon fibre/foam sandwich monocoque construction, without bulkheads or substantial fuselage frames. The manufacturer's Operator's Manual states that the aircraft has a maximum baggage weight of 25 kg, to be stowed in the rear fuselage immediately behind the rear cockpit bulkhead. Access is provided by a removable panel on either side of the fuselage immediately behind each cockpit door; the seatbacks can also be pulled forward to stow larger items. Any baggage is secured under two bungee nets (Figure 1).

The 'open monocoque' structural design of the rear fuselage in this aircraft would allow an unsecured item a significant range of movement, possibly to restrict aileron or elevator movement. While bungee nets may provide sufficient restraint of larger item they will not provide the same level of retention to thin objects. The following Safety Recommendation is made:

It is recommended that P&M Aviation/Flight Design review the design of the current baggage restraints in the CTSW design, to ensure that it provides effective restraint of all stowed baggage.
