ACCIDENT

Aircraft Type and Registration:	Flight Design CTSW, G-CFAZ	
No & Type of Engines:	1 Rotax 912 ULS piston engine	
Year of Manufacture:	2007	
Date & Time (UTC):	8 October 2008 at 0855 hrs	
Location:	Saddleworth Moor, Lancashire	
Type of Flight:	Private	
Persons on Board:	Crew - 1	Passengers - None
Injuries:	Crew - 1 (Fatal)	Passengers - None
Nature of Damage:	Aircraft destroyed	
Commander's Licence:	Private Pilot's Licence	
Commander's Age:	41 years	
Commander's Flying Experience:	123 hours (of which 29 were on type) Last 90 days - 11 hours Last 28 days - 0 hours	
Information Source:	AAIB Field Investigation

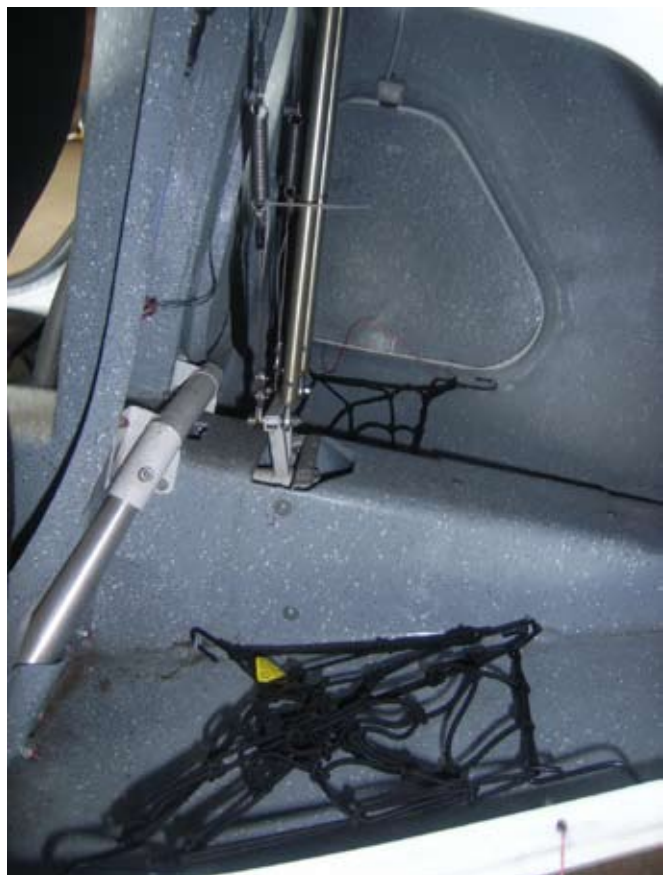
Figure 1

The fuselage is of carbon fibre/foam sandwich monocoque construction, without bulkheads or substantial fuselage frames. The manufacturer's Operator's Manual states that the aircraft has a maximum baggage weight of 25 kg, to be stowed in the rear fuselage immediately behind the rear cockpit bulkhead. Access is provided by a removable panel on either side of the fuselage immediately behind each cockpit door; the seatbacks can also be pulled forward to stow larger items. Any baggage is secured under two bungee nets (Figure 1).

G-CFAZ baggage restraint

The 'open monocoque' structural design of the rear fuselage in this aircraft would allow an unsecured item a significant range of movement, possibly to restrict aileron or elevator movement. While bungee nets may provide sufficient restraint of larger item they will not provide the same level of retention to thin objects. The following Safety Recommendation is made:

It is recommended that P&M Aviation/Flight Design review the design of the current baggage restraints in the CTSW design, to ensure that it provides effective restraint of all stowed baggage.

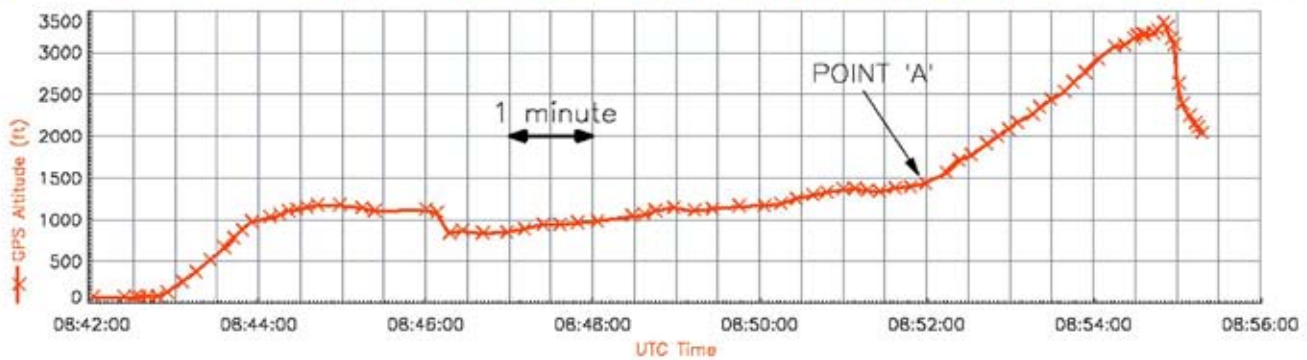
Figure 2

After takeoff, the aircraft climbed to a GPS altitude of around 1,000 ft, turned to the right onto a true heading of approximately 050° and began tracking around the north of Manchester (Figure 2, with expanded final section in Figure 3). Groundspeed, derived from rate of change of position increased to around 110 kt.

'BTN-SHACKLEWELL' route, G-CFAZ began to climb from a GPS altitude of approximately 1,500 ft (Point 'A', Figure 2). This climb continued with the aircraft initially tracking approximately parallel to the 'BTN-SHACKLEWELL' route before deviating to the left, ultimately achieving a maximum GPS altitude of 3,366 ft at 08:54:50 hrs (Point 'B', Figure 3).

G-CFAZ GPS data – accident flight
