ACCIDENT

Aircraft Type and Registration:	Flight Design CTSW, G-CFAZ	
No & Type of Engines:	1 Rotax 912 ULS piston engine	
Year of Manufacture:	2007	
Date & Time (UTC):	8 October 2008 at 0855 hrs	
Location:	Saddleworth Moor, Lancashire	
Type of Flight:	Private	
Persons on Board:	Crew - 1	Passengers - None
Injuries:	Crew - 1 (Fatal)	Passengers - None
Nature of Damage:	Aircraft destroyed	
Commander's Licence:	Private Pilot's Licence	
Commander's Age:	41 years	
Commander's Flying Experience:	123 hours (of which 29 were on type) Last 90 days - 11 hours Last 28 days - 0 hours	
Information Source:	AAIB Field Investigation

Synopsis

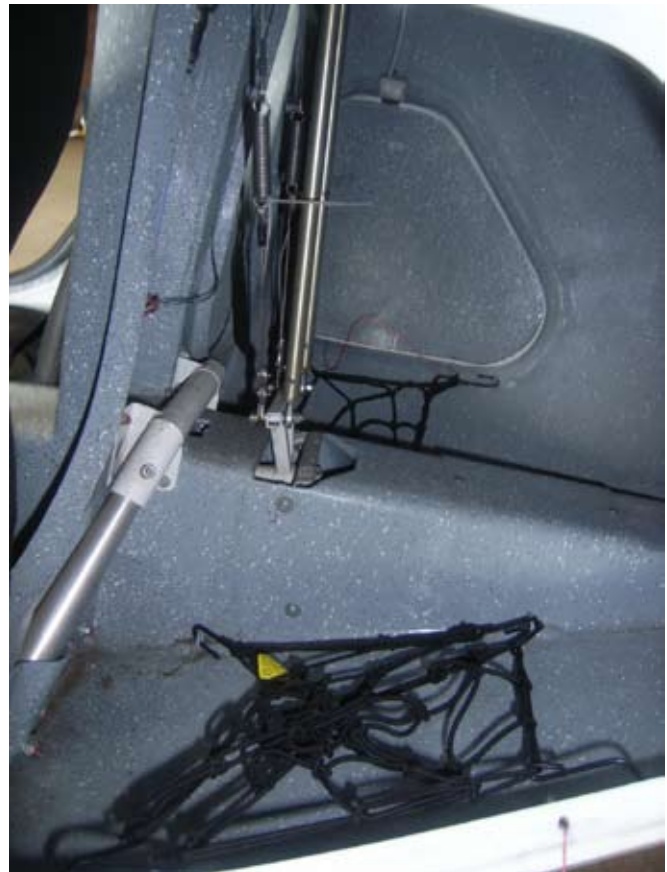
Figure 1
G-CFAZ baggage restraint

The fuselage is of carbon fibre/foam sandwich monocoque construction, without bulkheads or substantial fuselage frames. The manufacturer's Operator's Manual states that the aircraft has a maximum baggage weight of 25 kg, to be stowed in the rear fuselage immediately behind the rear cockpit bulkhead. Access is provided by a removable panel on either side of the fuselage immediately behind each cockpit door; the seatbacks can also be pulled forward to stow larger items. Any baggage is secured under two bungee nets (Figure 1).

The 'open monocoque' structural design of the rear fuselage in this aircraft would allow an unsecured item a significant range of movement, possibly to restrict aileron or elevator movement. While bungee nets may provide sufficient restraint of larger item they will not provide the same level of retention to thin objects. The following Safety Recommendation is made:

Safety Recommendation 2009-101

It is recommended that P&M Aviation/Flight Design review the design of the current baggage restraints in the CTSW design, to ensure that it provides effective restraint of all stowed baggage.

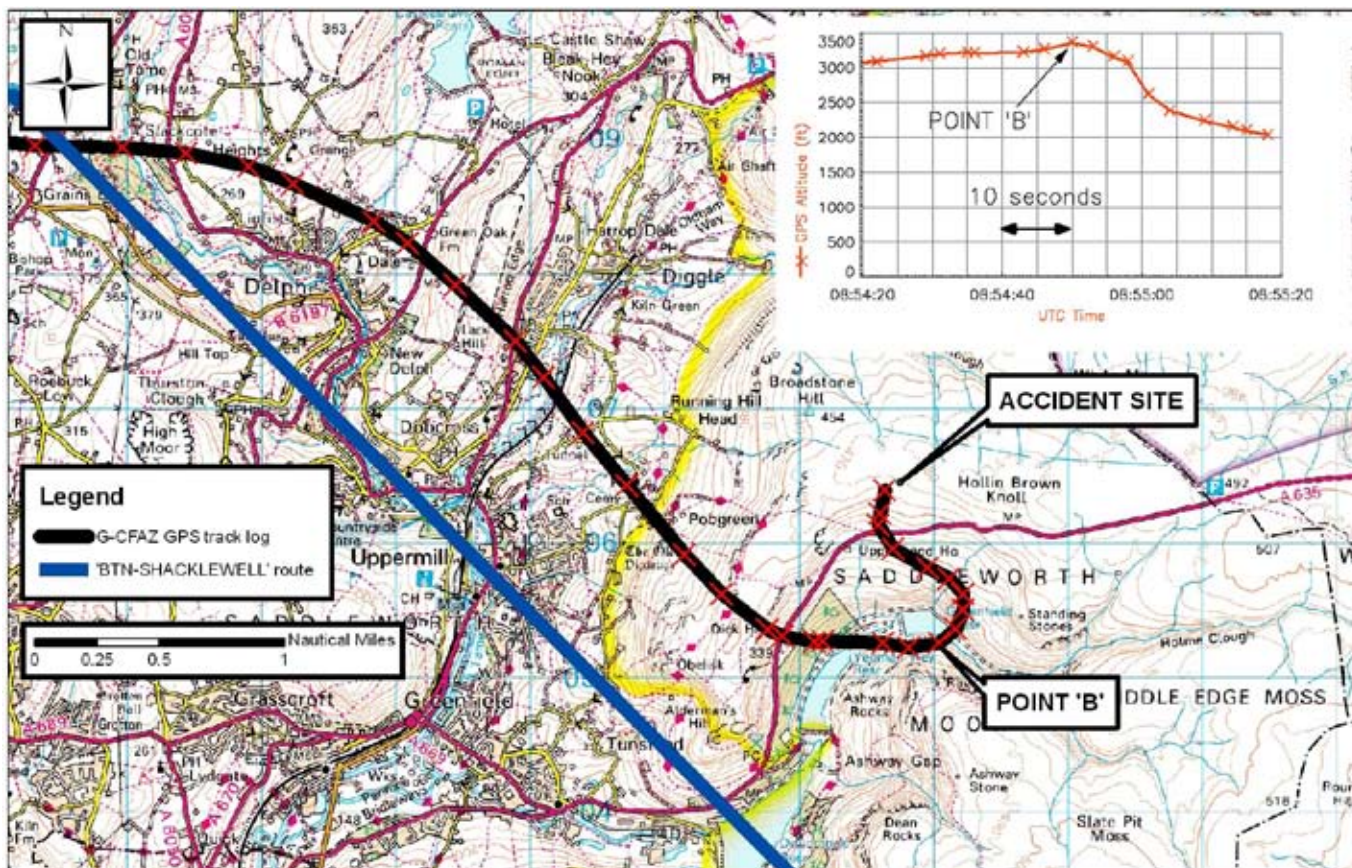
Figure 3

'BTN-SHACKLEWELL' route, G-CFAZ began to climb from a GPS altitude of approximately 1,500 ft (Point 'A', Figure 2). This climb continued with the aircraft initially tracking approximately parallel to the 'BTN-SHACKLEWELL' route before deviating to the left, ultimately achieving a maximum GPS altitude of 3,366 ft at 08:54:50 hrs (Point 'B', Figure 3).

After achieving the maximum GPS altitude, the recorded positions indicate a turn to the left followed by a descent. The derived average rate of descent between the maximum GPS altitude and the final recorded position was 2,800 ft/min. The final recorded GPS position was at 08:55:18 hrs at a GPS altitude of 2,043 ft and heading of 013°T. This position was a distance along the ground of 129 m from the initial ground impact mark. Terrain elevation of the initial impact was estimated at 1,541 ft, around 500 ft below the last recorded GPS altitude

G-CFAZ GPS data – accident flight approaching Saddleworth Moor
