## ACCIDENT

<b>Aircraft Type and Registration:</b>	Flight Design CTSW, G-CFAZ	
<b>No &amp; Type of Engines:</b>	1 Rotax 912 ULS piston engine	
<b>Year of Manufacture:</b>	2007	
<b>Date &amp; Time (UTC):</b>	8 October 2008 at 0855 hrs	
<b>Location:</b>	Saddleworth Moor, Lancashire	
<b>Type of Flight:</b>	Private	
<b>Persons on Board:</b>	Crew - 1	Passengers - None
<b>Injuries:</b>	Crew - 1 (Fatal)	Passengers - None
<b>Nature of Damage:</b>	Aircraft destroyed	
<b>Commander's Licence:</b>	Private Pilot's Licence	
<b>Commander's Age:</b>	41 years	
<b>Commander's Flying Experience:</b>	123 hours (of which 29 were on type) Last 90 days - 11 hours Last 28 days - 0 hours	
<b>Information Source:</b>	AAIB Field Investigation

### Synopsis

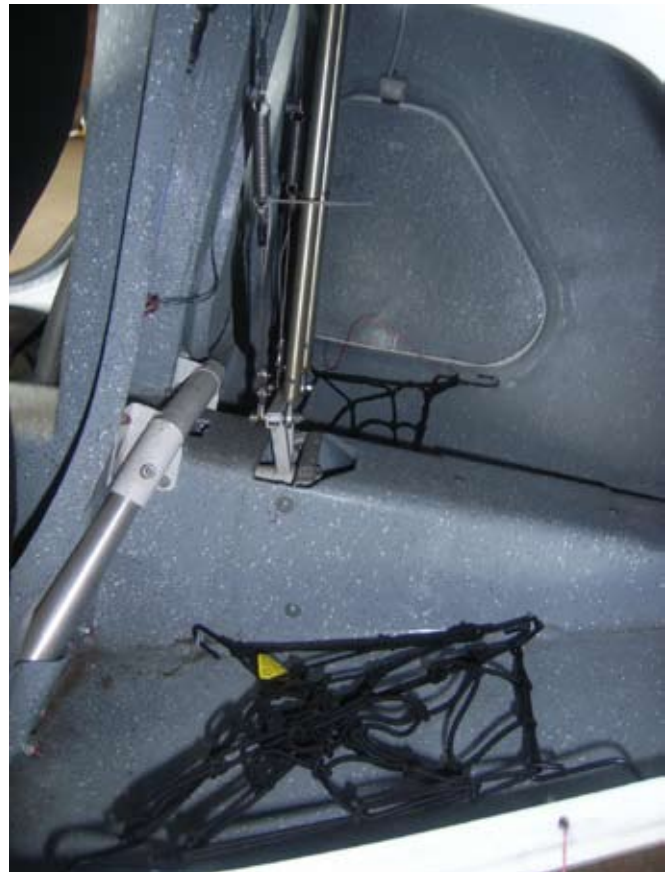
**Figure 1**  
G-CFAZ baggage restraint

The fuselage is of carbon fibre/foam sandwich monocoque construction, without bulkheads or substantial fuselage frames. The manufacturer's Operator's Manual states that the aircraft has a maximum baggage weight of 25 kg, to be stowed in the rear fuselage immediately behind the rear cockpit bulkhead. Access is provided by a removable panel on either side of the fuselage immediately behind each cockpit door; the seatbacks can also be pulled forward to stow larger items. Any baggage is secured under two bungee nets (Figure 1).

The 'open monocoque' structural design of the rear fuselage in this aircraft would allow an unsecured item a significant range of movement, possibly to restrict aileron or elevator movement. While bungee nets may provide sufficient restraint of larger item they will not provide the same level of retention to thin objects. The following Safety Recommendation is made:

It is recommended that P&M Aviation/Flight Design review the design of the current baggage restraints in the CTSW design, to ensure that it provides effective restraint of all stowed baggage.

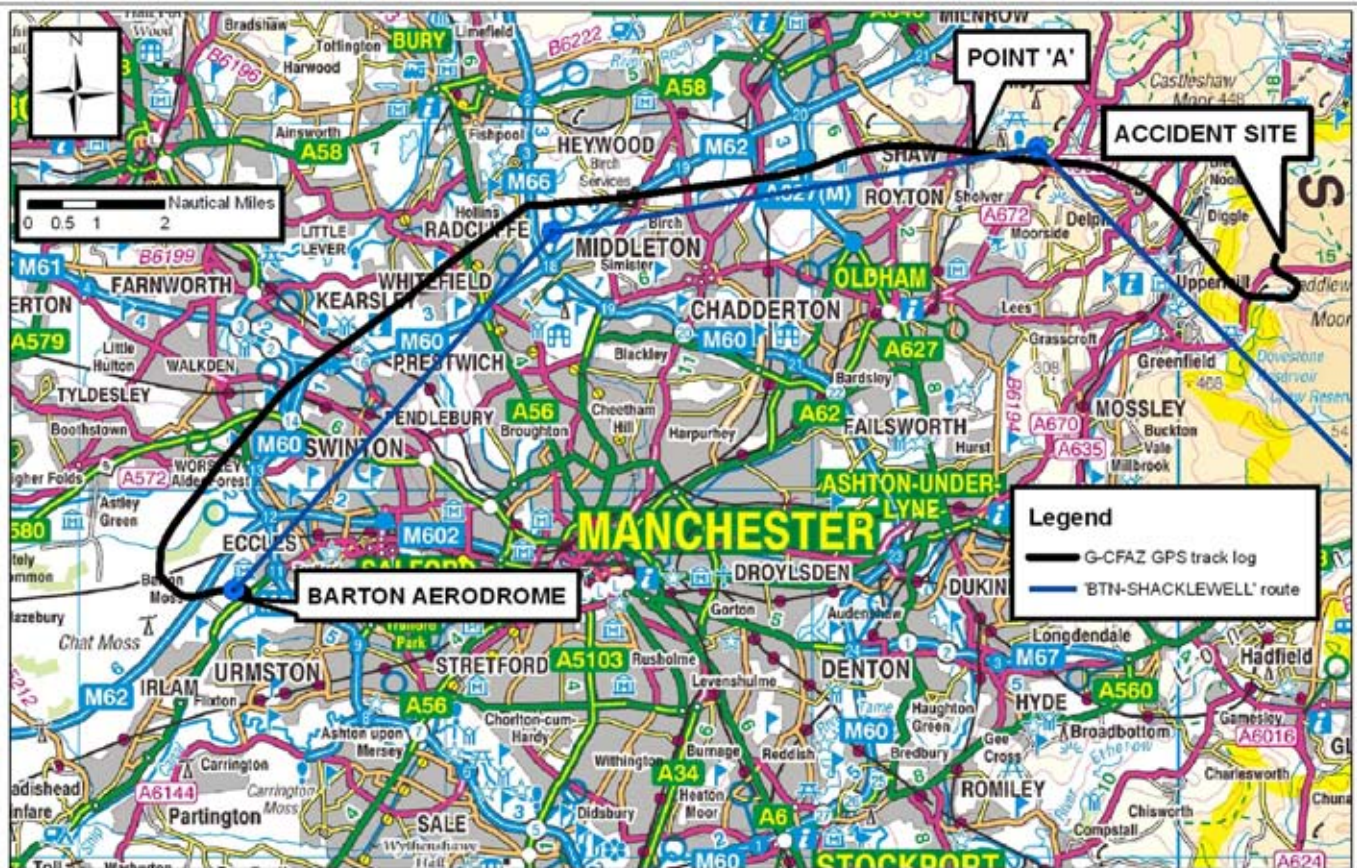
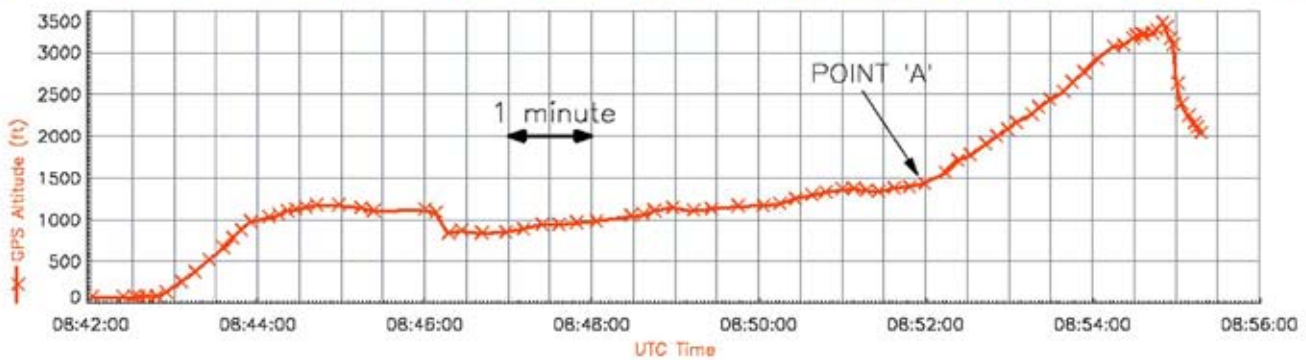
Figure 2

'BTN-SHACKLEWELL' route, G-CFAZ began to climb from a GPS altitude of approximately 1,500 ft (Point 'A', Figure 2). This climb continued with the aircraft initially tracking approximately parallel to the 'BTN-SHACKLEWELL' route before deviating to the left, ultimately achieving a maximum GPS altitude of 3,366 ft at 08:54:50 hrs (Point 'B', Figure 3).

G-CFAZ GPS data – accident flight

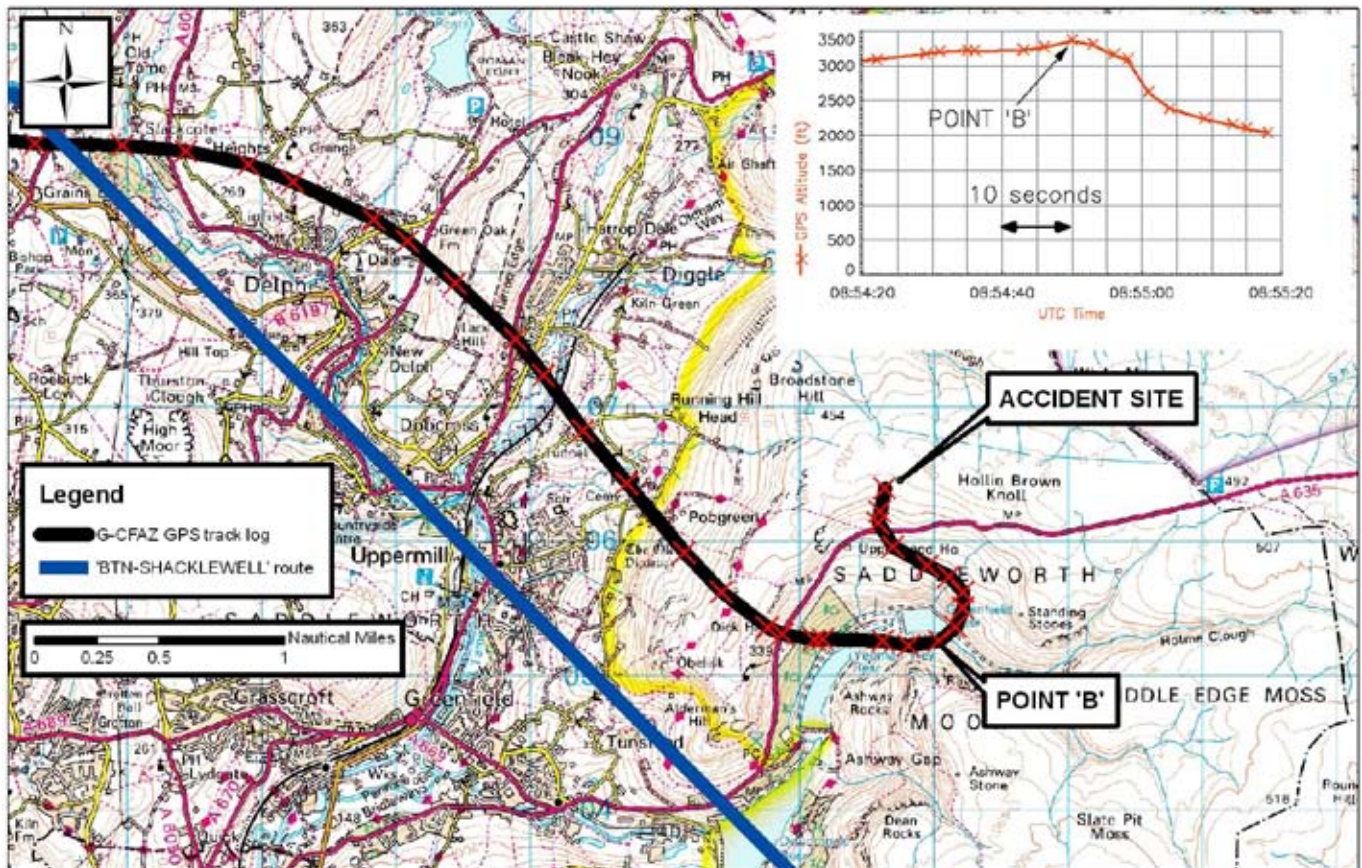
Figure 3

After achieving the maximum GPS altitude, the recorded positions indicate a turn to the left followed by a descent. The derived average rate of descent between the maximum GPS altitude and the final recorded position was 2,800 ft/min. The final recorded GPS position was at 08:55:18 hrs at a GPS altitude of 2,043 ft and heading of 013°T. This position was a distance along the ground of 129 m from the initial ground impact mark. Terrain elevation of the initial impact was estimated at 1,541 ft, around 500 ft below the last recorded GPS altitude

G-CFAZ GPS data – accident flight approaching Saddleworth Moor
