ACCIDENT

Aircraft Type and Registration:	Mooney M20F Executive, G-CEJN	
No & Type of Engines:	1 Lycoming IO-360-A1A piston engine	
Year of Manufacture:	1966	
Date & Time (UTC):	8 August 2009 at 1218 hrs	
Location:	Wellesbourne Mountford Airfield, Warwickshire	
Type of Flight:	Private	
Persons on Board:	Crew - 1	Passengers - None
Injuries:	Crew - None	Passengers - N/A
Nature of Damage:	Damage to the engine cowling, cowl flaps, propeller, nose landing gear, lower fuselage, wing and the engine shock-loaded	
Commander's Licence:	Private Pilot's Licence	
Commander's Age:	39 years	
Commander's Flying Experience:	106 hours (of which 14 were on type) Last 90 days - 31 hours Last 28 days - 4 hours	
Information Source:	AAIB Field Investigation

Synopsis

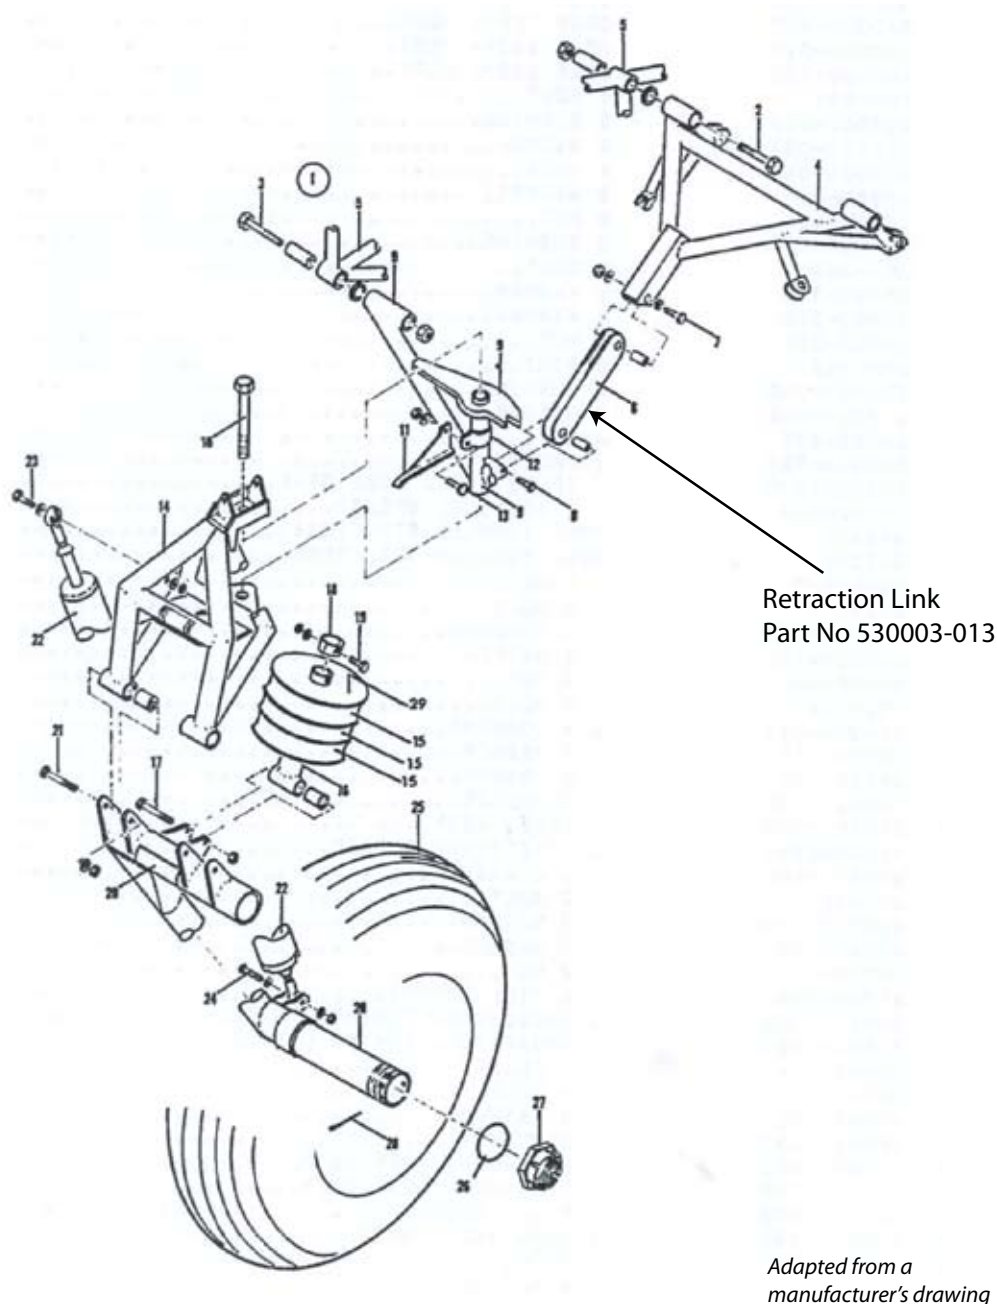
Figure 1

Examination of the aircraft revealed that the retention link, part number 53001-013, an item in the landing gear downlock system, had been fitted upside down.

Further examination by the local aircraft engineering staff and the AAIB found that the nose landing gear downlock mechanism would not engage into the full overcentre position due to mechanical interference. This resulted in a 'soft' downlock. Further examination by the maintenance organisation revealed that the nose landing gear downlock Retraction Link, part number 53003-013 (Figure 1), was fitted upside down and did not have either of the two grease nipples fitted in their threaded holes¹. In the illustration (Figure 1) the Retraction Link,

Nose landing gear assembly

part number 530003-013, appears symmetrical but the difference in profile between the upper and lower surfaces requires correct orientation during assembly.

It is recommended that the Federal Aviation Administration require the aircraft manufacturer, Mooney Airplane Company, to publish guidance material on the correct orientation of the nose landing gear Retraction Link part number 530003-013.

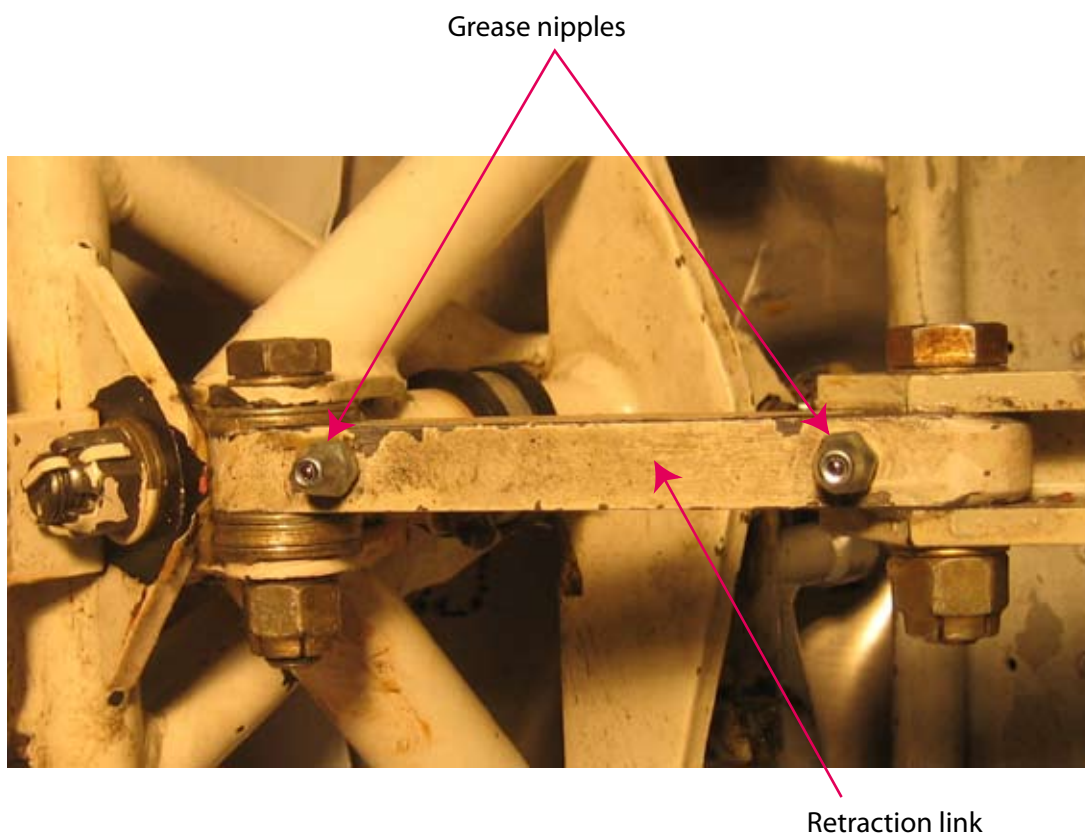
Figure 2

After correctly fitting the retraction link the downlock mechanism went into a 'hard' overcentre lock (Figure 2).

Nose landing gear retraction link with grease nipples fitted and correctly orientated
