INCIDENT

Aircraft Type and Registration:	Airbus A330-323X, N270AY
No & Type of Engines:	2 Pratt & Whitney PW4000 SER turbofan engines
Year of Manufacture:	2000
Date & Time (UTC):	29 May 2008 at 1025 hrs
Location:	Manchester Airport
Type of Flight:	Commercial Air Transport (Passenger)
Persons on Board:	Crew - 12 Passengers - 250
Injuries:	Crew - None Passengers - None
Nature of Damage:	Damage to main landing gear and brake pack; debris recovered from runway
Commander's Licence:	Airline Transport Pilot's Licence
Commander's Age:	60 years
Commander's Flying Experience:	14,650 hours (of which 2,390 were on type) Last 90 days - 58 hours Last 28 days - 26 hours
Information Source:	AAIB Field Investigation

Synopsis

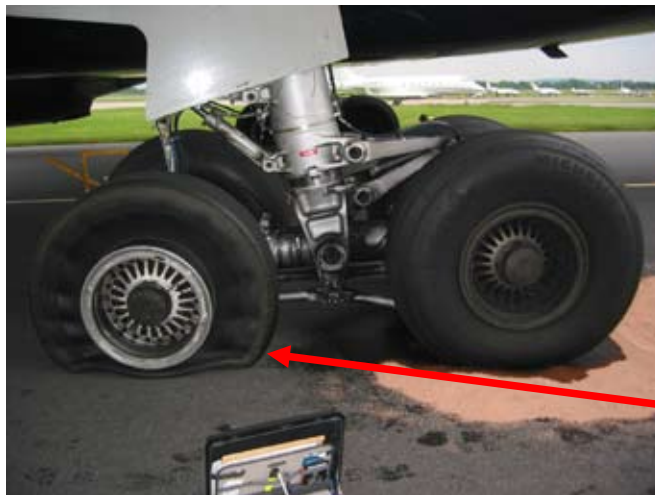
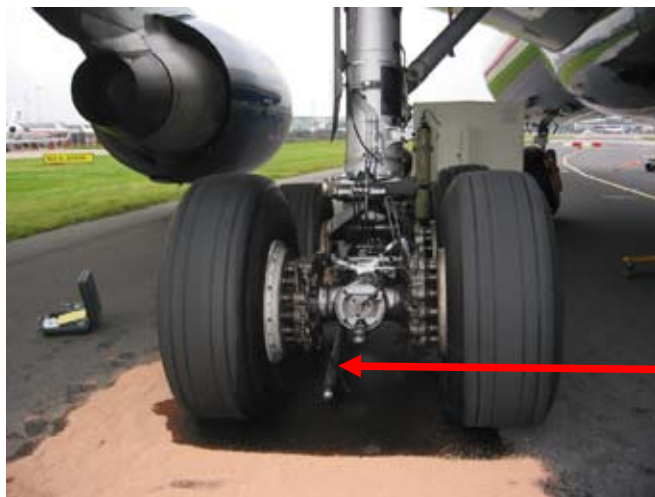
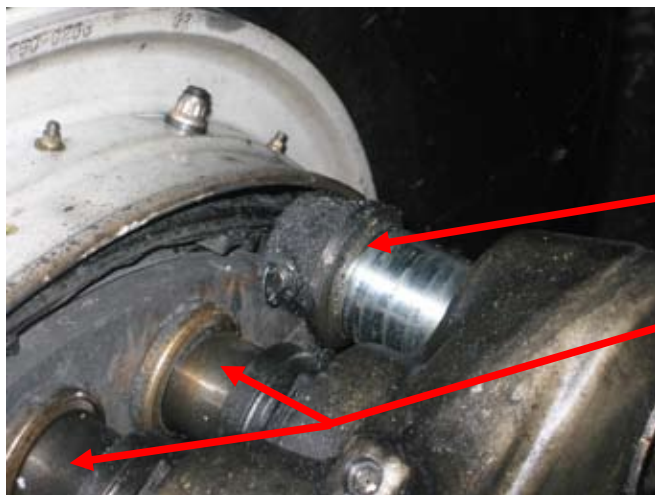
Figure 2
Views of the left landing gear. Note hydraulic fluid spillage

Deflated No 1 tyre

Disconnected brake reaction rod

Torque pin migrated into wheel rim following flange failure

Upon examination it was immediately apparent that the brake unit on the No 5 wheel (ie rear left wheel on the left landing gear bogie) had become disconnected from its associated brake reaction rod as a result of the failure of the attaching torque pin. As a result, the brake unit had been free to rotate with the wheel, causing the consequent failures of the hydraulic hoses and electrical harness that were attached to it; these failures were responsible for generating the PFR and Maintenance Reports. The tension in the hoses had in turn caused the failure of a bracket/cable guide assembly that was mounted on the bogie beam. It was clear that

The No 1 tyre (ie the one ahead of the No 5 wheel) had deflated following the RTO as a result of the heat generated during the heavy braking, thereby causing the activation of the fusible plug in the wheel. It was subsequently noted that the No 6 tyre was showing only 65 psi, as opposed to the normal pressure of around 215 psi. It was found that the core within the fusible plug had melted but had resolidified before the tyre had become completely deflated. Otherwise, none of the tyres displayed any evidence of damage, such as skid-induced flats or cuts, that could have been attributable to the incident.

The brake rod attachment pin had migrated in an outboard direction within the brake housing to the extent that the end of the pin had been in contact with the wheel rim as it rotated; some swarf had been generated as a result. The pin had been able to move axially in the bore in the brake housing due to the fracture of the flange at the head end. The pin was removed by driving it out of the housing, following which it was subjected to specialist metallurgical examination.

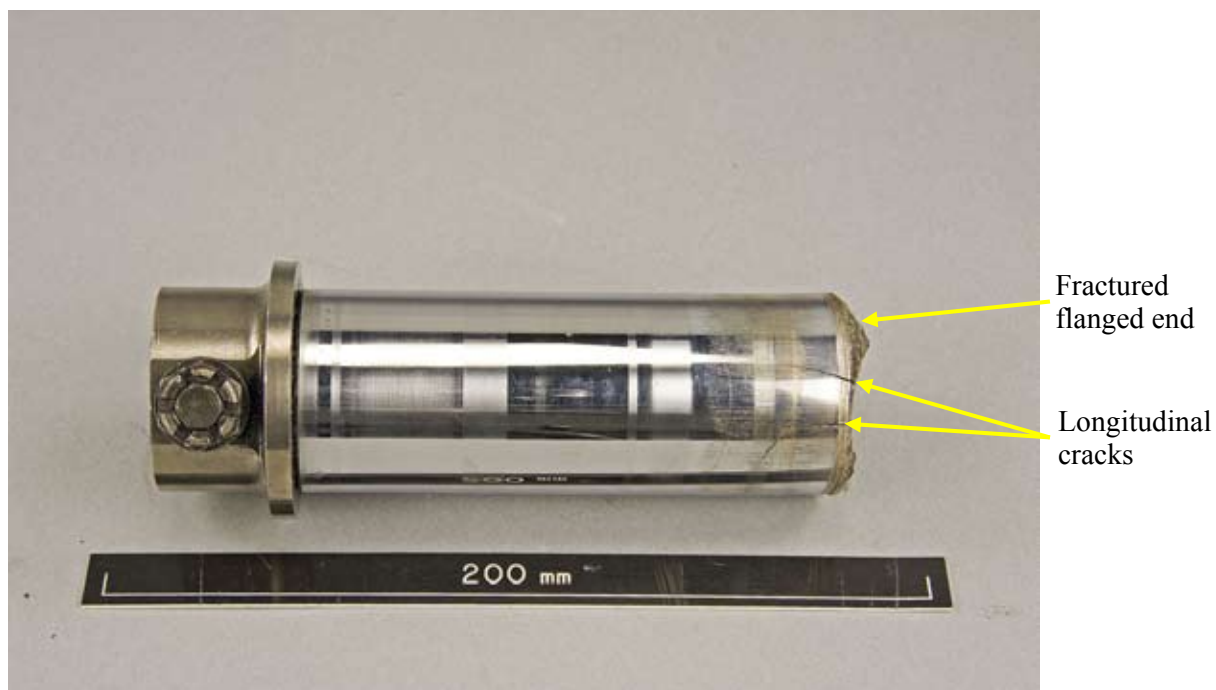
Figure 4

The runway debris included fragments of the flange, from the head of the pin, amounting to about 50% of the circumference. The remainder was not recovered. Photographs of the pin and flange fragments in their 'as received' condition are shown at Figure 4.

No 5 torque pin together with flange fragments that were found on the runway

bulletins VSB 2-1577-32-7, issued in August 2004 and VSB 2-1577-32-8, issued in May 2005. However the metallurgical examination revealed no evidence of material or manufacturing defects, so the flange failure was due entirely to overload. However, part of the fracture face on the pin was found to be corroded (Figure 5), leading to the conclusion that the associated part of the flange had failed at an earlier date. Although it was not possible to estimate when this was likely to have occurred, it was noted that there had been minimal accumulation, on the fracture face, of the brake dust that had liberally coated adjacent components, suggesting a relatively recent event. Significantly, none of the recovered pieces of the flange were from the corroded area of the pin. This in turn suggested that the pin flange had failed in overload during the RTO, having been weakened in a previous event in which part of the flange had become detached. There was no evidence to indicate the nature of any previous event, although

Two axial cracks were evident in the pin at the fracture end and it was additionally noted that the pin was bent. It was considered that the pin was subjected to a bending action during the process of the flange failure, with the axial cracks opening up as a consequence of a crushing force applied across the diameter, imposed by the bores of the brake rod and/or housing.
