AAIB Bulletin No: 11/94

Ref: EW/C94/6/1

Aircraft Type and Registration: Piper PA-34-200T Seneca II, G-BEHU

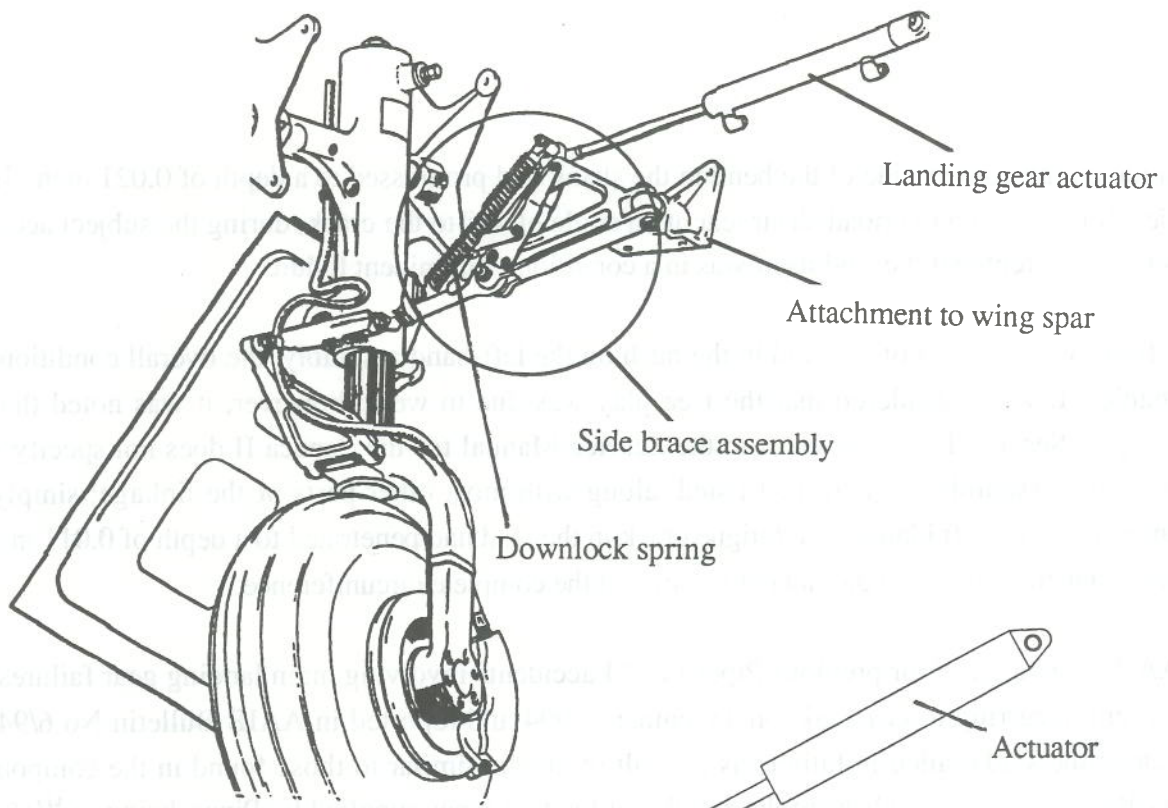
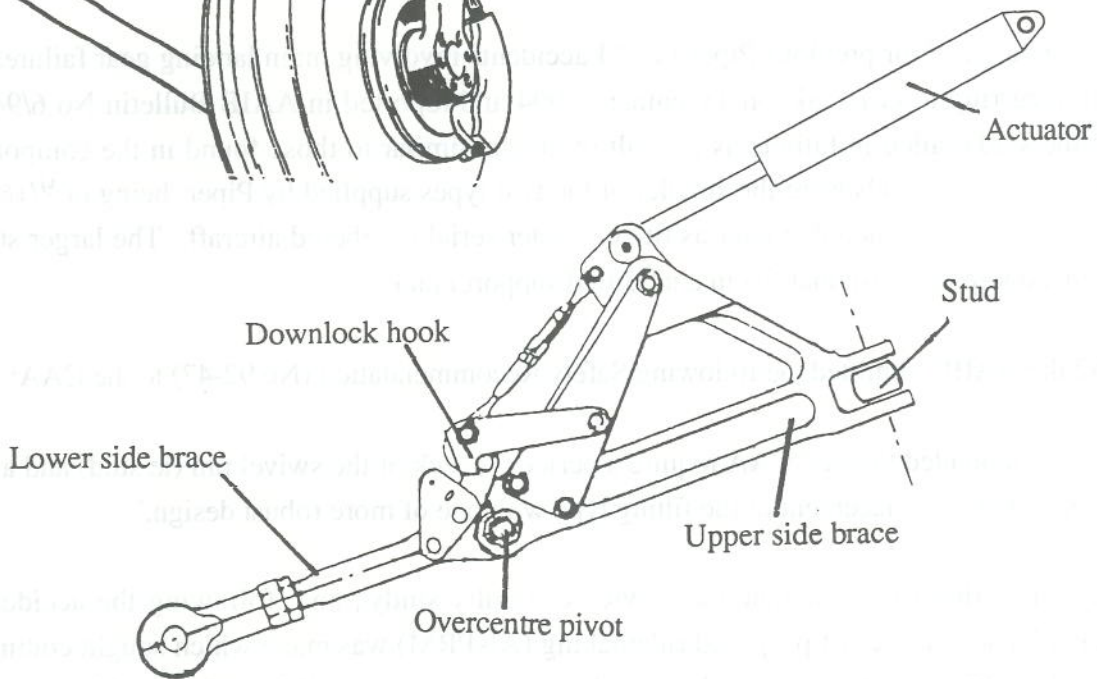
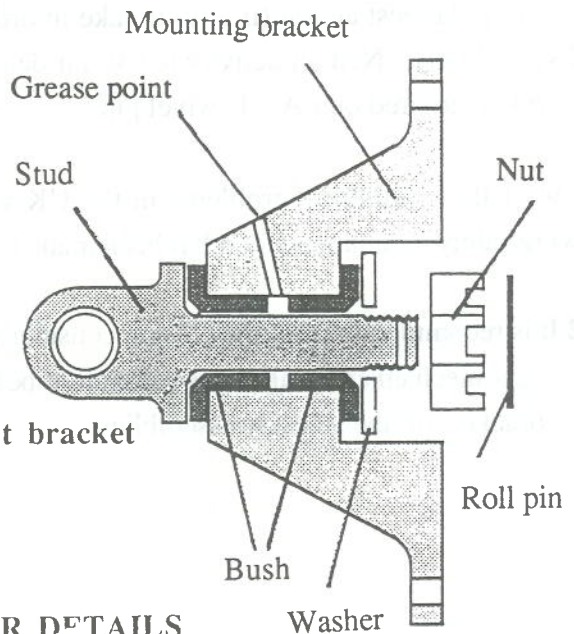
FIGURE 1 PA34 MAIN LANDING GEAR DETAILS

Figure 1 shows a diagram of the landing gear. The side brace linkage essentially consists of an upper and lower link, which, when the gear is extended, are held in an overcentre position with the aid of a spring and downlock hook. The retraction process is initiated by the actuator lifting the hook off the pawl, followed by the rotation of the linkage.

When the landing gear was pulled fully down during the recovery, it was noted that there appeared to be a significant amount of free play in the stud/bushing assembly that attached the side brace to the front spar of the wing, and about which the linkage rotated. It was apparent that any movement in the linkage occurring as a result of the free play would reduce the overcentre and hence increase the risk of the geometric lock breaking and the landing gear collapsing. A lesser amount of play was also observed in the same components on the intact left landing gear. The studs and bushings were located in machined alloy bracket assemblies which were bolted to the wing spar. Once the aircraft had been ferried to its repair station, the components from both main landing gears were removed for examination by the AAIB. It is not known how long these components had been fitted to this aircraft.

The stud (Part No 95299-02) from the right-hand side was found to be bent when it was removed from the assembly. The associated bush (Part No 67026-12) is manufactured in two halves, with a space between the two acting as a grease groove. The half-bushing nearest the head of the stud was found to be a very loose fit in the bracket, and had adopted a slightly oval shape, with the bore diameter varying between 0.566 to 0.575 inch. Metallurgical examination revealed that the out-of-round on the outside diameter and the greater part of the out-of-round in the bore was the result of plastic deformation. There was also plastic distortion of the flange of the bush at one position, and this had formed a part-circumferential depression on the edge of the hole in the bracket. The diameter of the hole varied between 0.753 to 0.766 inch, with plastic deformation being responsible for the variation. It was therefore concluded that the condition of the assembly was the result of an overload such that could have occurred in a heavy landing.

Examination of the studs revealed that both of them contained evidence of poor machining and corrosion in the blend radius between the head and shank. The corrosion had occurred before the studs were last cadmium plated. In addition, they both contained fatigue cracks in this area. The cracks were examined in detail after the studs were sectioned longitudinally. It was found that the right-hand stud was cracked to a total depth of 0.013 inch on the concave side of the bend in the shank. It was apparent that the crack had developed to a depth of 0.003 inch before being relieved plastically by overloading. The crack had then progressed, in fatigue, to the full depth of 0.013 inch. It was considered that the overload condition must have occurred a significant time before the subject incident.

The crack on the convex side of the bend in the shank had progressed to a depth of 0.021 inch. It had then developed into an overload shear tear at an angle of 45° to the crack, during the subject accident. It was thus apparent that the stud itself was in a condition of imminent failure.

94-32 It is recommended that the CAA reconsider with the FAA a requirement for the main landing gear mechanism on all PA-34 aircraft to be fitted with the larger diameter studs and modified brackets on the sidestay assemblies.
