ACCIDENT

Aircraft Type and Registration:	DHC-8-311 Dash 8, G-BRYW	
No & Type of Engines:	2 Pratt & Whitney Canada PW123 turboprop engines	
Year of Manufacture:	1997	
Date & Time (UTC):	7 October 2005 at 1822 hrs	
Location:	Stand 8 at Aberdeen Airport	
Type of Flight:	Public Transport (Passenger)	
Persons on Board:	Crew - 4	Passengers - 50
Injuries:	Crew - None	Passengers - None
Nature of Damage:	Aircraft: damage to engine, propeller and fuselage Ground Vehicle: damage to cabin and bodywork	
Commander's Licence:	Airline Transport Pilot's Licence	
Commander's Age:	31 years	
Commander's Flying Experience:	5,600 hours (of which 648 were on type) Last 90 days - 99 hours Last 28 days - 28 hours	
Information Source:	AAIB Field Investigation

Synopsis

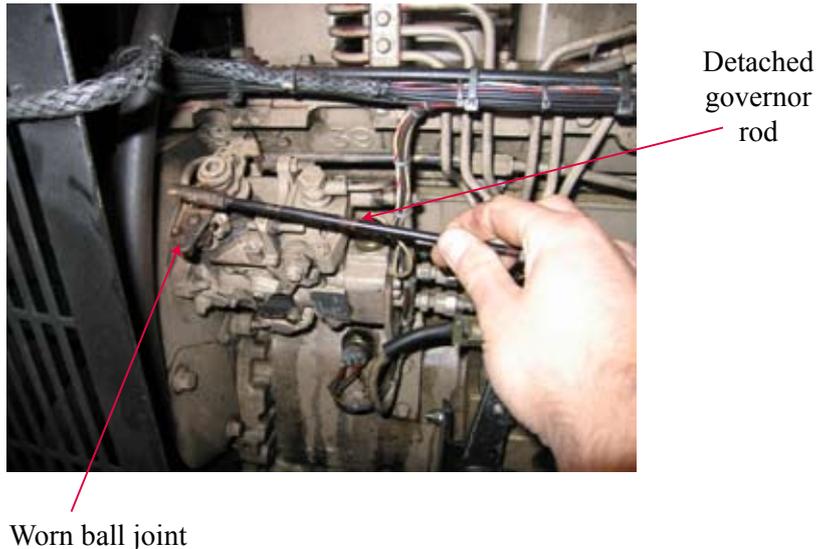
Photograph showing detached governor rod and worn ball joint

On opening the engine cover the governor rod was found to be disconnected from the fuel pump. Further inspection revealed that the ball joint on the fuel pump lever was worn, hence the governor rod could become detached from the fuel pump lever with little effort. Figure 2 shows the detached governor rod and the worn ball joint. The spring on the fuel pump was also worn so that when the governor rod became detached from the fuel pump, the engine ran at a moderate speed and not at idle.

The engine speed was significantly higher than the normal idle setting, such that the vehicle could override the parking brake. This is attributed to excessive wear on the ball joint, which allowed the engine governor rod to become detached, and to the worn spring on the fuel pump, which did not subsequently set the engine to idle. Whilst the airport authority used the check list recommended in CAP 642, this does not include a check on engine controls. The worn ball joint and the worn spring were not identified or rectified by the operator’s maintenance system and there was no dedicated check in the manufacturer’s recommended maintenance scheme.

The incident occurred because the GPU was being operated with a worn ball joint on the governor rod, a worn fuel pump spring and a worn gate in the FORWARD-NEUTRAL-REVERSE selector.

It is recommended that Houchin Aerospace update their recommended servicing schedule to include checks for governor rods, fuel pump springs and forward-neutral-reverse selectors at appropriate intervals. These changes should be promulgated to all operators of relevant equipment world-wide.

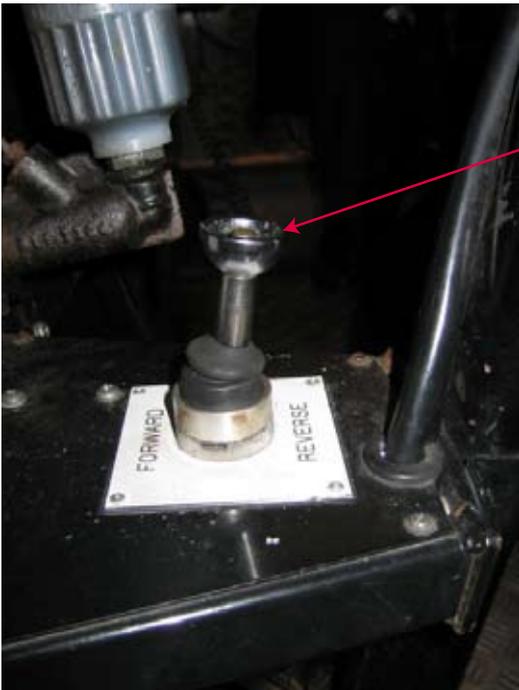
Figure 3 (left)

Button - in normal use this must be pressed to allow FORWARD or REVERSE to be selected

Photograph showing location of FORWARD-NEUTRAL-REVERSE selector in front of the steering column
