## ACCIDENT

<b>Aircraft Type and Registration:</b>	Maverick 430, G-ONFL
<b>No &amp; Type of Engines:</b>	1 Rotax 503 piston engine
<b>Year of Manufacture:</b>	1995 (Serial no: PFA 259-12750)
<b>Date &amp; Time (UTC):</b>	5 October 2013 at 1100 hrs
<b>Location:</b>	North Coates Airfield, Lincolnshire
<b>Type of Flight:</b>	Private
<b>Persons on Board:</b>	Crew - 1                      Passengers - None
<b>Injuries:</b>	Crew - None                      Passengers - N/A
<b>Nature of Damage:</b>	Hole in fuselage, left tail lower bracing cable snapped, large tear under fuselage by tail
<b>Commander's Licence:</b>	Private Pilot's Licence
<b>Commander's Age:</b>	46 years
<b>Commander's Flying Experience:</b>	318 hours (of which 38 were on type) Last 90 days - 3 hours Last 28 days - 2 hours
<b>Information Source:</b>	Aircraft Accident Report Form submitted by the pilot

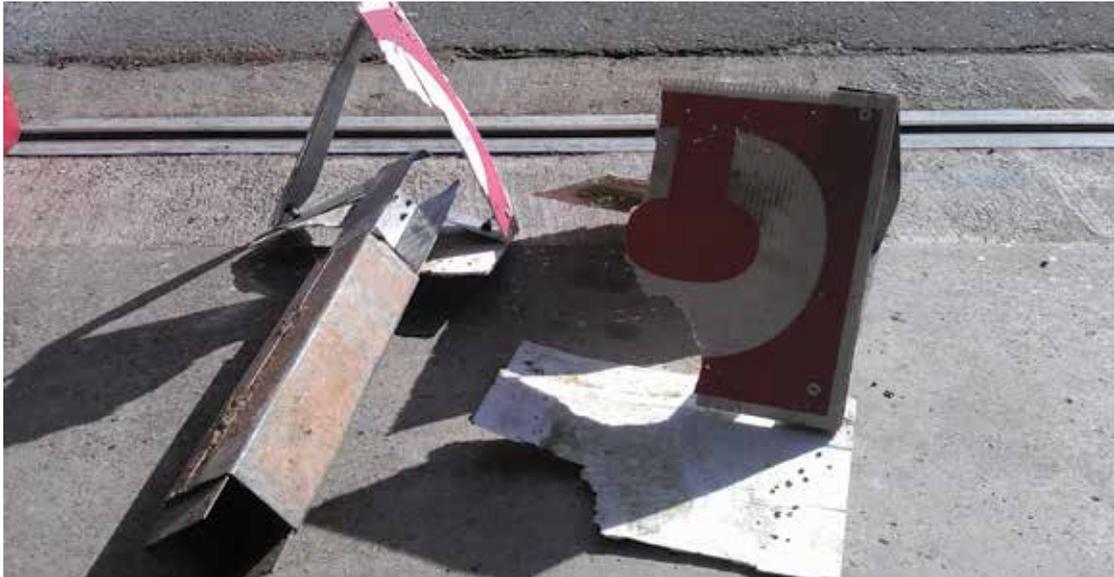
The pilot was using North Coates Airfield for local flying. The visibility was reported by the pilot as excellent, with a slight northerly wind. At the end of the second flight of the day, the aircraft touched down on the centreline of grass Runway 23 but later in the landing roll it drifted to the right despite the application of left rudder. The pilot reported that he was not overly concerned as there was a large grass area adjacent to the runway. However, the tail dragger configuration of the aircraft obscured the pilot's forward view and so he did not see a runway marker which the aircraft then struck. The impact resulted in a hole and a large gash in the aircraft fuselage and a snapped bracing cable. There were no problems reported with the rudder system serviceability.

The marker consisted of a triangle of plastic signs held up with a metal frame that was embedded in the ground (Figure 1).

**Figure 1**  
Damaged marker

*'Any aids to air navigation to be sited within a runway strip should be made as light and as frangible as design and function will permit. In this context a frangible object is one which retains its structural integrity and stiffness up to a desired maximum load, but when subjected to a greater load than desired will break, distort or yield in such a manner as to present the minimum hazard to an aeroplane.'*

Following this accident, the markers at North Coates Airfield have been replaced with markers of a different design.
