AAIB Bulletin No: 2/96

Ref: EW/C95/8/2

Aircraft Type and Registration: Beechcraft Baron 58, G-BAHN

Location: Fyfield, near Andover, Hampshire

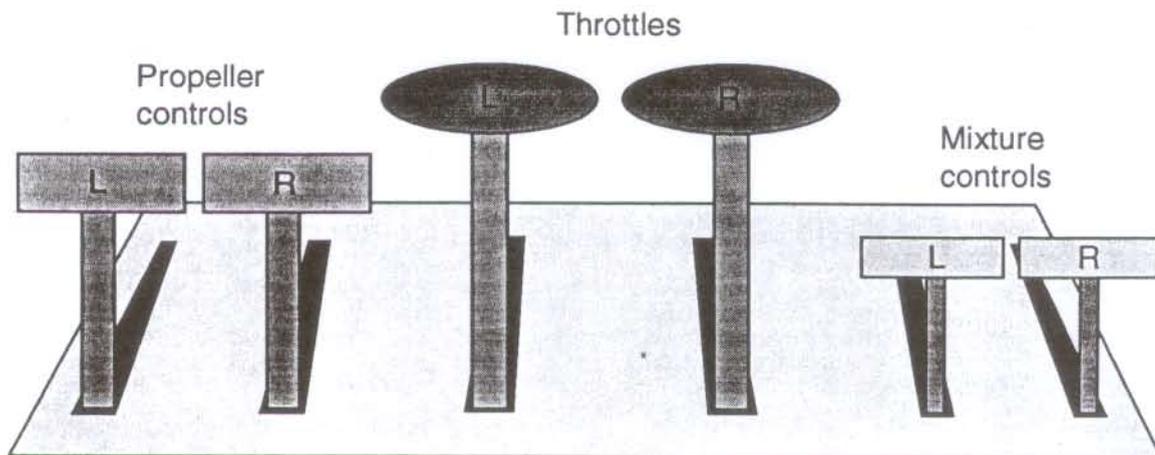
Figure 1: Beechcraft Baron engine control layout

The Beechcraft Baron is unusual in that the engine controls are grouped in the order, Propellers, Throttles and Mixtures in pairs from left to right, positioned centrally on the instrument panel in front of the pilot as in Figure 1. The conventional layout is, Throttles, Propellers and Mixtures from left to right as in Figure 2. On the latest models of the Baron, the manufacturer has changed the layout to the more conventional one.

From examination of the wreckage measurement of the engine control cables indicated that the controls had been at the following positions at impact; propeller levers fully forward, throttles and mixture levers in the mid-position. Because of the damage that the cables had sustained the

The combination of throttles and mixture controls at the mid-position is anomalous in that it is a combination that would only ever be demanded under normal conditions when combined with a lower setting of the propeller RPM levers. For example, this would be the procedure adopted when the aircraft reaches the desired cruising altitude. It is more likely that the pilot deliberately throttled back the engines to prevent the aircraft accelerating to too great a speed for the visual circuit in which he planned to return the aircraft to the runway. This power reduction may have been a rapid reaction to the situation caused by the open door whereby the pilot was obliged to change his plans at very short notice and join a left-hand low-level visual circuit. It would be normal procedure to then reduce the propeller RPM to a slightly lower level and, on the conventional lever layout, this would be the two levers to the right of the throttles. On this Baron these levers controlled Mixture and, if they were inadvertently retarded instead of the RPM levers, then the engines would probably have sounded as described by the witnesses.
