**ACCIDENT**

<b>Aircraft Type and Registration:</b>	EADS Socata TBM 700C1, N700GY	
<b>No &amp; Type of Engines:</b>	1 Pratt & Whitney Canada PT6A-64 turboprop	
<b>Year of Manufacture:</b>	2004	
<b>Date &amp; Time (UTC):</b>	27 March 2008 at 1039 hrs	
<b>Location:</b>	Alderney Airport, Channel Islands	
<b>Type of Flight:</b>	Private	
<b>Persons on Board:</b>	Crew - 1	Passengers - None
<b>Injuries:</b>	Crew - None	Passengers - N/A
<b>Nature of Damage:</b>	Major damage to propeller, engine and aircraft nose	
<b>Commander's Licence:</b>	Airline Transport Pilot's Licence	
<b>Commander's Age:</b>	54 years	
<b>Commander's Flying Experience:</b>	17,400 hours (of which approximately 150 were on type) Last 90 days - 240 hours Last 28 days - 90 hours	
<b>Information Source:</b>	Aircraft Accident Report Form submitted by the pilot and subsequent enquiries by the AAIB

**Synopsis**

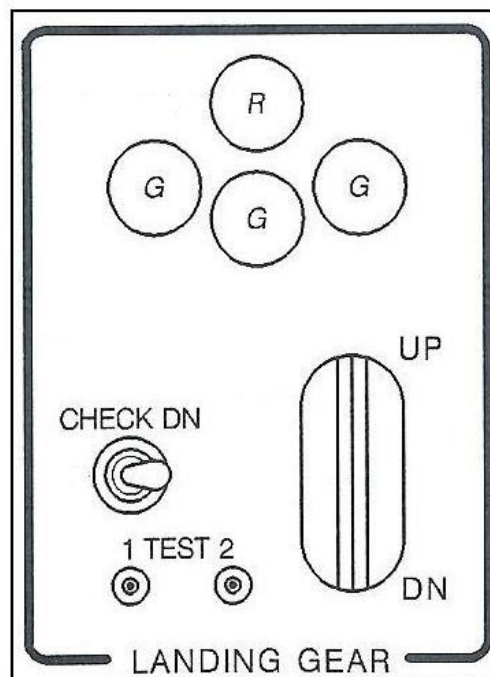
**Figure 1**

- 3 green indicator lights (one per landing gear) indicate that each landing gear is down-locked,
- 1 red warning light indicates that landing gears are operating, or not locked down or up

*The red warning light flashes as soon as landing gears are operating and remains continuously on in case of locking problem.'*

TBM 700 - Landing gear control and indication panel

Section 7.5 of the TBM 700 POH states that a continuous red warning light indicates a landing gear locking problem, irrespective of the condition of the green lights and the significance of the red warning light should be explained during pilot training. Notwithstanding this, on this, and at least one other occasion, the three green lights led a pilot to believe that the gear was locked down, even though a red light was showing. On most other aircraft types the green lights will only illuminate when the landing gear is locked down and a locking problem is indicated by a failure of the green lights to illuminate. Pilots who fly other aircraft types in addition to the TBM 700 are therefore more likely to assume that three greens signify that the landing gear is locked down, when in fact it is not. If, as in this and the Le Bourget accident, the pilot has interpreted the three green lights to mean that the landing gear is locked down, despite the red warning light showing, then the pilot is likely to

Given this situation, and in order to prevent similar accidents from occurring in the future, the POH would benefit from being amended to explain more clearly the significance of a red light, particularly when three green lights are displayed concurrently. For example, the following sentence in Section 7.5 of the POH is potentially misleading because if there is a continuous red light showing together with three greens, the gear is not locked:

It is recommended that EADS Socata amends the TBM 700 Pilot's Operating Handbook, to clarify the need for manual extension of the landing gear if a continuous red light is showing, even if the green gear lights on the landing gear control and indication panel are lit.
