INCIDENT

Aircraft Type and Registration:	1) Extra 300, G-OFFO 2) Extra 300, G-ZEXL
No & Type of Engines:	1) 1 Lycoming AEIO-540-L1B5 piston engine 2) 1 Lycoming AEIO-540-L1B5 piston engine
Year of Manufacture:	2006
Date & Time (UTC):	26 March 2006 at 1110 hrs
Location:	15 miles NW of North Weald
Type of Flight:	Private
Persons on Board:	1) Crew - 1 Passengers - 1 2) Crew - 1 Passengers - None
Injuries:	1) Crew - None Passengers - None 2) Crew - None Passengers - None
Nature of Damage:	1) G-OFFO Propeller tip damage 2) G-ZEXL Propeller impact to right wing
Commander's Licence:	1) Private Pilot's Licence 2) Private Pilot's Licence
Commander's Age:	1) 40 years 2) 34 years
Commander's Flying Experience:	1) 4,300 hours (of which 15 were on type) Last 90 days - 40 hours Last 28 days - 20 hours 2) 3,000 hours (of which 5 were on type) Last 90 days - 37 hours Last 28 days - 19 hours
Information Source:	Aircraft Accident Report Form submitted by the pilot

Synopsis

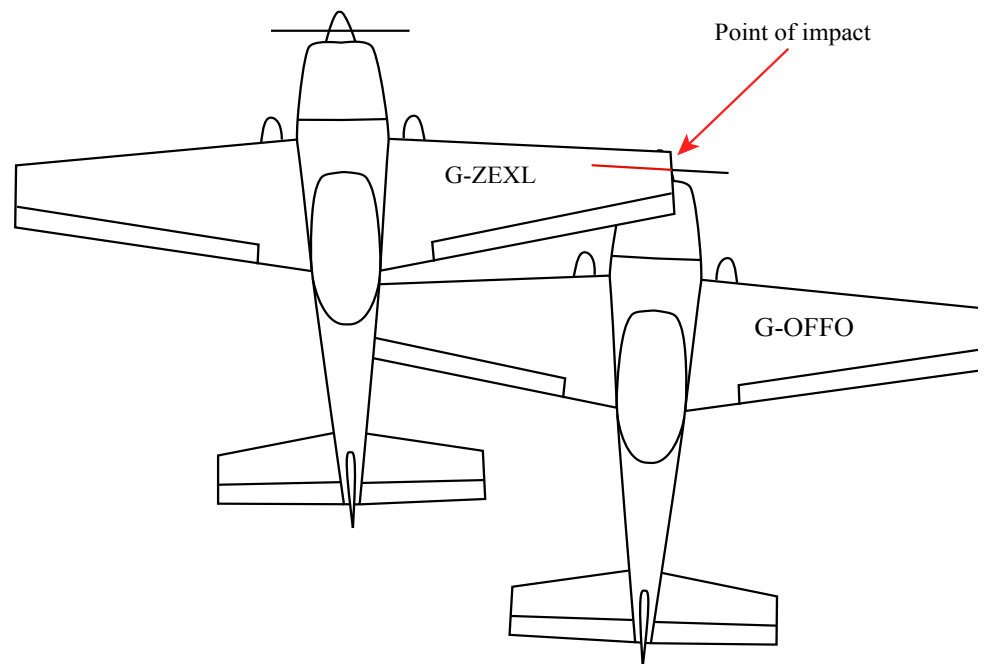
Figure 1

other aircraft. The propeller of 'FO' contacted the right wing tip of 'XL', just forward of the aileron leading edge, penetrating the full depth of the wing structure (Figure 1). Both aircraft turned back to North Weald and, having confirmed that no damage had been sustained to the flight controls, completed a precautionary landing.

Both pilots agreed that the primary cause of the incident was a breakdown in communication. The pilot of 'XL' was not aware of the position of the other aircraft and thought that he was clear to turn to the right. This situation occurred because the pilot of 'FO' had not fully communicated his intention to take up the 'deep echelon right' position, merely that he would reposition

The two pilots believed that other contributory factors included the gusty wind conditions causing the wing rocking motion, which masked the initial turn to the right, and the need to complete the sortie objectives within the limited flying time available, which may have introduced an expeditious approach to the formation change to the 'deep echelon' position.

Having considered all the factors of this accident the operator has introduced safety actions to improve the briefing process and RT procedures, as well as adopting a more measured approach to formation training.
