INCIDENT

Aircraft Type and Registration:	Boeing 747-436, G-CIVB	
No & Type of Engines:	4 Rolls-Royce RB211-524G2-19 turbofan engines	
Category:	1.1	
Year of Manufacture:	1993	
Date & Time (UTC):	18 June 2005 at 1200 hrs	
Location:	London Heathrow Airport, London	
Type of Flight:	Public Transport (Passenger)	
Persons on Board:	Crew - 17	Passengers - 334
Injuries:	Crew - None	Passengers - None
Nature of Damage:	Damage to nose wheel tyres and nose landing gear torque link	
Commander's Licence:	Air Transport Pilot's Licence	
Commander's Age:	52 years	
Commander's Flying Experience:	12,560 hours (of which 4,212 were on type) Last 90 days - 215 hours Last 28 days - 64 hours	
Information Source:	Aircraft Accident Report Form submitted by the pilot

Synopsis

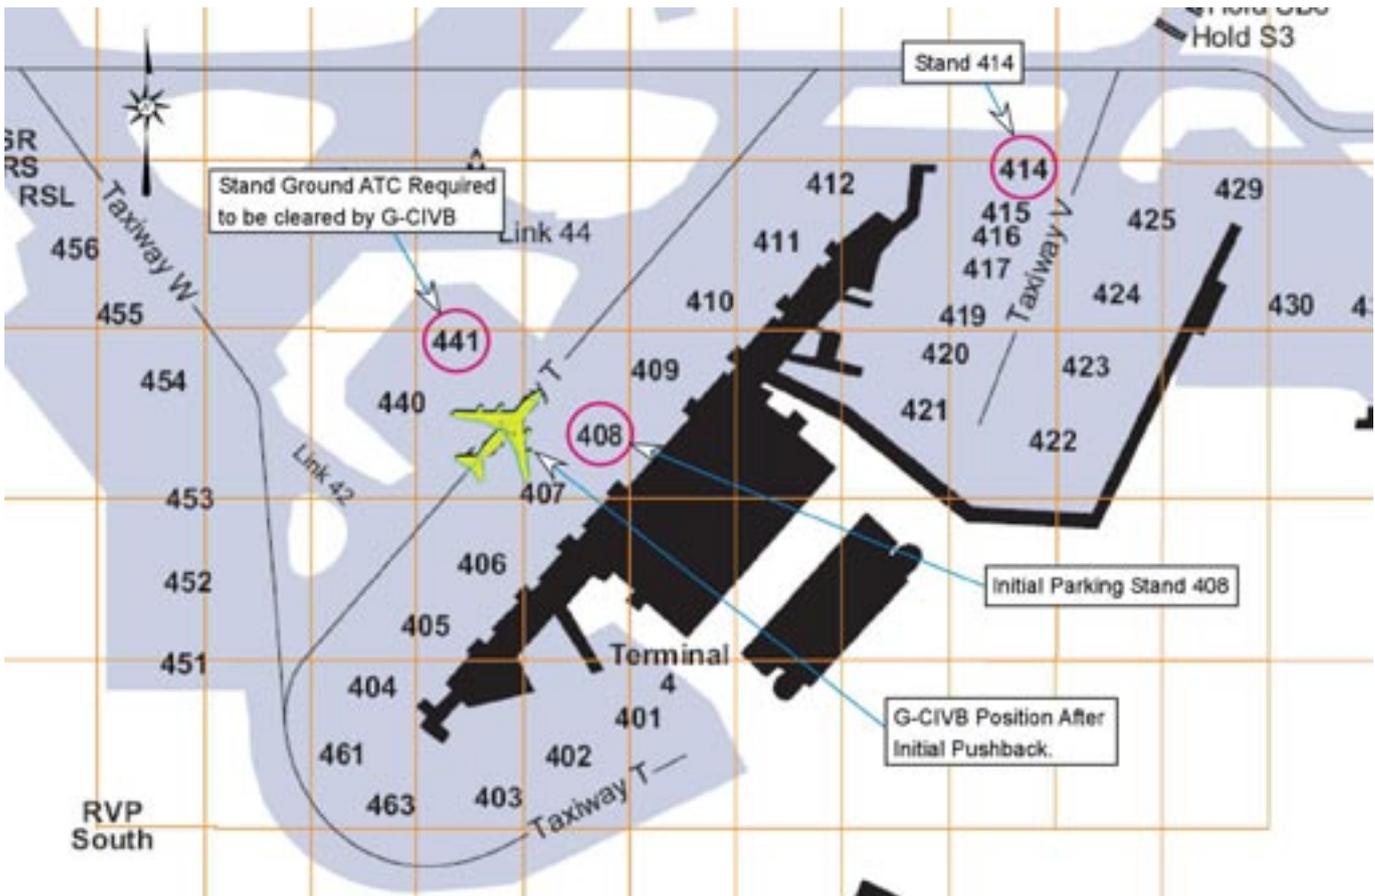
Figure 1

flight to Boston, Figure 1. A towbarless tug was attached to the aircraft's nose gear and the headset operator connected his headset into the aircraft communication system in order to talk to the aircraft's commander.
