AAIB Bulletin No: 1/96

Ref: EW/C95/10/5

INCIDENT

Aircraft Type and Registration:	Boeing 747-400, HL7482	
No & Type of Engines:	4 Pratt & Whitney PW4056 turbofan engines	
Year of Manufacture:	1991	
Date & Time (UTC):	30 October 1995 at 1718 hrs	
Location:	Stand L27 at London Heathrow Airport	
Type of Flight:	Scheduled Passenger	
Persons on Board:	Crew - 22	Passengers - 297
Injuries:	Crew - None	Passengers - None
Nature of Damage:	Minor to upper surface of left wing	
Commander's Licence:	Airline Transport Pilot's Licence	
Commander's Age:	58 years	
Commander's Flying Experience:	17,000 hours (of which 4,000 were on type)	
	Last 90 days - 200 hours	
	Last 28 days - 75 hours	
Information Source:	AAIB Field Investigation

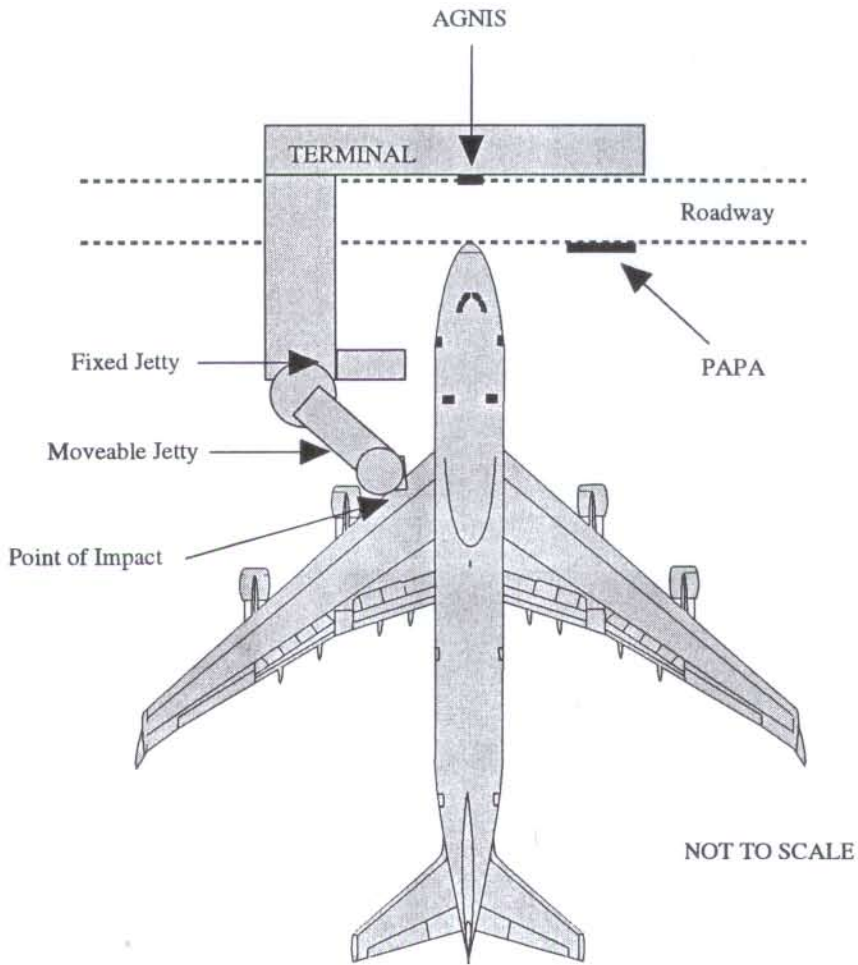
DIAGRAM OF AIRCRAFT POSITION ON STAND

The aircraft was initially aligned to the right of the lead-in line as it taxied onto the stand and hence the commander's attention was occupied primarily with the aircraft's correct azimuth alignment. The first officer's duty during this manoeuvre was to monitor the alignment and advise the commander of the aircraft's ground speed displayed on the EFIS (Electronic Flight Instrument System). He could not comment on the aircraft's progress in relation to the PAPA as his view of it was obstructed by a windscreen pillar and its alignment was set up for use only by the aircraft's left seat occupant.

The dispatcher realised that the aircraft was not going to stop at its designated position when he saw the passenger door travel past the jetty opening. He had no means of signalling to the crew. The commander stopped the aircraft when he realised that he was beyond the correct position but he was not aware that the left wing upper surface had been damaged as it came into contact with the lower section of the moveable jetty. At the time of the collision the aircraft's nosewheel was some 21 feet beyond its normal stopping position. The crew were informed that the aircraft had hit the jetty by a ground crew member via the aircraft's external interphone system after the engines had been shut down. The passengers were disembarked normally via mobile steps positioned at the rear door.

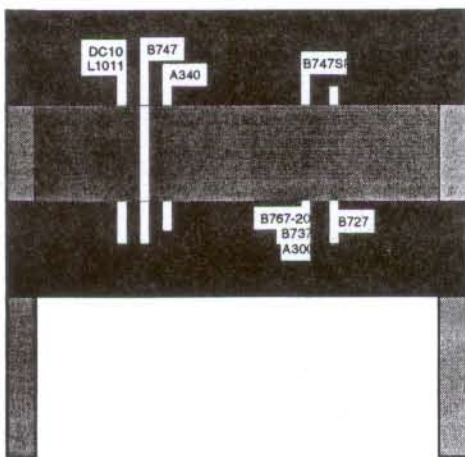
PAPA BOARD INDICATIONS

Pilot's view of PAPA Board indications for correct parking position.

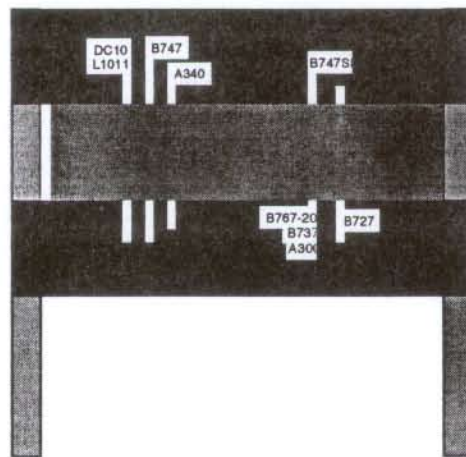
The first officer reported that the aircraft's ground speed was 3 kt as it approached the stand. Data recorded on the aircraft's DFDR (Digital Flight Data Recorder), analysed by the AAIB, showed that the ground speed was in fact 6 kt. Furthermore, the dispatcher standing in the mouth of the fixed jetty, stated that the aircraft's taxi speed was "very fast indeed" and "a lot faster than normal". The commander stated that he inadvertently missed the correct stopping position, as indicated in the PAPA, because his attention was split between the AGNIS display ahead of the aircraft and the PAPA display board some 60° to his right.

Pilot's view of PAPA Board indications at time of collision.
